2025 ENU WSDO

#### WSD0 - Install Upgrade to the Software Network VR28.11 (Workshop Campaign)

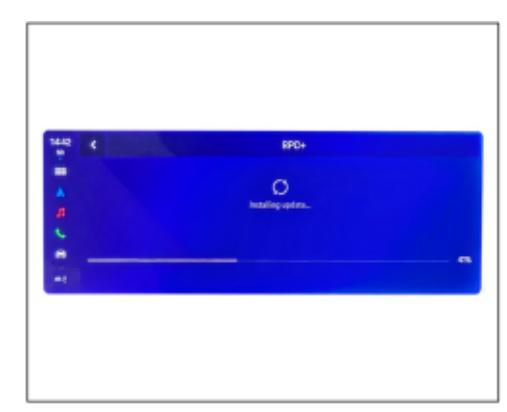
Update progress on the central display

If WiFi coverage is insufficient, the connection between the PIWIS Tester and VCI can be interrupted (battery charge indicator inactive on the Tester display at the top right). The vehicle will nevertheless continue programming **independently**. In the meantime, no entry must be made on the PIWIS Tester, and the programming must not be restarted. In such a case, the progress of the update can still be followed inside the vehicle via the central display by activating the **"Messages"** tile.
