**Title:** Switch Pack Programming Troubleshooting Information

**Applies To:** Horizon Vehicles

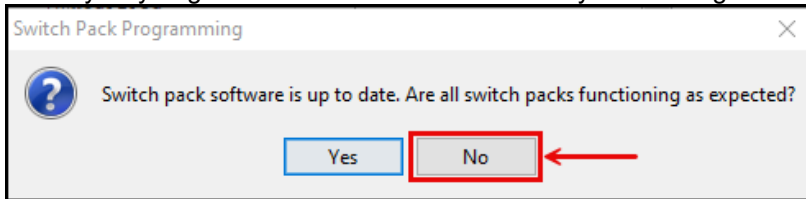
5. Once programming is successful and DLB asks you if all switch packs are working correctly, select "No". Selecting "No" is the only way to get to the next screen that allows you to change the switch pack's source address.

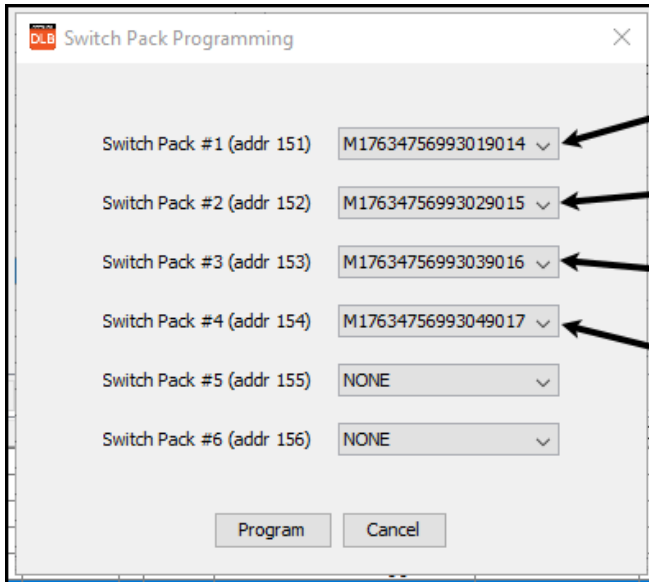
6. The next screen allows you to set the switch pack source addresses. The drop down menu presents the serial number for all connected switch packs. Make sure you select the correct serial number on the correct line, then click the "Program" button.

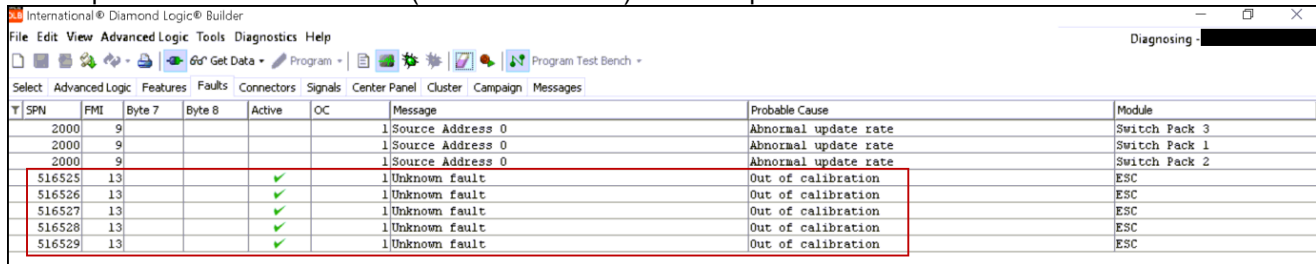
## 2. Switch pack out of calibration fault (screenshot below) or switch pack mismatch fault.

These faults are not typically caused by the kernels or source addresses. Instead, these faults are typically caused by switches being installed in different locations in the truck compared to what is shown in the DLB "Center Panel" tab. Switches and switch locations must match exactly between the vehicle and DLB. Examples of common issues are listed below.

- Example: DLB shows no switch installed in a specific location, but the truck has an unlabeled switch installed. An unlabeled switch can look similar to a blank cover plate.
  - Fix: Make sure switches match exactly between DLB and vehicle. Remove switches from vehicle or move/change switch programming in DLB.
- Example: All switches and switch locations match visually between DLB and the vehicle, but the switch packs have the wrong source addresses. If the switch pack programmed to source address 151 has different switches in it than what DLB shows, that will cause one of the faults from the screenshot above. This could happen with any of the switch pack source addresses (151, 152, 153, 154).
  - Fix: Make sure switches match exactly between DLB and vehicle. Remove switches from vehicle or move/change switch programming in DLB.

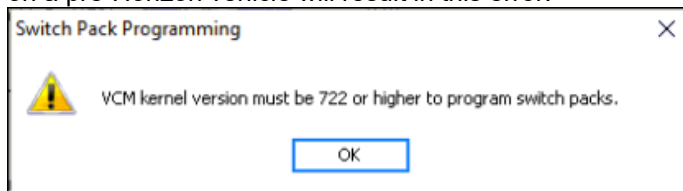
- When you hear the word "kernel", think "operating system". The kernel is the software that runs the switch pack's functionality.
- Only Horizon vehicles (LT, MV, HV, RH...) have programmable switch packs (switch packs that have their own operating system that can be updated with DLB).
- Pre-Horizon vehicles (Durastar, Prostar, Lonestar...) have switch packs, but they cannot be updated or programmed with DLB (because they do not have a kernel). Attempting to use DLB to program switch packs on a pre-Horizon vehicle will result in this error:
