INSIDE THIS ISSUE:

TECH TALK - VOLUME 286
MAY/JUNE 2025

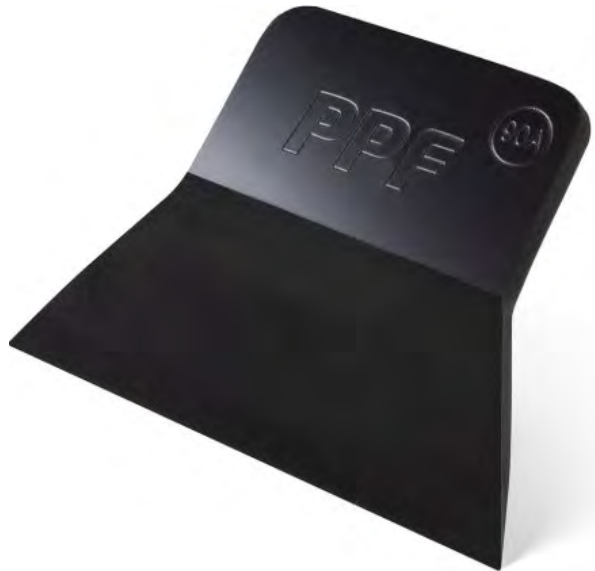
During installation of the new Paint Protection Film, certain types of squeegees will scratch the redesigned grill and possibly the hood. To mitigate the chance of scratches, MMNA recommends the use of TPU Anti-Scratch Rubber Squeegees, such as Model 90A, shown below. These can be purchased from any on-line retailer.

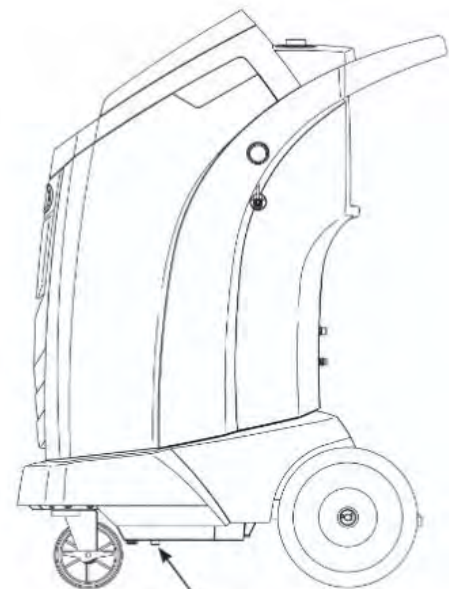
Figure 21

2. Refer to Figure 21, and verify the magnet on the bottom of the machine is clean.
3. Attach the calibration weight to the magnet on the bottom of the machine. Select **OK**.
 - If the display shows

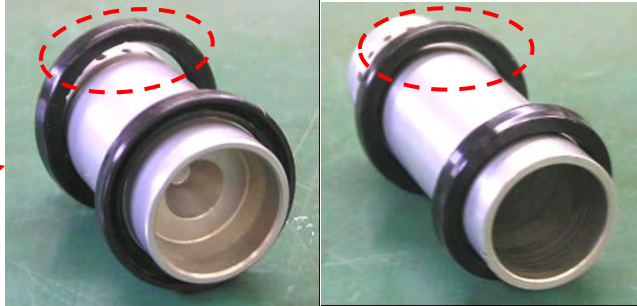
- Using or mixing any brake fluid other than the specified type (including low-quality brake fluid, a different specification) accelerates the wear of the linear solenoid valve inside the brake actuator, potentially decreasing braking performance.
- Pouring brake fluid into the container that still contains engine oil allows residual mineral oil to enter the brake system. This may cause the rubber parts to swell, potentially decreasing braking performance.

Swelling of the piston cup due to mineral oil

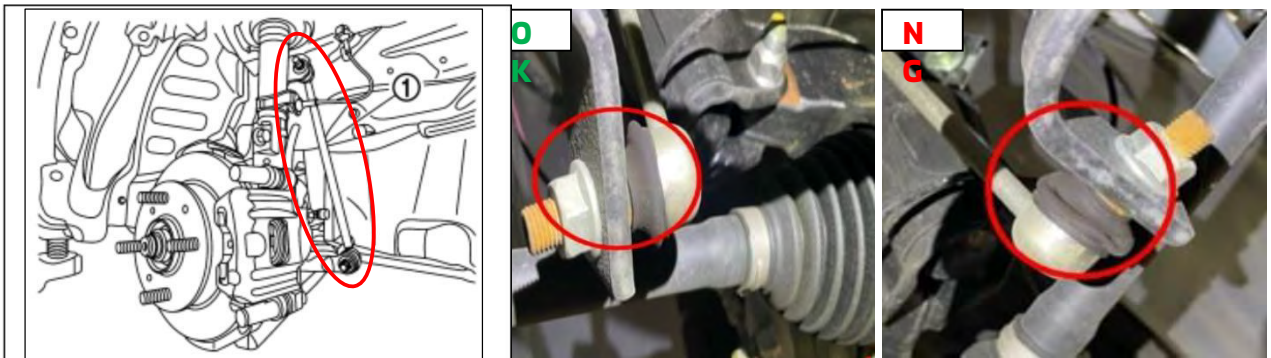
For example : Stabilizer link

The dust cover for suspension parts is a crucial component that prevents foreign objects from entering the ball joint. If a technician performs improper maintenance and/or neglects the final inspection, the dust cover may be installed in a twisted state. As a result, this can lead to early damage to the dust cover and potential damage to the suspension parts. To prevent unnecessary parts replacement, this article introduces precautions regarding the dust cover.

1. Please ensure that the dust cover is not twisted after replacing or removing suspension parts with the ball joint.
