**HYUNDAI**
Technical Service Bulletin

GROUP BODY	NUMBER 25-BD-012H
DATE NOVEMBER 2025	MODEL(S) ALL

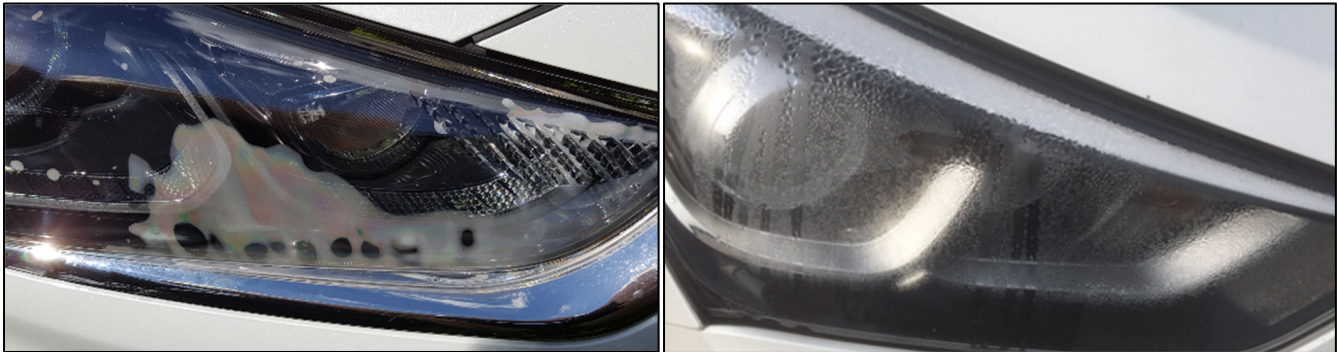
Applicable Vehicles: All

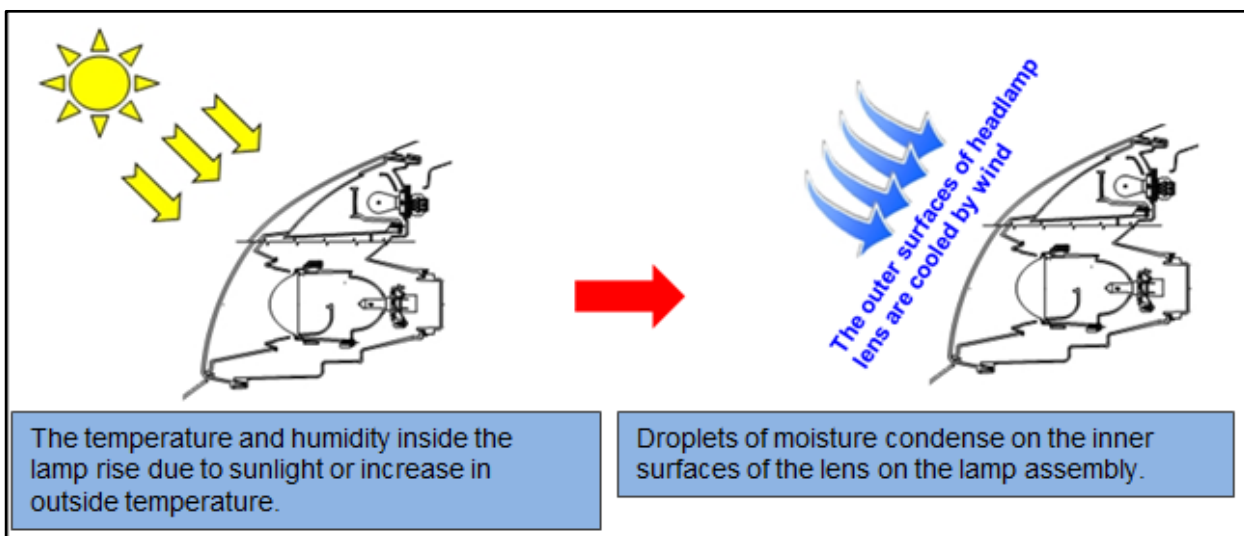
2. Condensation from Engine Startup

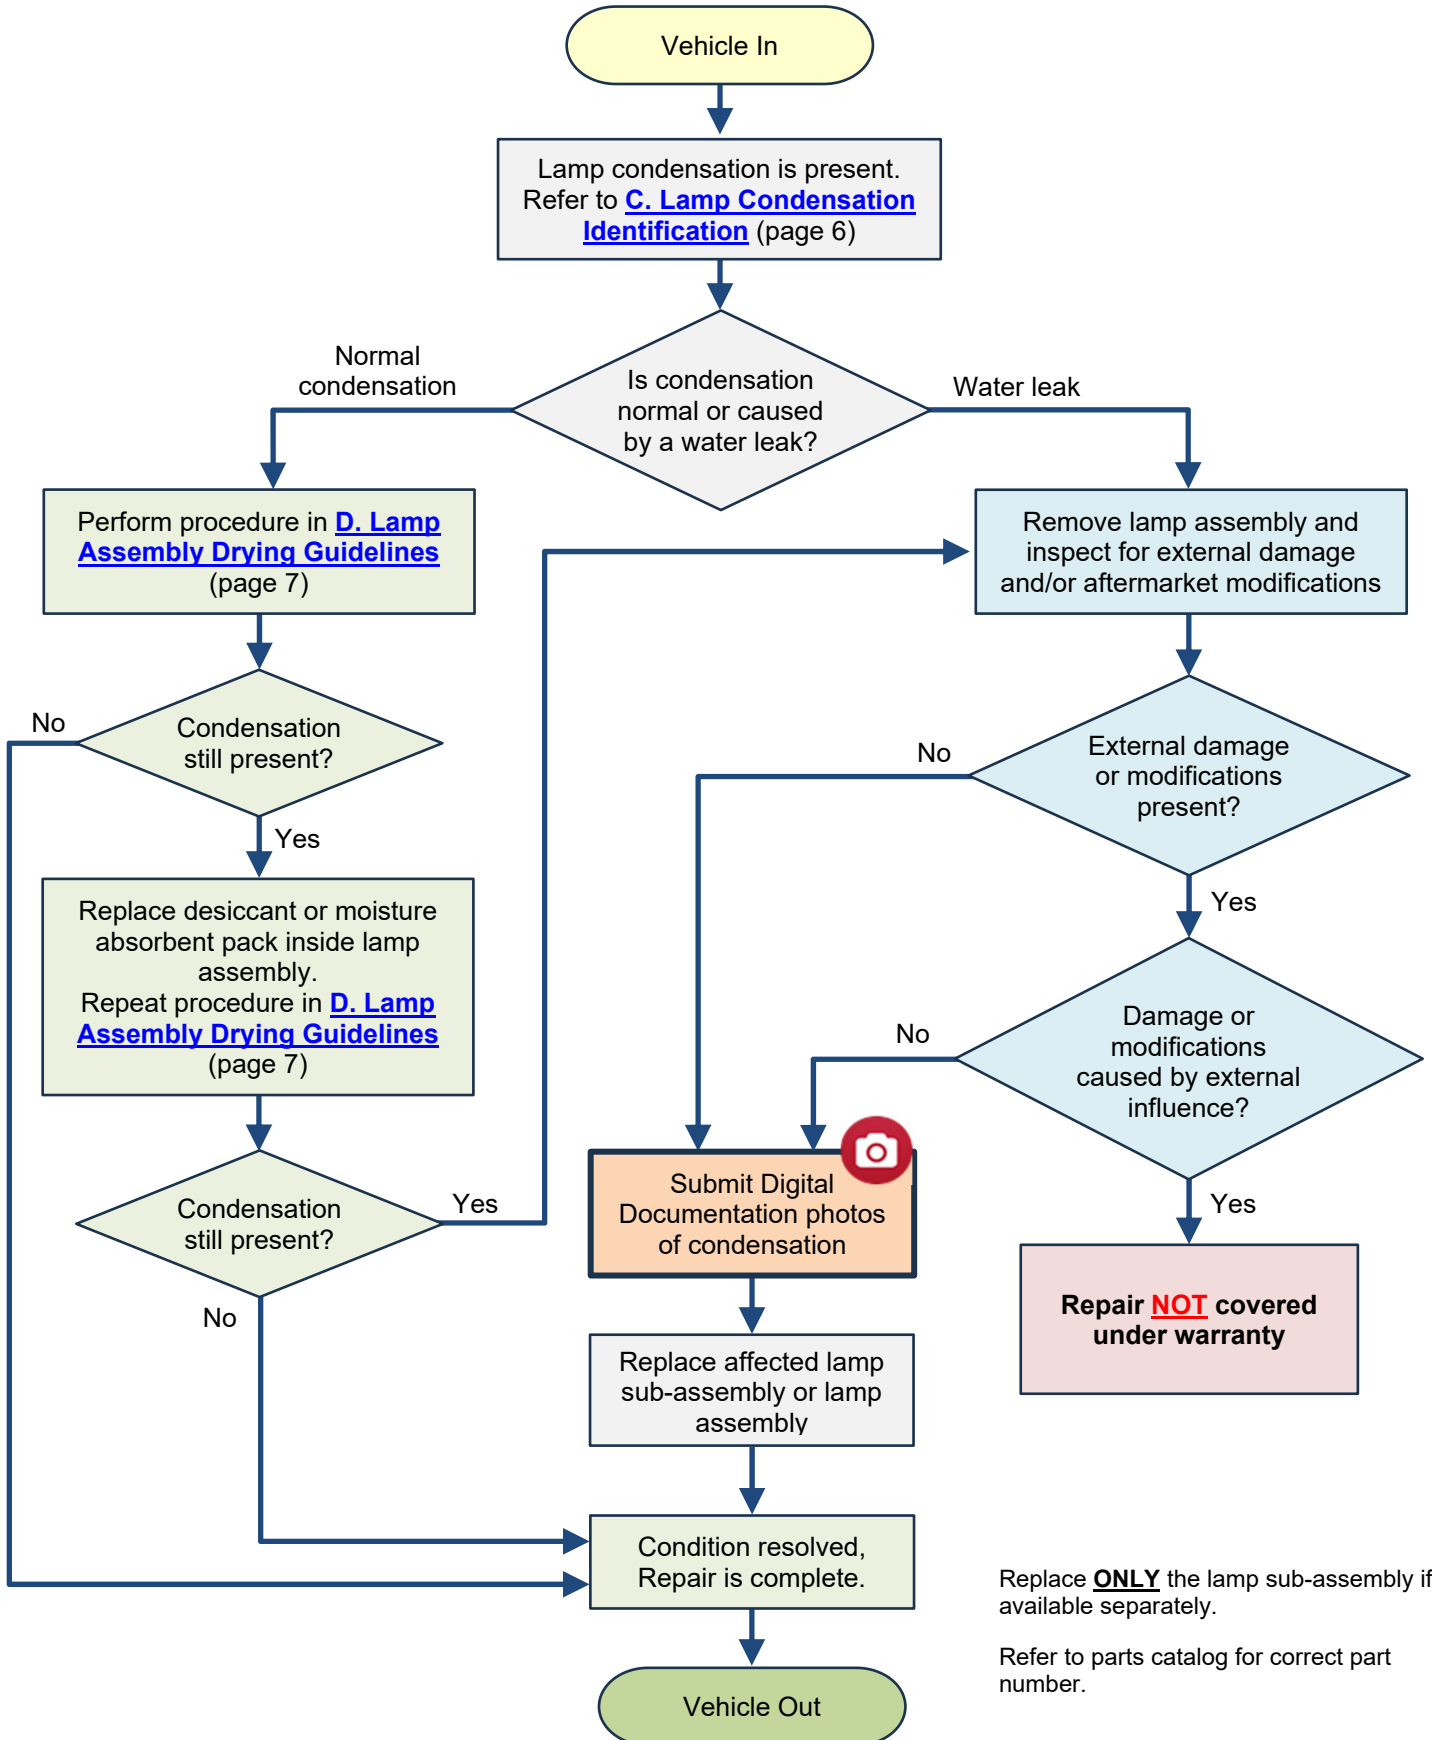
Replace **ONLY** the lamp sub-assembly if available separately.

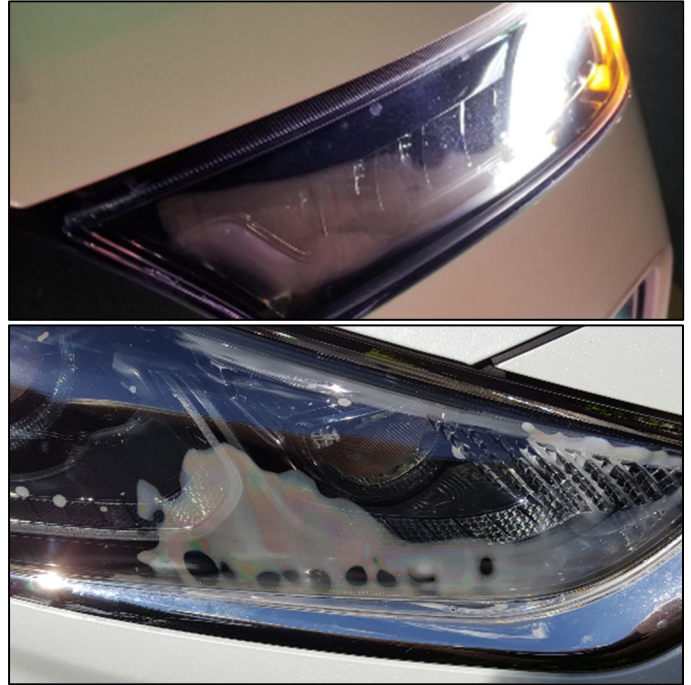
Normal Condensation in the Lamp

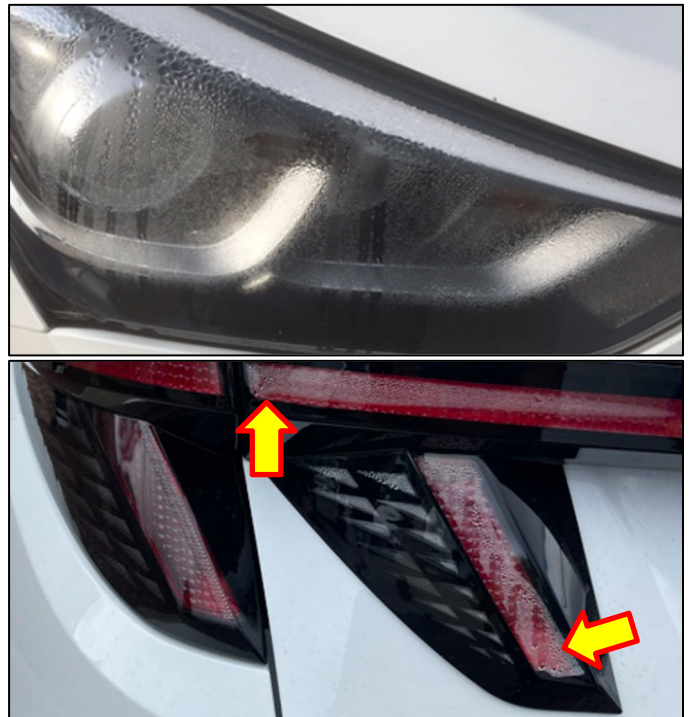
D. Lamp Assembly Drying Guidelines

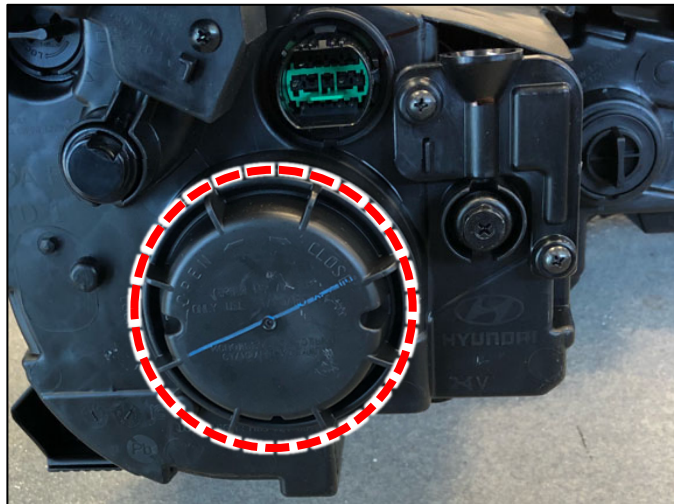
Example Location of Dust Cap
