## Condition

Model(s)	Year(s)	VIN Range	Vehicle Specific Equipment
Q5, Q5 Sportback, SQ5, and SQ5 Sportback (GU)	2025	All	79H

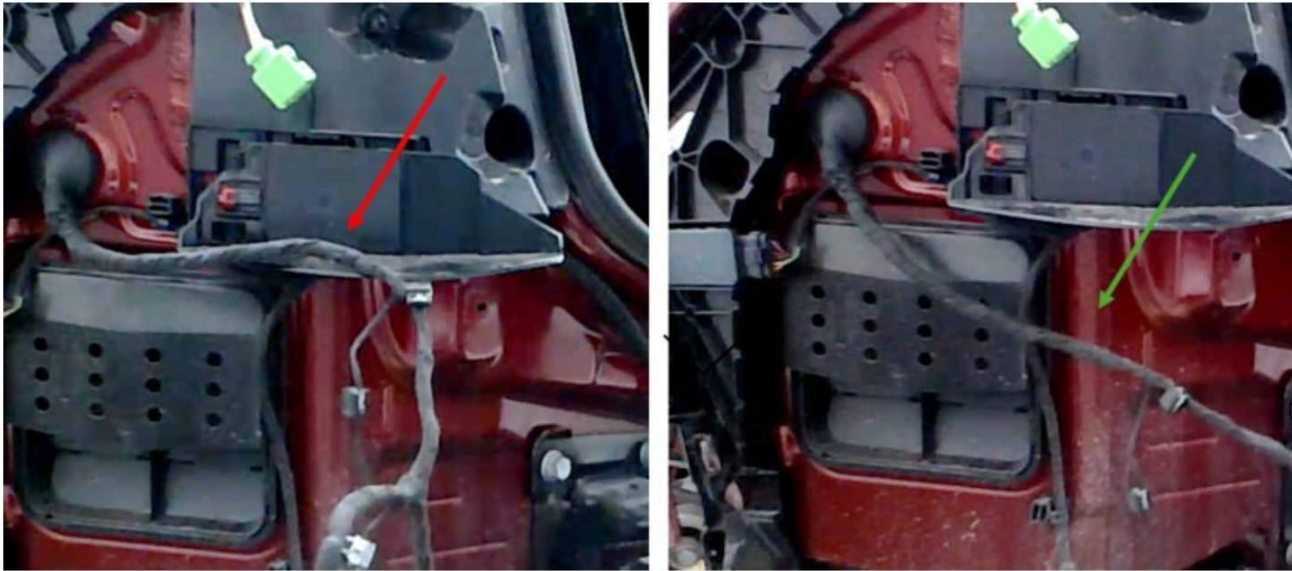
**Figure 1.** *Incorrect cable routing (left in image) and correct cable routing (right in image) of bumper wiring harness*
