## Technical Service Bulletin

GROUP <b>BODY</b>	NUMBER <b>26-BD-002H</b>
DATE <b>APRIL 2026</b>	MODEL(S) <b>SEE BELOW</b>

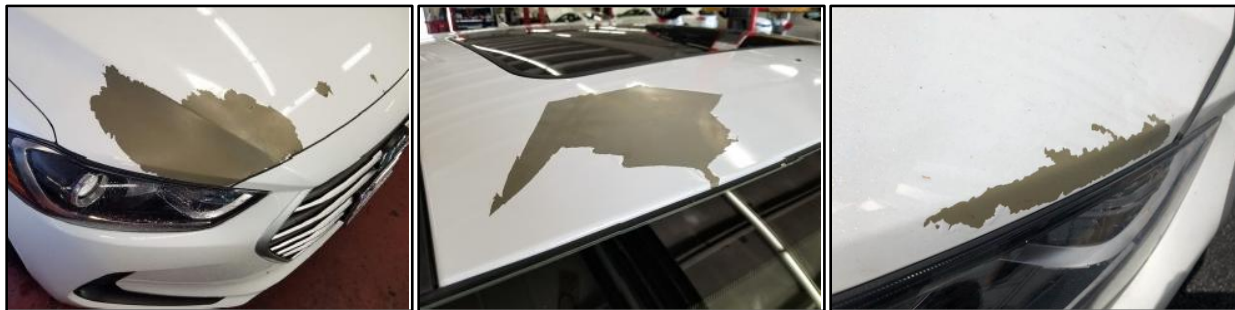
**Applicable Vehicles (Certain):**

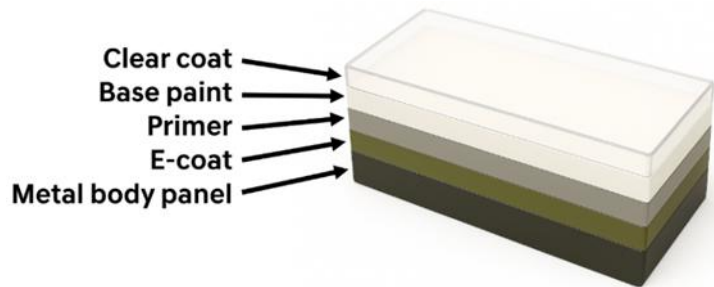
Paint peeling is caused by excessive amounts of ultraviolet (UV) rays penetrating through the clear coat and base paint and into primer. The primer loses adhesion to the e-coat from the excessive exposure to UV rays, which causes the upper paint layers to peel and flake off.

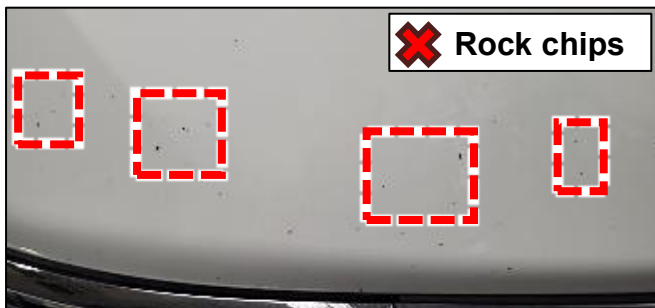
- Rock chips
- Scratches
- Bird droppings
- Sap/wax
- Aftermarket wraps
- Collision damage
- Customer-induced damages

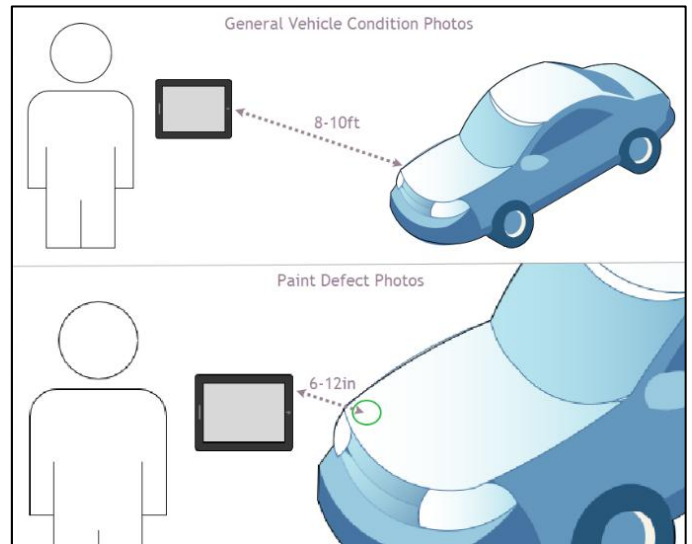
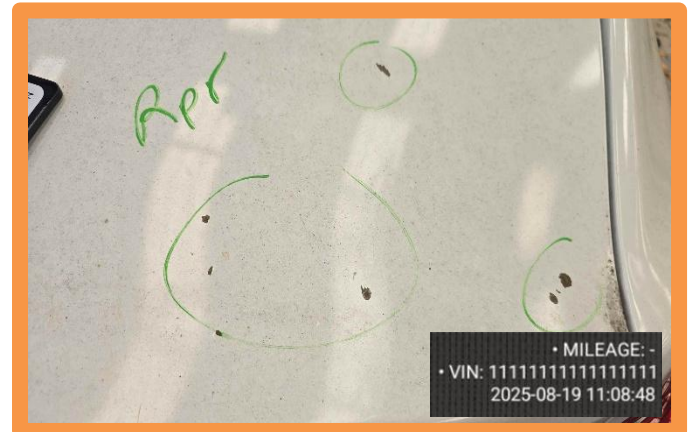
Upload the photos to STUI with file names and descriptions that describe the location of the affected panel(s) (hood, roof, fender, etc.).

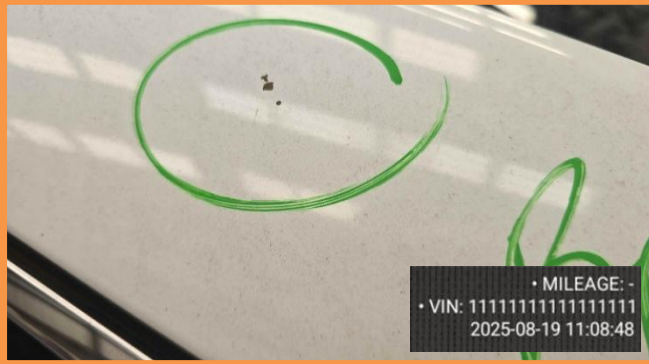
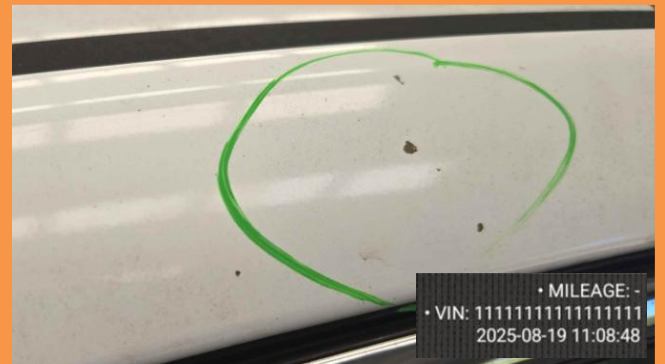
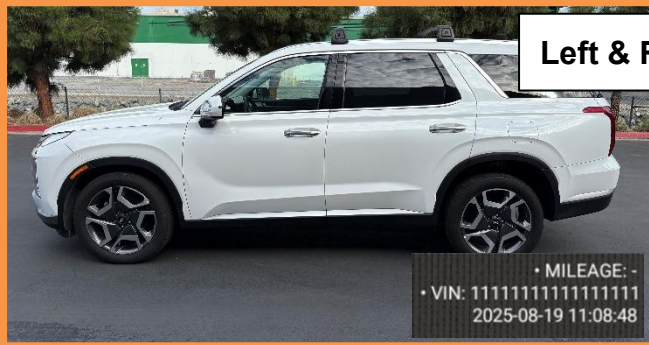
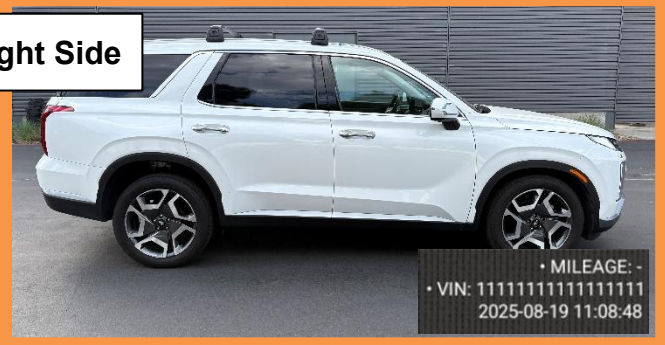
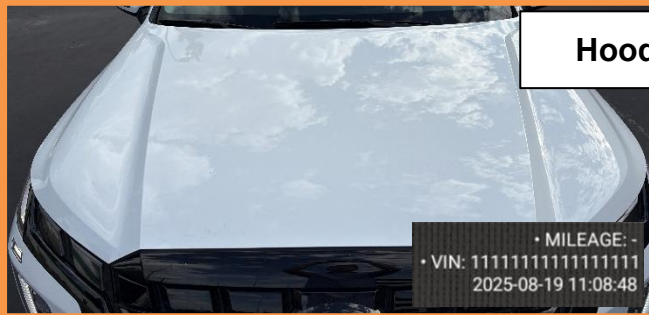
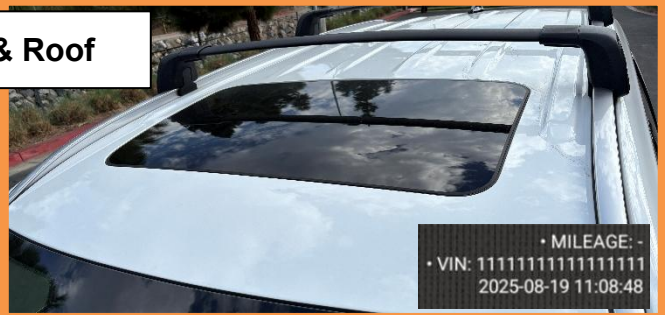
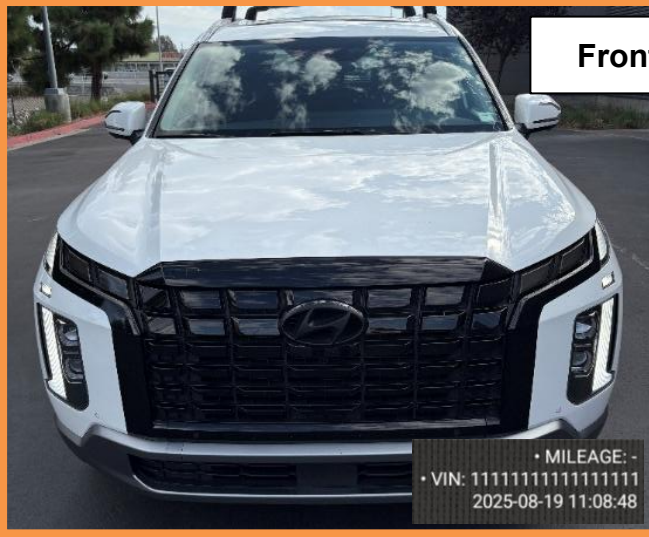
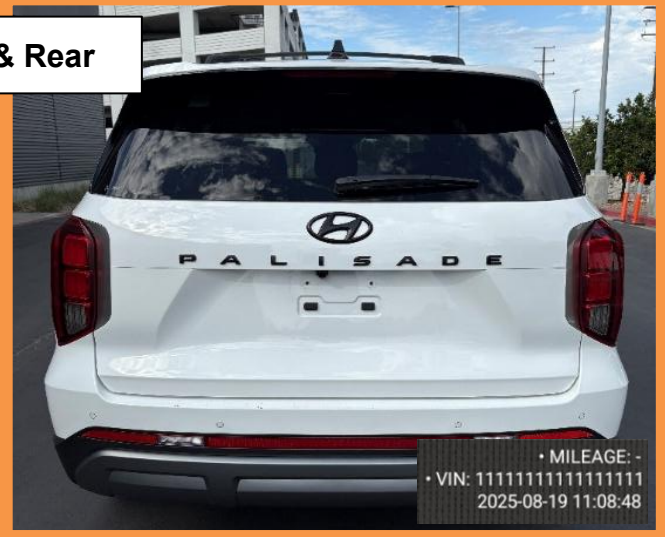
**White Paint Repair Procedure**
