SIB 31 06 26

FRONT AXLE CONTROL ARM BALL JOINT BOOT DAMAGE

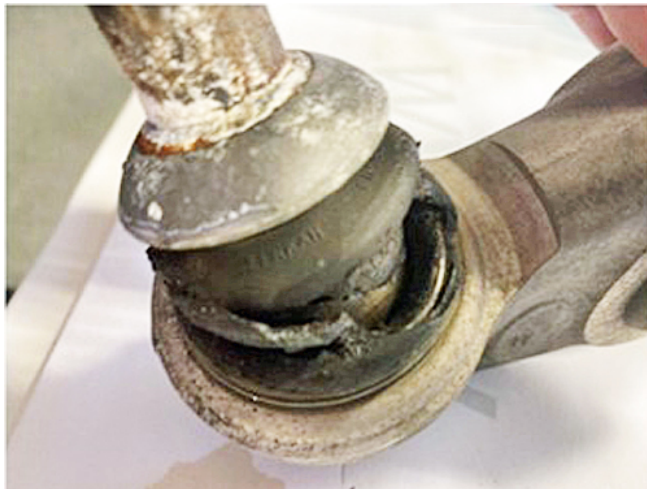
Cracks occur in the ball joint boot when corrosion develops in the boot's lower groove due to infiltration.
