## Technical product information

| Topic | Paint Surface Marking After Storage |

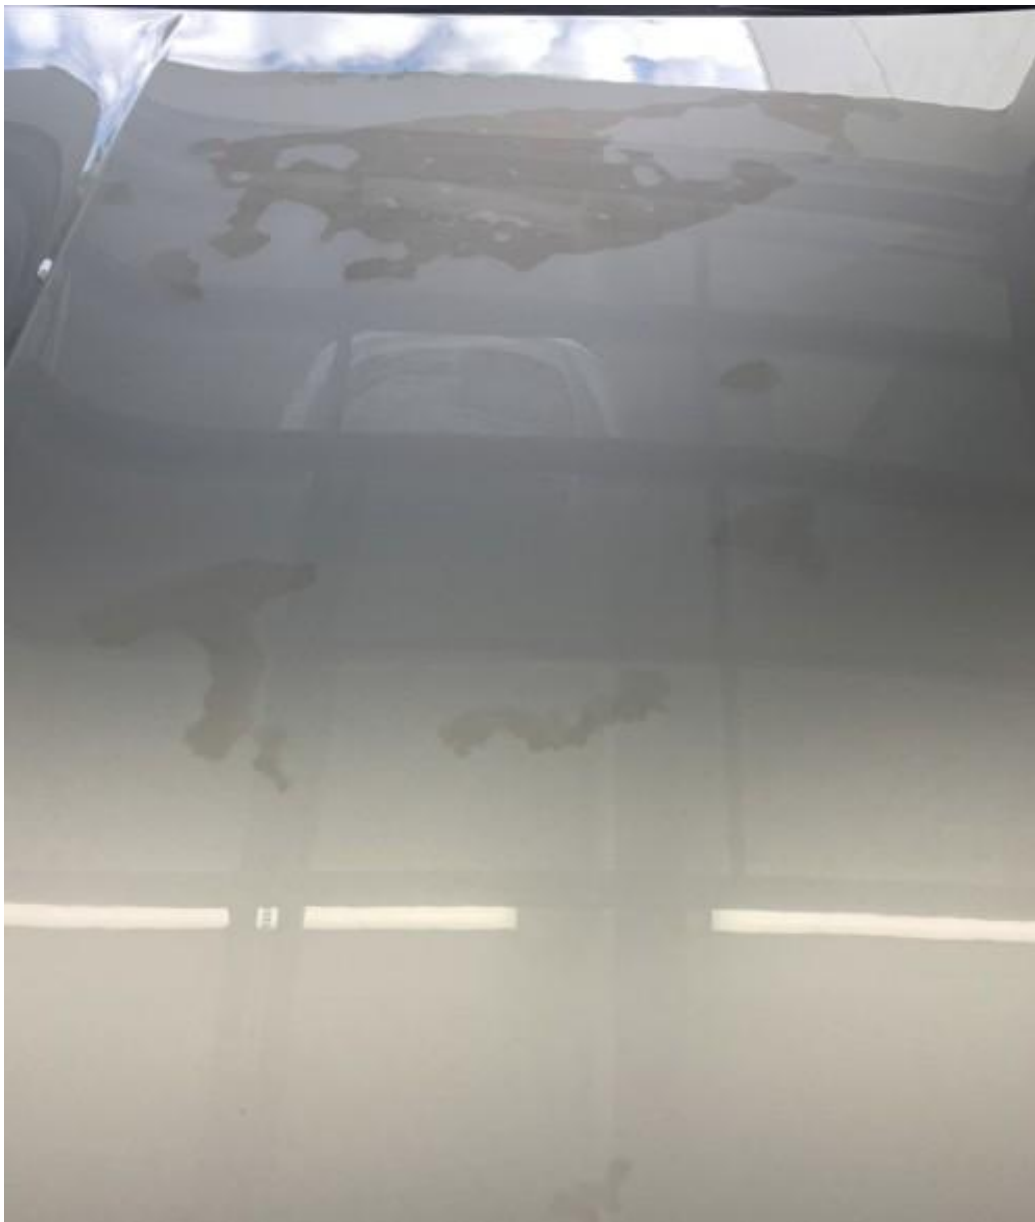
**Figure 1.** *Paint marking example*
