**Figure 3. Cosmetic Cylinder Staining**

**Figure 4. Cosmetic Cylinder Staining**

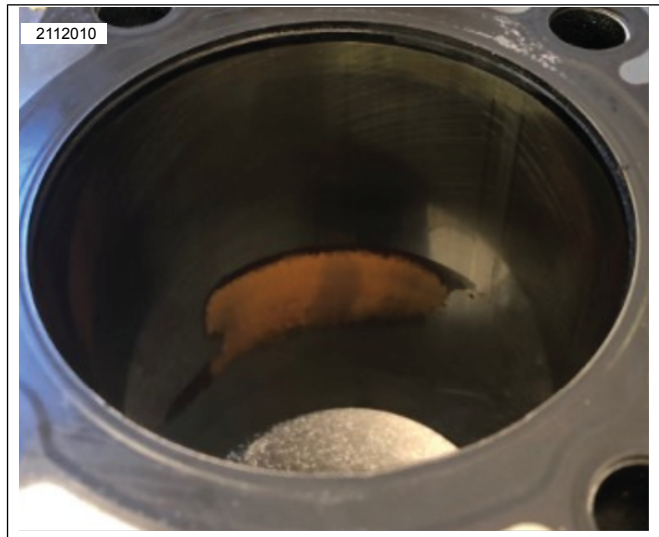
**Figure 5. Oxidation**
