## Technical Service Bulletin

| GROUP<br><b>CAMPAIGN</b> | NUMBER<br><b>26-01-074H</b> |

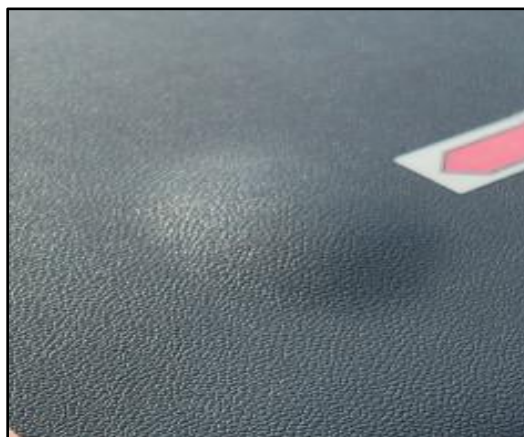
### Applicable Vehicles (Certain):

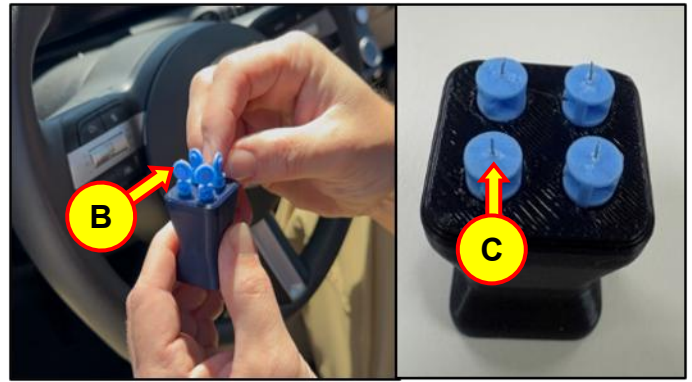
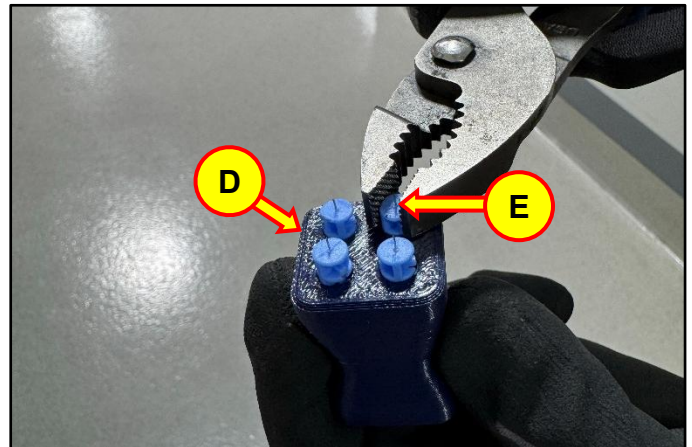
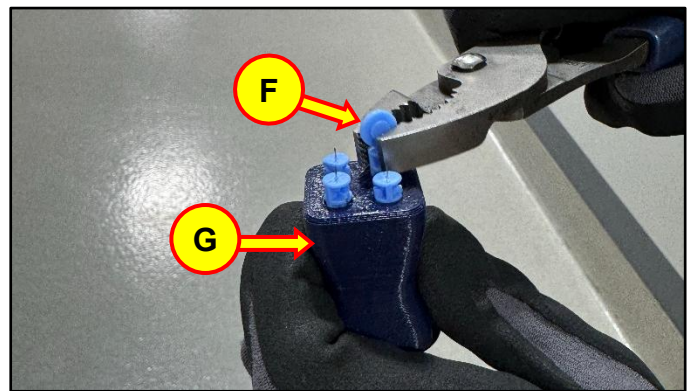
3. Use the needling tool (D) to make at least 6 punctures around the bubbling area(s) as shown.

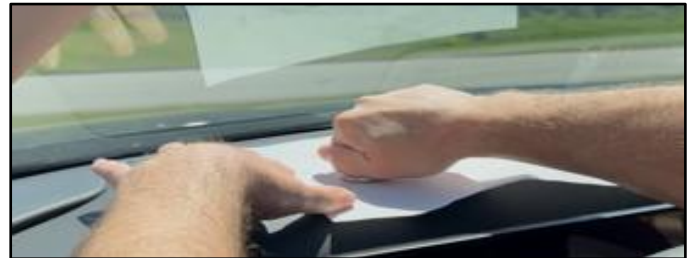
**SUBJECT:****DASHBOARD AIR BUBBLING – INSPECTION & REPAIR  
(LIMITED COVERAGE CAMPAIGN LA33)**

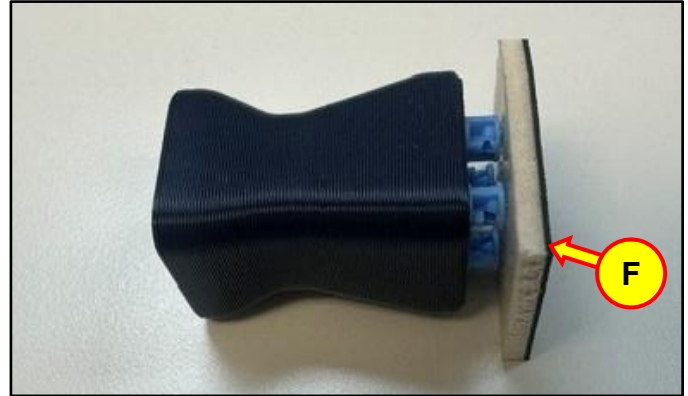
Do **NOT** dispose of the needling tool; it is able to be used on additional vehicles needing repair.

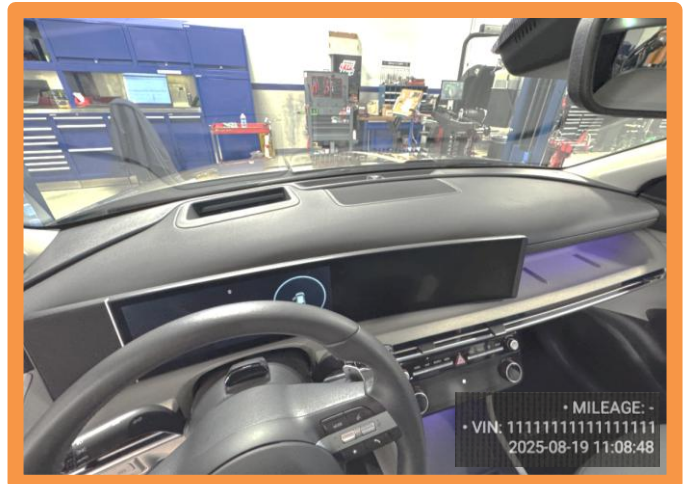
9. The service procedure is now complete.
