Congress of the United States
House of Representatives
Washington, DC 20515-3002

I have received the enclosed information from [REDACTED]
[REDACTED] of Ocean City, New Jersey, regarding his concern about
brake line corrosion on his Lincoln Town Car.

Dear Director: Re: NHTSA ID # 02V101000

AUTOMOTIVE**Copper-Nickel Automotive Vehicle Brake Tubing**

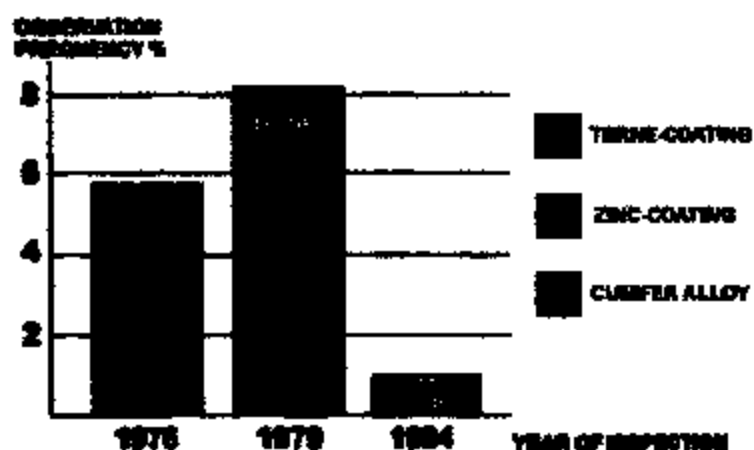
Figure 2. Annual Swedish Vehicle Safety Inspection Results. The bars indicate the percentage of 8-year old Volvo passenger cars inspected in the indicated year with brake lines which did not meet the inspection requirements. 1976 was the year Volvo introduced 90-10 copper-nickel tubes ("Copper Alloy") into their vehicles.

The bar graph shown in Figure 2 depicts the percentage of vehicles failing safety inspections because of defects in the

brake systems of eight-year-old Volvo passenger cars. The 1970 model cars had tarne-coated steel tubes. Tubes in the 1971 models were zinc coated. Defects other than rusted tubes are included in these values, but their effect on the data is minimal. The reduction in defects related to the introducing of 90-10 copper-nickel tube in 1976 is dramatic.
