Re: Toyota Tacoma Front Suspension  
Part 573, Defect Information Report

# DEFECT INFORMATION REPORT

SUBJECT: SPECIAL SERVICE CAMPAIGN - T06  
(1995-1996 TACOMA FRONT SUSPENSION SUPPORT)

## SSC T06 - 1995 to 1996 TACOMA 4X2 VEHICLE FRONT SUSPENSION SUPPORT SAFETY RECALL NOTICE

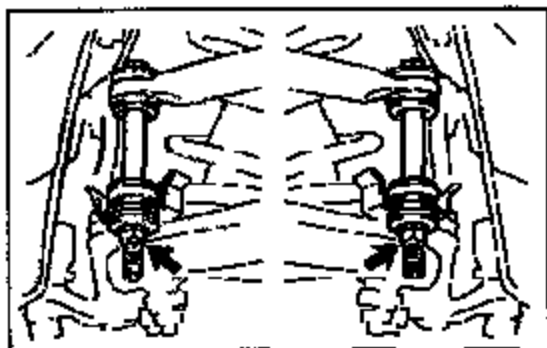
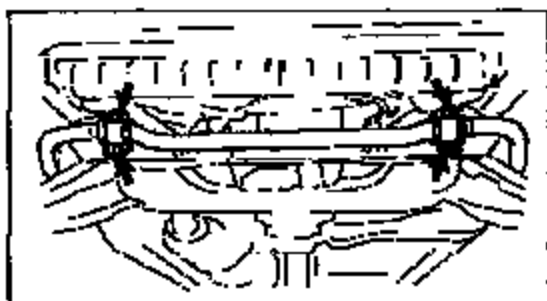
(a) Hold the bolt with a wrench, then remove the two (2) nuts, retainers, collars and cushions from the lower suspension arm.

(b) Remove the four (4) bolts and stabilizer bar with the cushions and brackets.
