DOT Auto Safety Hotline  
**Vehicle Owner's Questionnaire**  
To Report Vehicle Safety Defects  
1-888-DASH-2-DOT  
(1-888-327-4236)  
INTERNET: www.nhtsa.dot.gov/hotline

COUNTRY COACH

INTRIGUE

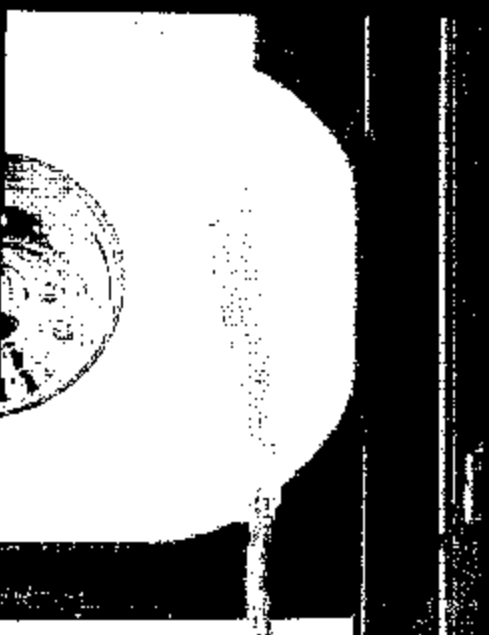
January 11, 2006  
Radiators being replaced  
Lazydays RV center  
Seffner, Florida
