[REDACTED]
Farragut, TN [REDACTED]
March 3, 2006
Phone: [REDACTED]

National Highway Traffic Safety Administration
400 Seventh Street, S. W.
Washington, DC 20590
Phone: 888-327-4236

I am forwarding to you copies three letters to my local Honda dealer and three letters of transmittal to American Honda concerning a runaway incident that occurred on February 9, 2001 while my wife was driving our new 2006 Honda Odyssey EXL van on the interstate highway. The vehicle failed to slow down even though my wife depressed the brakes. It speeded down the interstate at approximately 70 MPH narrowly missing other vehicles for 4 or 5 miles until my wife finally stopped it by turning off the ignition. Fortunately no one was injured and there was no collision. However, the transmission and brakes were severely damaged. The Honda dealer called in American Honda engineering/service immediately, they blamed the incident on rubber floor mats jamming the accelerator, and the dealer refused to repair the known problems under warranty. As of today the vehicle is still sitting broken at the Honda dealer.

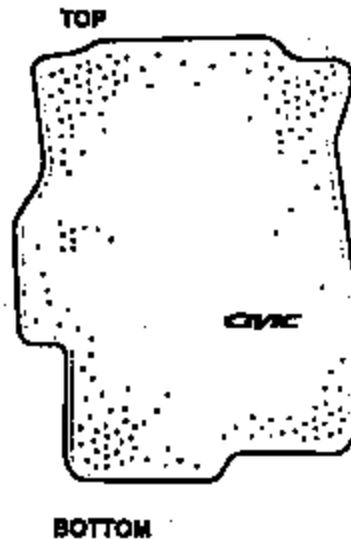
As soon as possible, you should determine if your car is equipped with a Genuine Honda Accessory floor mat in the driver's position. Honda floor mats are shaped like the illustration below. If yours looks like the illustration, you probably have an affected mat.
