**DOT Auto Safety Hotline**  
**Vehicle Owner's Questionnaire**  
**To Report Vehicle Safety Defects**  
**1-888-DASH-2-DOT**  
**(1-888-327-4236)**  
**INTERNET: www.nhtsa.dot.gov/hotline**

072200 FUEL SYSTEM, GASOLINE:DELIVERY:HOSES, LINES/PIPING, .

On December 16 2006, the rear brake line on my truck ruptured due to severe rusting. With only the front brakes working, it was very difficult to the truck stopped at 25 MPH. Seeing the condition of the brake and fuel lines, I decided to replace all the fuel and brake lines. I purchased a replacement set of lines make by Inline tube.com on 12/18/06. They are located at 15066 Technology Dr. Shelby Twp. Michigan.

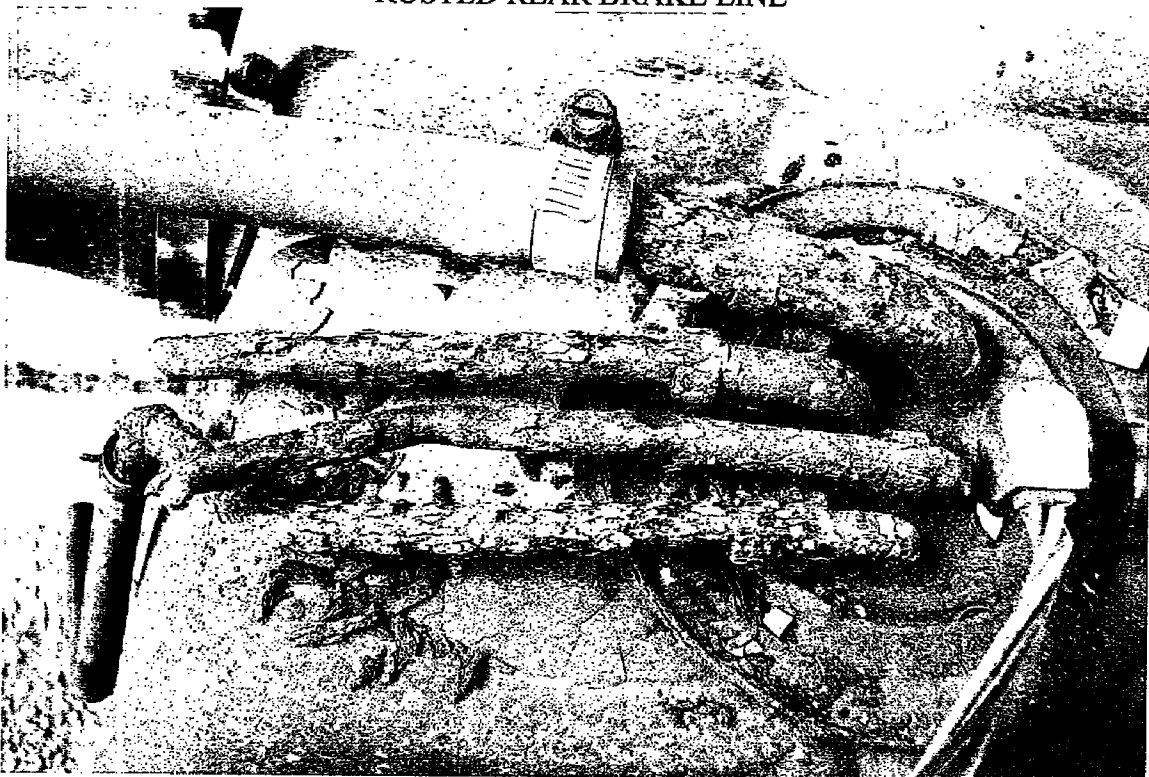
FUEL LINES AT FUEL TANK SENDER
