Vehicle Owner's Questionnaire
To Report Vehicle Safety Defects
1-888-DASH-2-DOT
(1-888-327-4236)
INTERNET: www.nhtsa.dot.gov/hotline

17 digit Vehicle Identification Number Located at bottom of windshield on driver's side
4YDF329235 [REDACTED] Make: KEYSTONE Model: MONTANA 3295RK Model Year: 2005
Date Purchased: 17-AUG-04 Dealer's Name and Telephone Number: FOLEY RV. INC. Engine: No. Cylinders: N/A Fuel Type: N/A
Original Owner: Dealer's City: BURLINGTON State: WA Zip Code: 98233
Transmission Type: N/A Antilock Brakes: N/A Cruise Control: N/A Powertrain: N/A
Vehicle Component Code: 181100 STRUCTURE: FRAME AND MEMBERS; UNDERBODY SHIELDS
Multiple Failure: 2 3

KING PIN FRAME FLEX FAILURE
REFER TO LETTER OF FAILURE'S

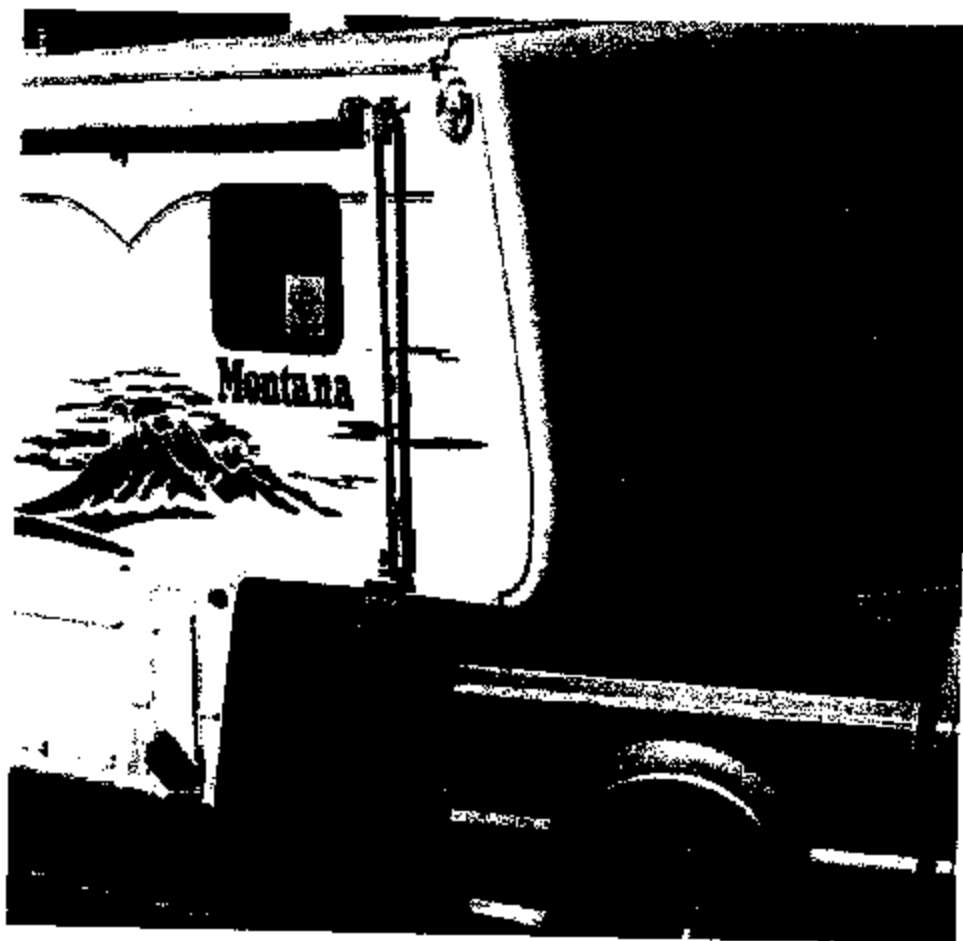
The arrows show where we saw the gaps when we had the overhang frame problem. Check all along that trim including the corners. You'll see where the trim is pulled away from the caulk line if you have this problem.

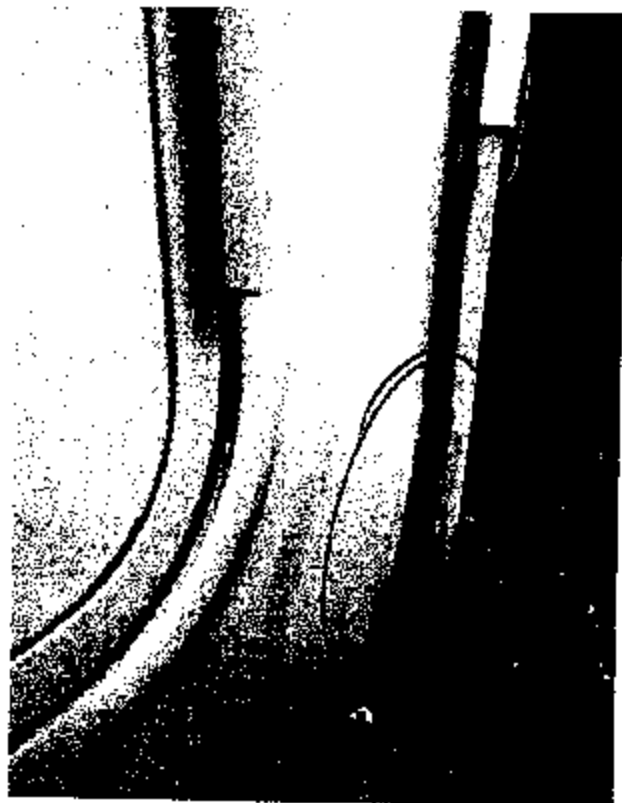
I ran across another picture showing the gap at the lower corner, when hitched up. This was on our 2003 3295RK, not our 2007 3400RL. We've had no problem of this sort with the 2007.
