DOT Auto Safety Hotline  
**Vehicle Owner's Questionnaire**  
To Report Vehicle Safety Defects  
1-888-DASH-2-DOT  
(1-888-327-4236)  
INTERNET: www.nhtsa.dot.gov/hotline

351000 EQUIPMENT: RECREATIONAL VEHICLE

Subject: Keystone RV Dometic Refrigerator Recall  
NHTSA Recall # 07V-134

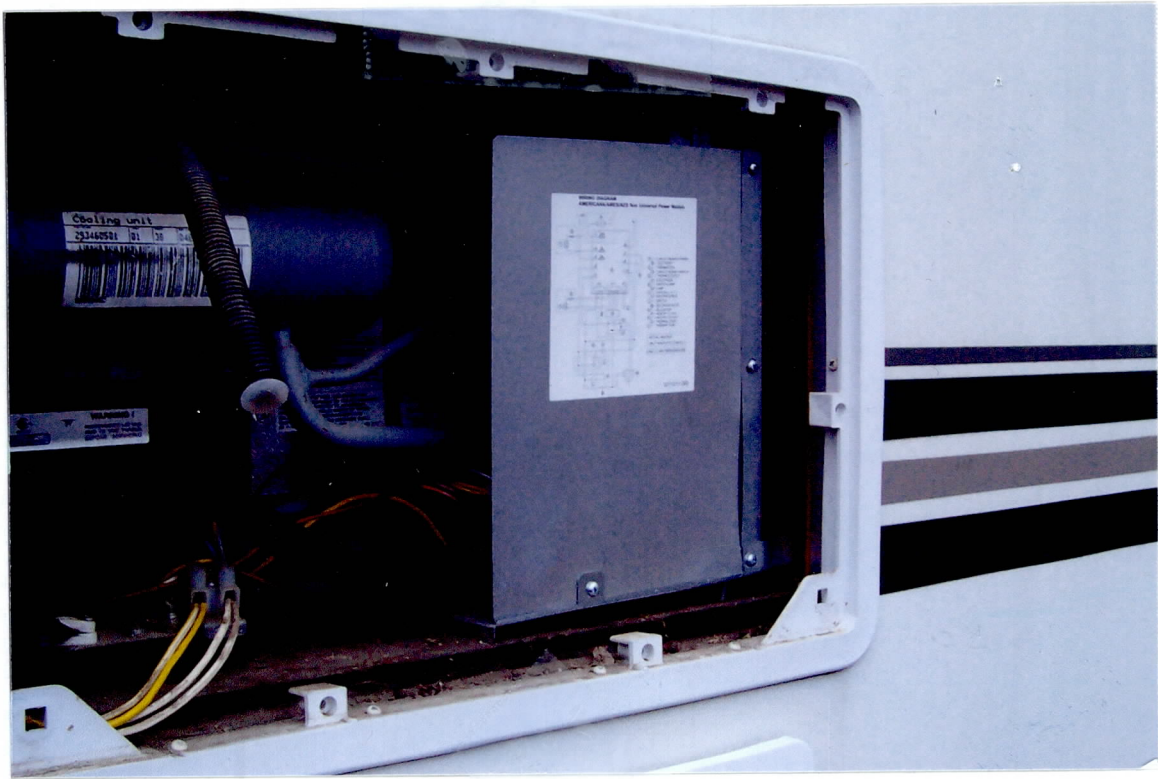
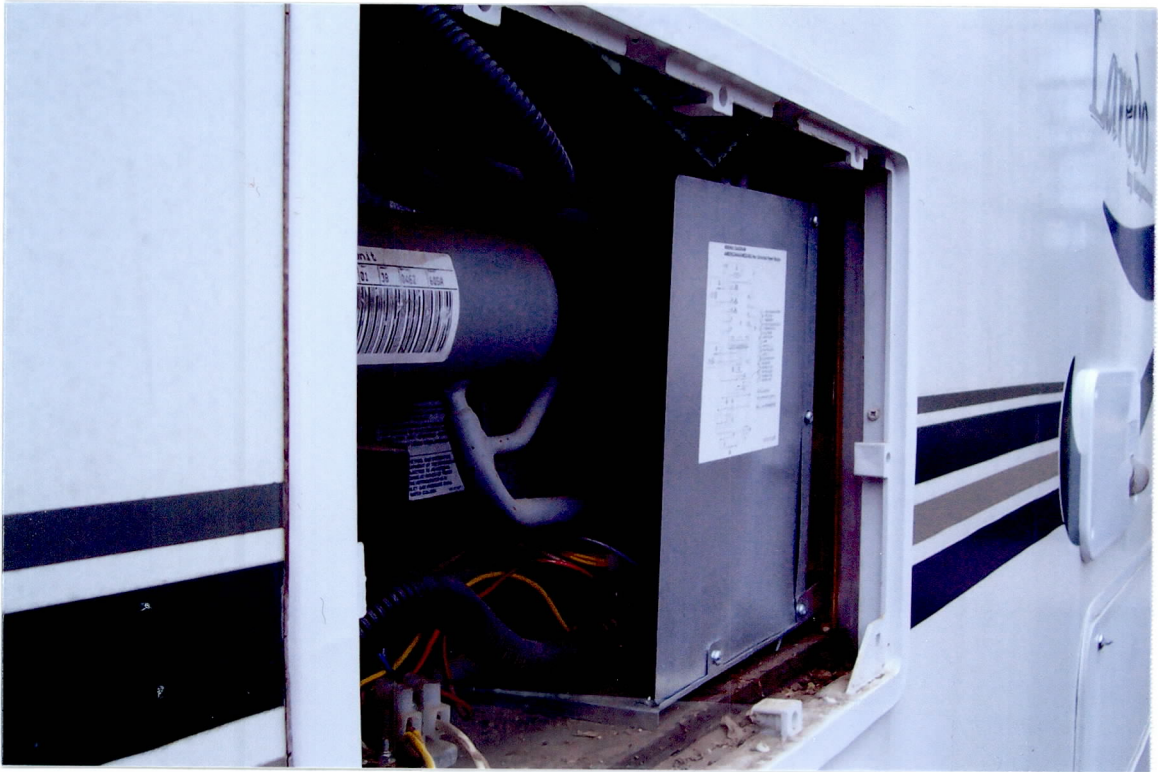
Here is 2 Photos of Sheet Metal. They are not fixing the Problem  
They are just covering it up. This has nothing to do with the  
Bailer Tube. if the Tube cracks there is still a chance  
of vehicle fire Saredo Ven #4YDF27R262
