Vehicle Owner's Questionnaire

TL\* THE CONTACT OWNS AFTERMARKET RAYBESTOS, MANUFACTURED BY BRAKE PARTS INC., MODEL #MKD500(NA) FRONT BRAKE PADS. AFTER EXAMINING THE BRAKE PADS HE NOTICED THAT THE SQUEAL SHIMS WERE CUTTING THROUGH THE ROTORS. THE BRAKE PADS WERE BEING USED ON A 1991 TOYOTA PREVIA.

1991 Toyota Previa, (w/4 wheel disc & ABS) front brake pad replacement.

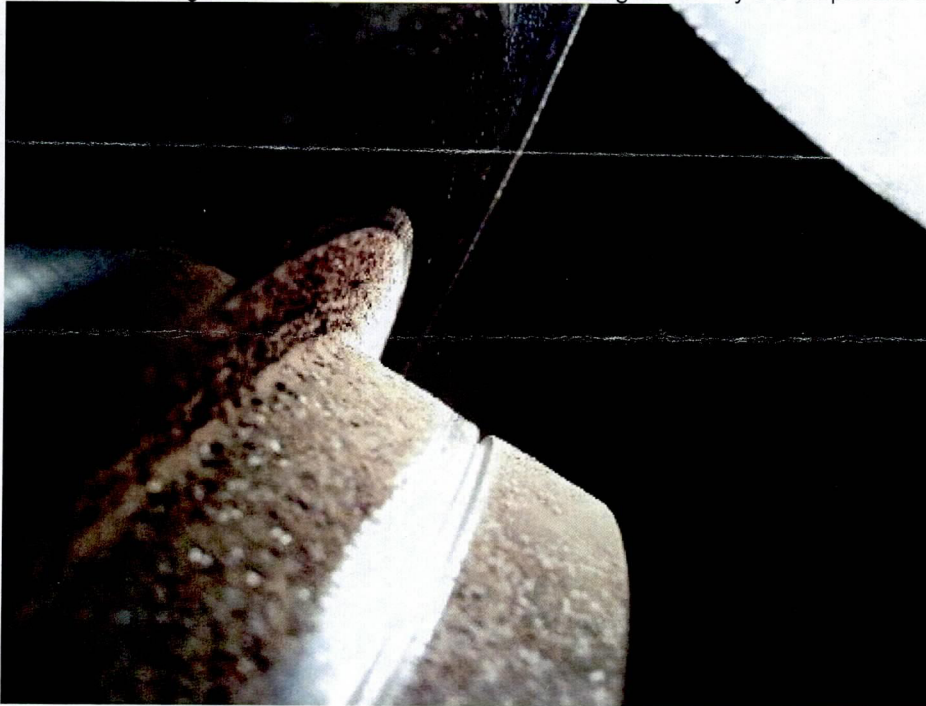
This shows the groove cut into the base of the front right rotor by the displaced shim.

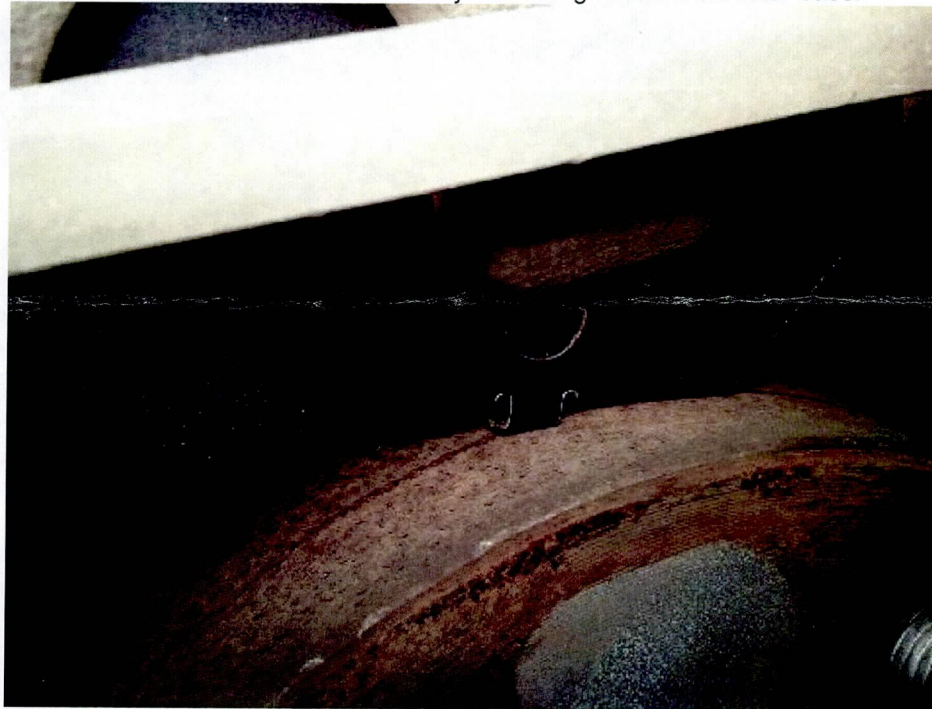
This is the front left rotor with the shim just starting to score the rotor base.

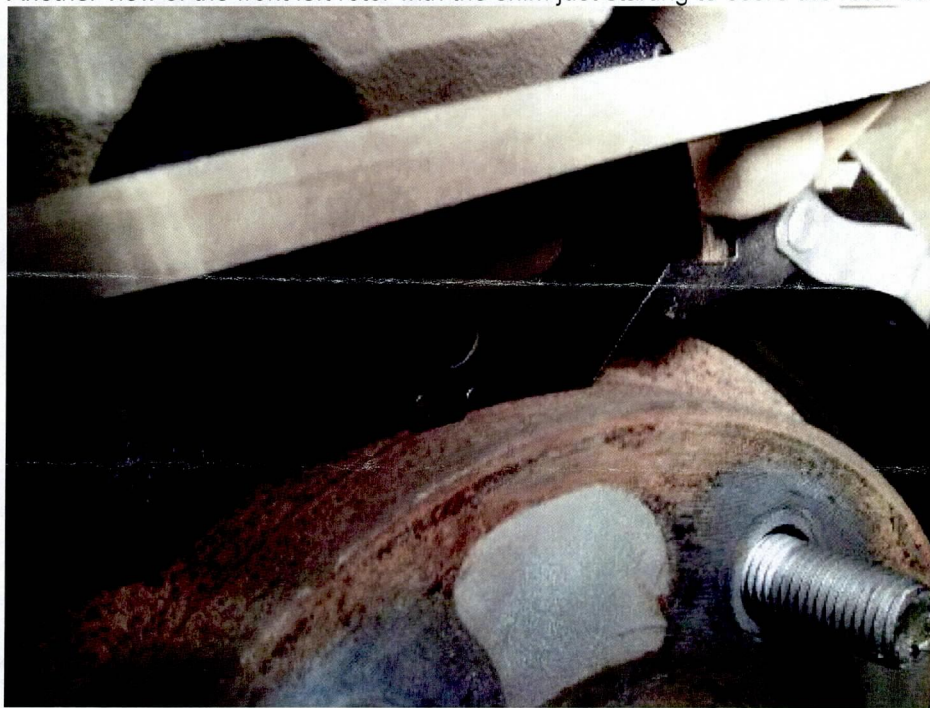
Another view of the front left rotor with the shim just starting to score the rotor base.

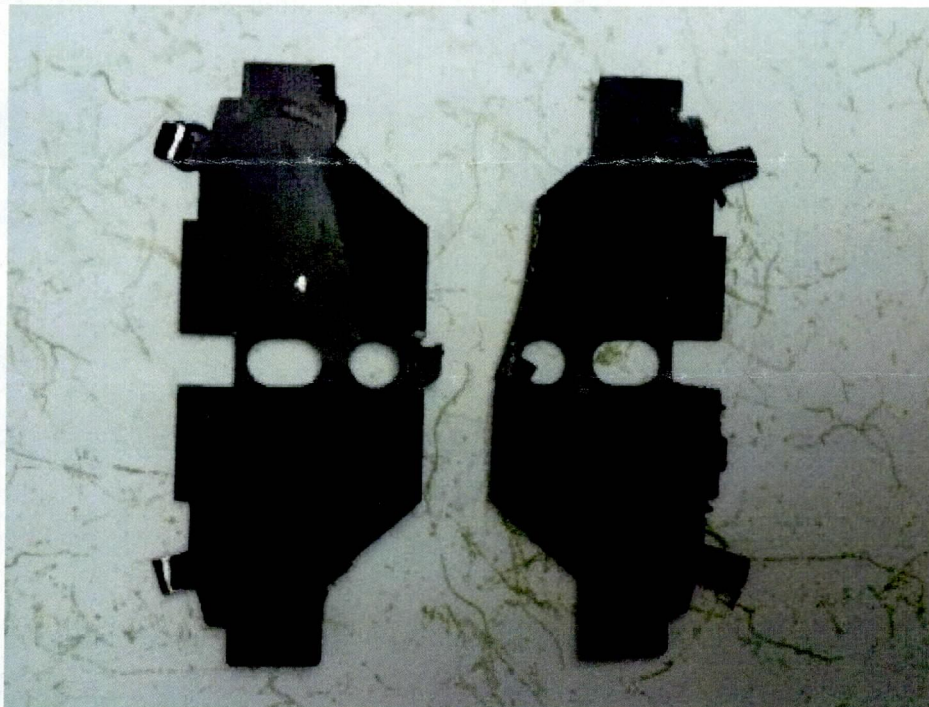
These are the shims I removed from the front right pads. The one on the right cut the groove in the rotor.

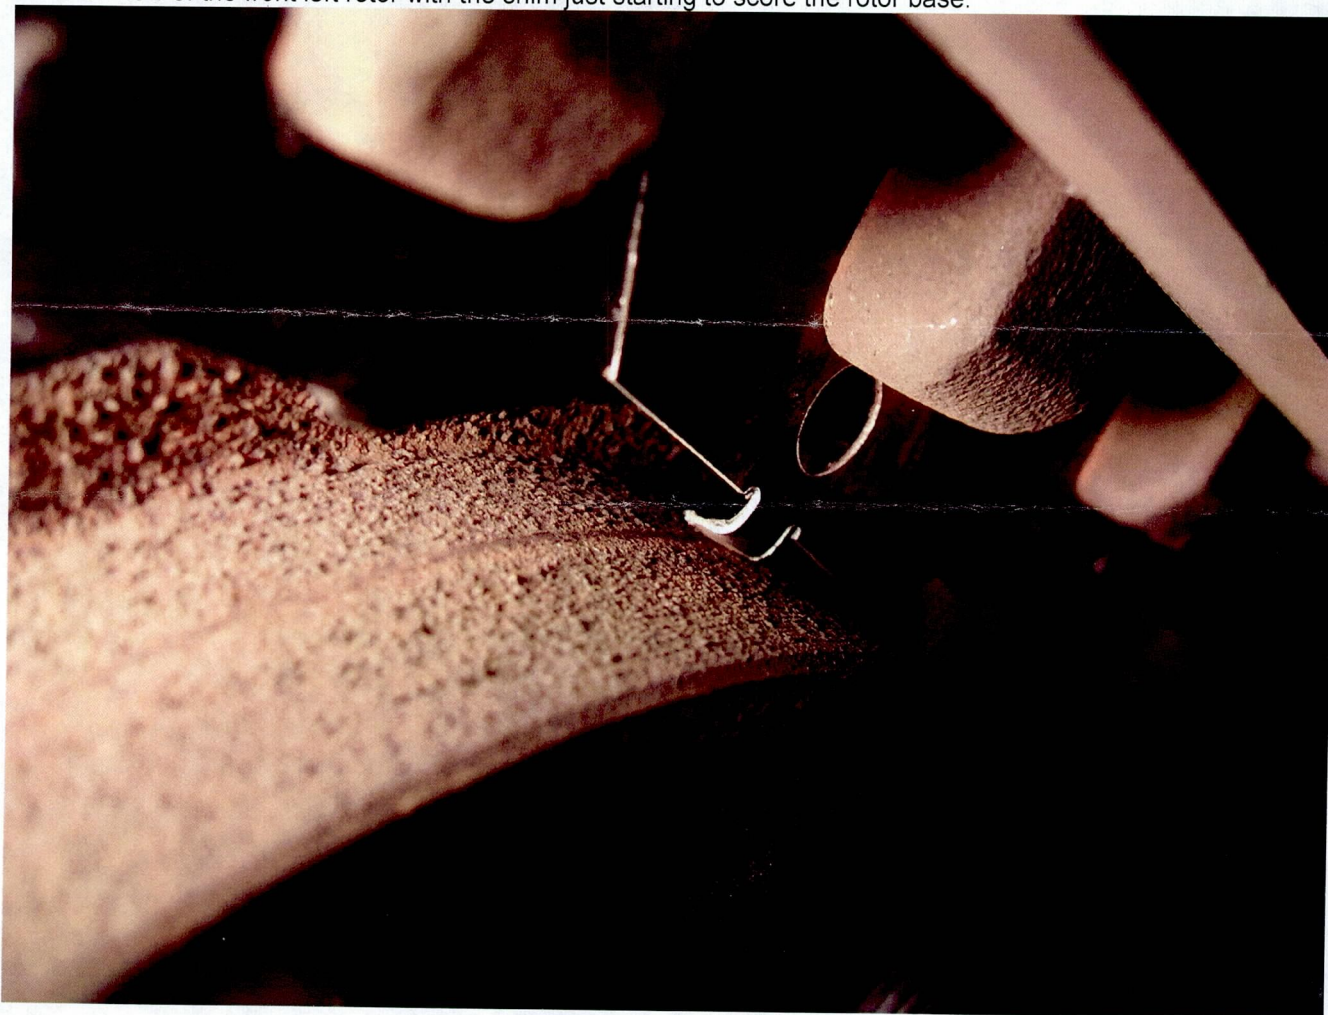
Another view of the front left rotor with the shim just starting to score the rotor base.

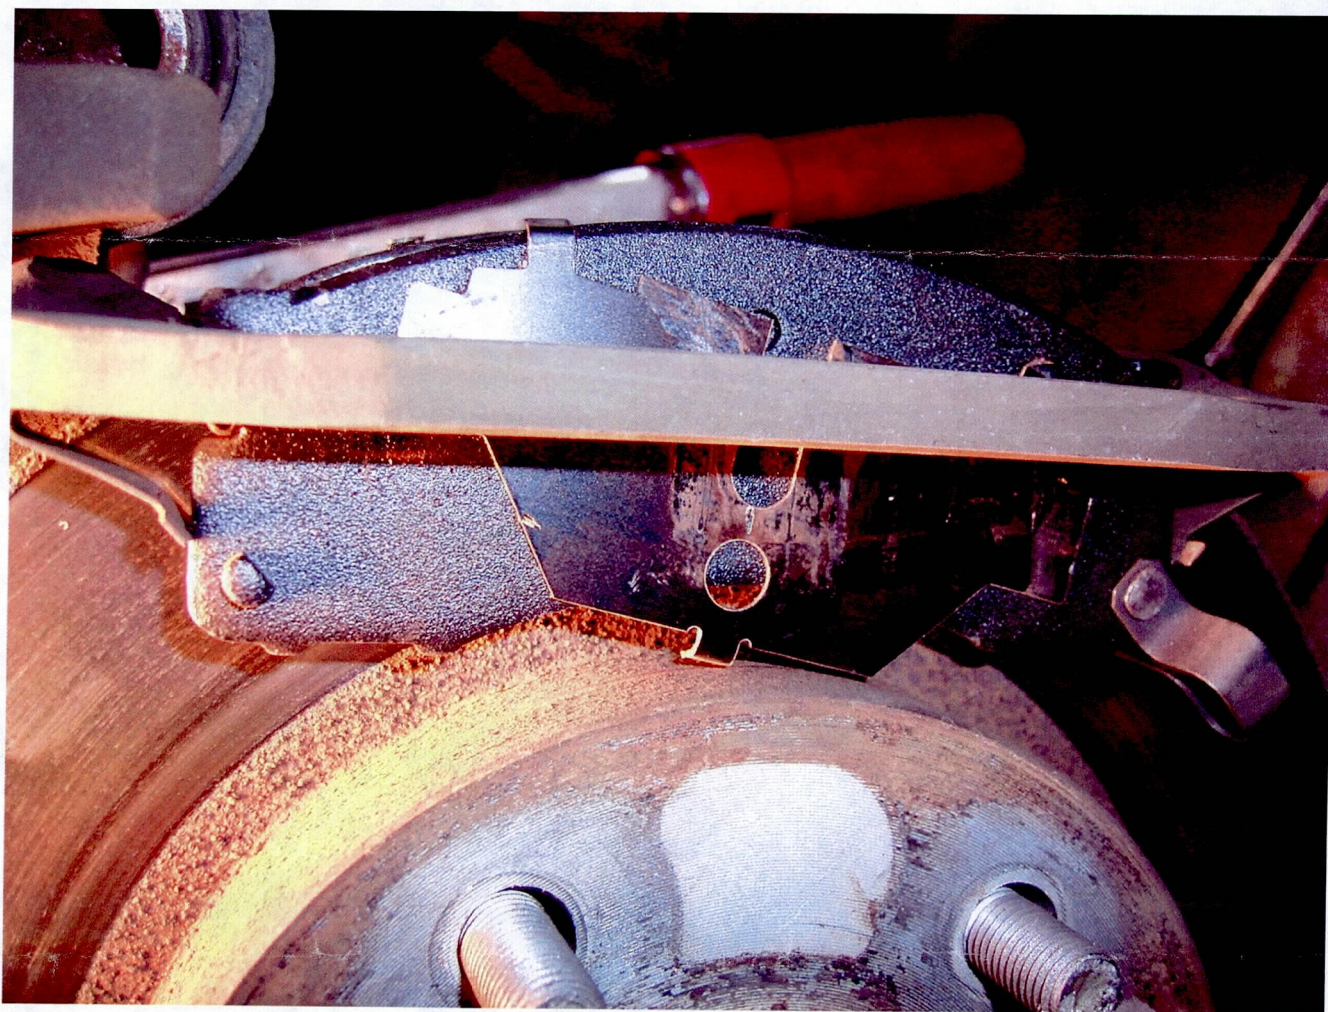
Another view of the front left rotor with the shim just starting to score the rotor base.

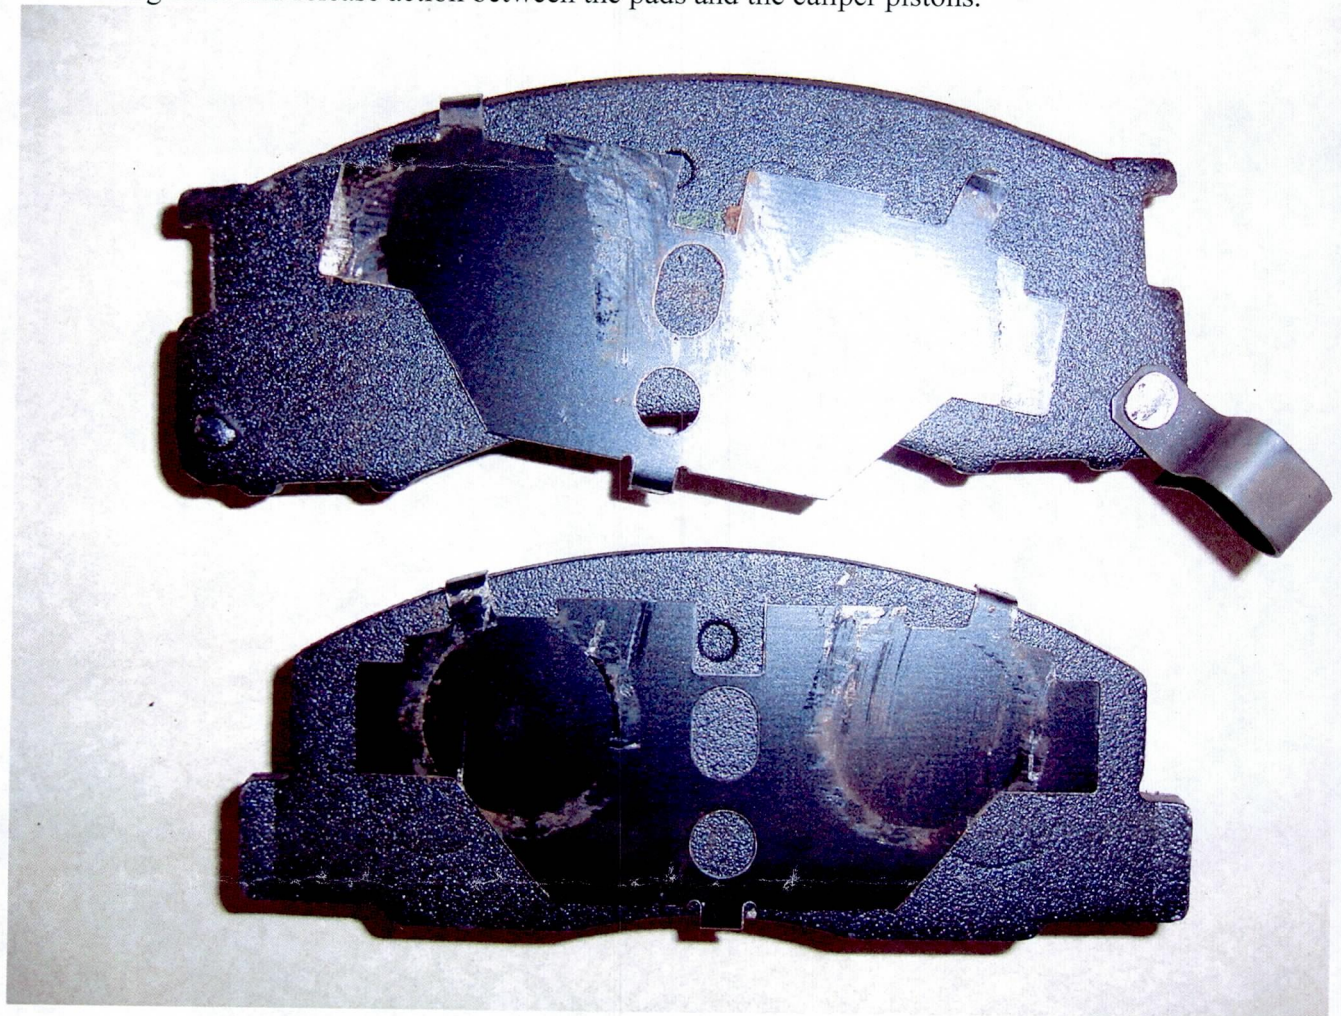
The front left brake pads with the shims still attached, the outer pad has the shim displaced. I believe the two outer front shims are walked off the pads due to dynamics of the braking force and release action between the pads and the caliper pistons.
