**I believe I have found the solution to the Toyota unintended acceleration issue.**

# The application of relay coil suppression with DC relays

# Finding, curing dangerous voltage spikes boosts reliability

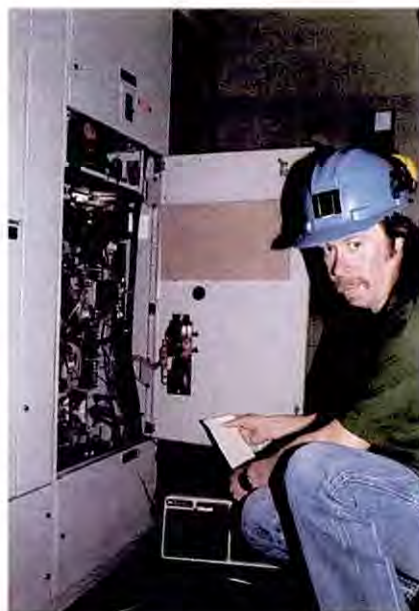
### Voltage spikes and the damage they can cause

Voltage transients or spikes are primarily caused by switching disturbances—the source usually being the stored energy in the inductive components of the system. When a dc coil is energized, it stores energy in the form of a magnetic field surrounding the coil. When de-energized, this field collapses, inducing a voltage transient. This voltage is much higher than the original energizing voltage, often thousands of volts. It is impressed on all wiring and components from the coil and the point of circuit opening through the remainder of the circuit.

The high-voltage spike actually jumps across the switch while it is opening, not only damaging the switch but momentarily impressing its extremely high voltage on the entire circuit. Altogether, high coil-induced voltage transients can cause arcing and burning of relay and switch contacts, insulation damage, and damage to the originating coil itself. All solid-state and especially the newer electronic components are extremely susceptible to high-voltage transients.

Many times, the damage sustained by an electronic component is not instantly fatal. More commonly, the damage is cumulative, causing failure after many high-voltage "hits." This characteristic makes the problem difficult to diagnose and is subsequently overlooked for the type of problem it really is.
