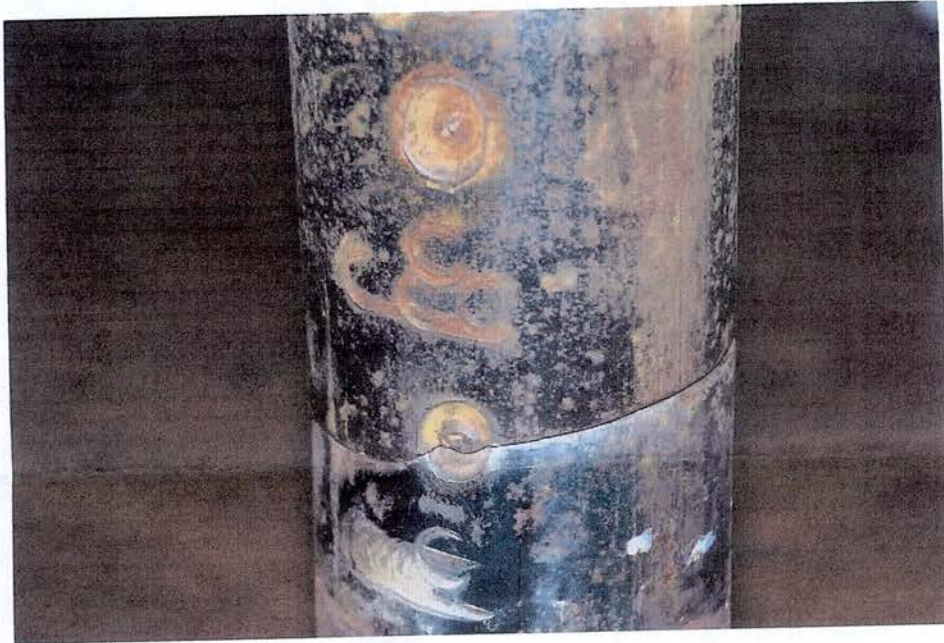
Photo 2

2. The failure of the gooseneck post was the result of the propagation of a crack that originated at the point where the bottom post retaining bolt interfaced with the post (See Photo 2). Based on the evidence, the crack appears to be the result of excessive bending of the post resulting from insufficient mobility of the ball in the socket. In that regard, during operation, interference between the truck mounted ball and the edge of the post mounted socket caused an excessive and unintended bending load to be applied to the post. This interference is evidenced by wear on the edge of the socket (See Photo 3). In addition, the lack of tongue weight changed the geometry between the ball and socket exacerbating the condition. In my opinion, this is also a design issue.
