Attached is a second letter sent to Workhorse Manufacturer referring to their recall (50002-1 interim bulletin their #) on brake calipers.

Ref: Vin B4MP67G683

Thank you for your response regarding premature brake failure I incurred. I can tell by your response I failed to communicate. You generously sent pictures of conditions you will and will not cover in the recall. Since a picture is worth a thousand words enclosed are pictures of my brake pads and rotors.

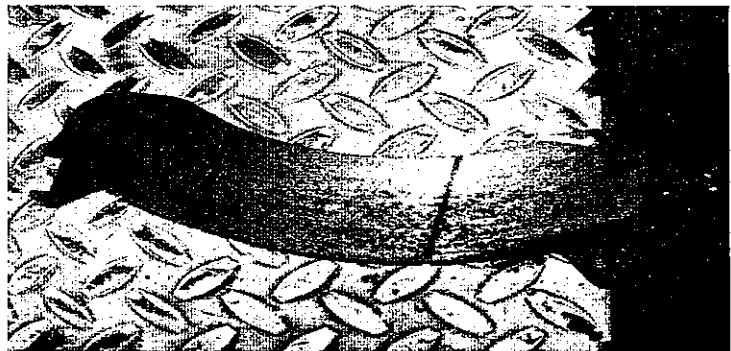
The brake pad shown below exhibits the rough/damaged surface typically associated with material transfer from the pad to the rotor due to excessive heat. The corresponding rotor will most likely exhibit corresponding material deposits from these pads. Replacement of a brake pad in this condition is considered collateral damage and is covered by the interim repair procedure.

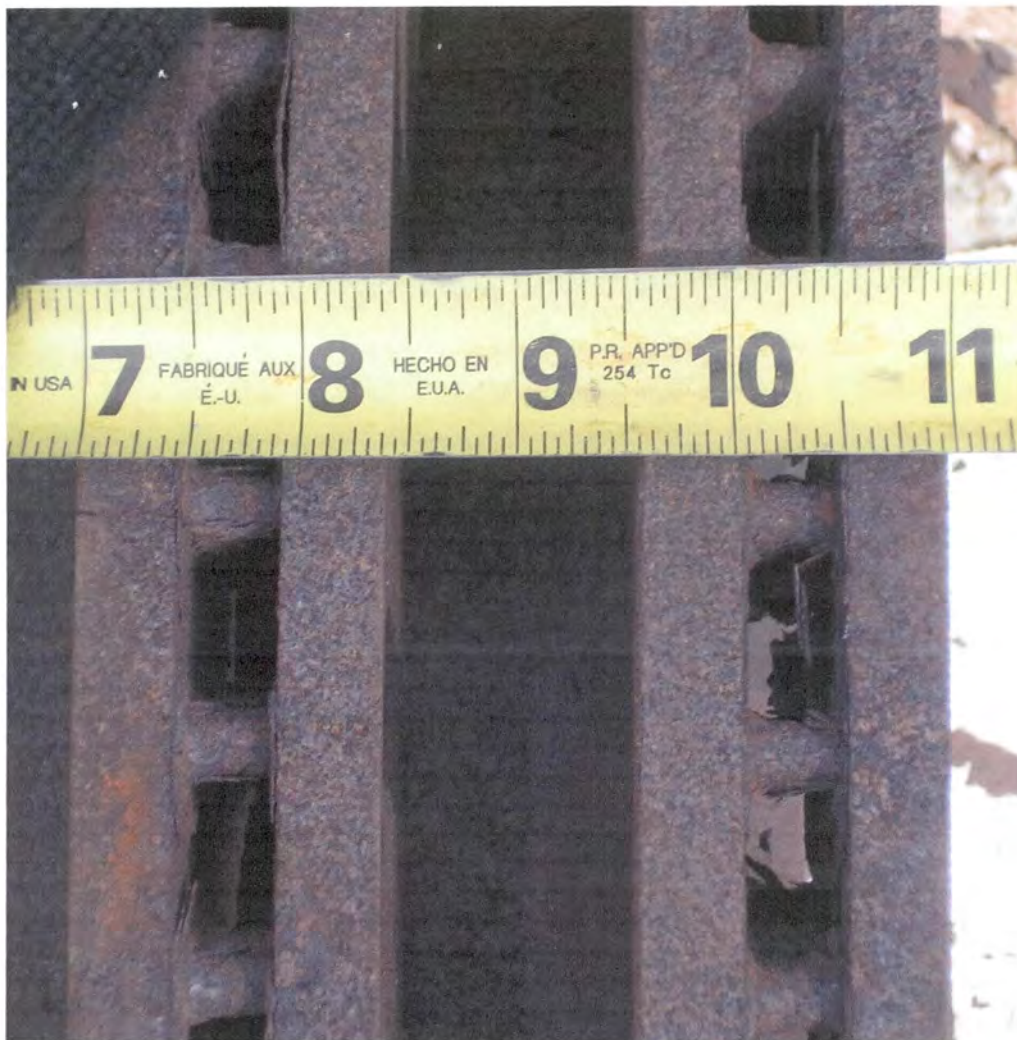
Note the thickness of rotors also note the heat factor as evidenced by cracking and delaminating of metal on rotors.

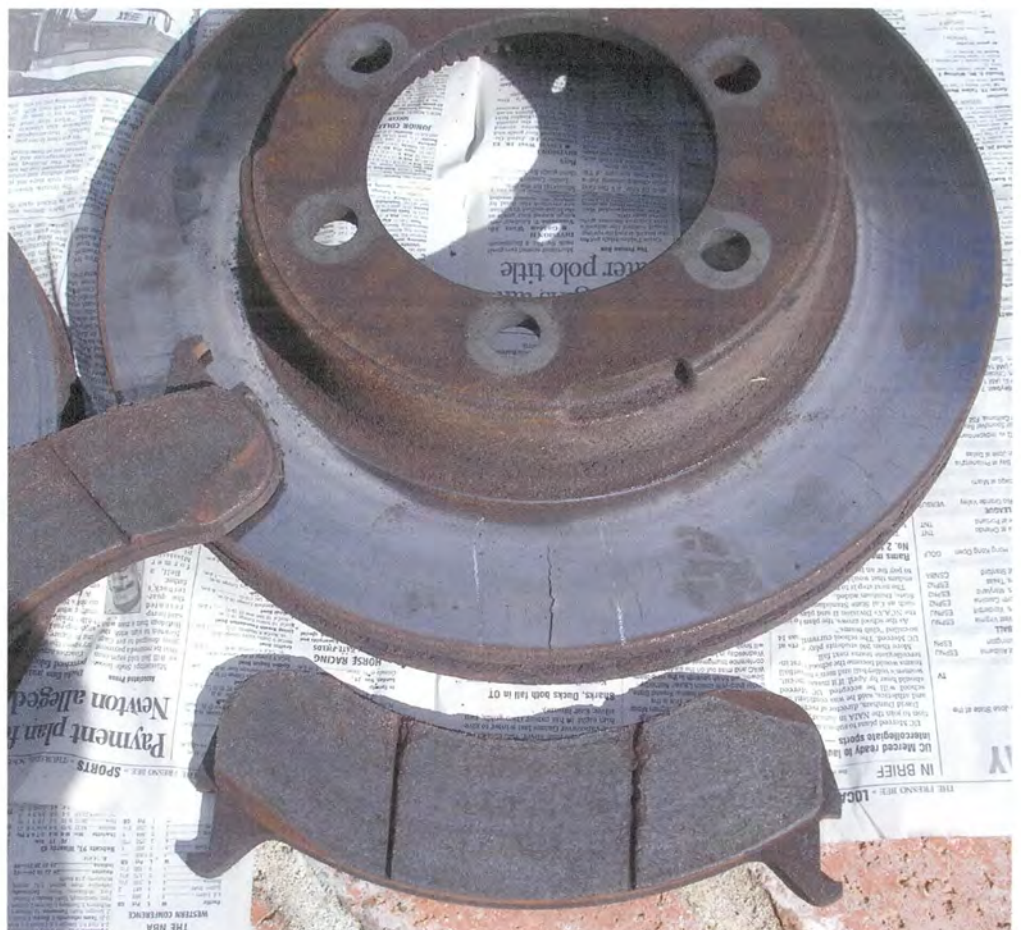
Note crack through rotor this is the same crack evidenced above in end view. Notice lack of scoring normally associated to worn pads.

Noted there was no transfer of resins etc.

Per your bulletin: "a large radial crack that has migrated through the outer surface, will need to be replaced."
