I am submitting the enclosed pictures as supporting documentation in reference to the complaint concerning my defective Ducati motorcycle fuel tank filed on 14 Jun 11 via phone, (NHTSA ODI# 10406268) vin# ZDM1VA2K86E [REDACTED]. Please keep these pictures on file and use them as you see fit.

Index of Photographs

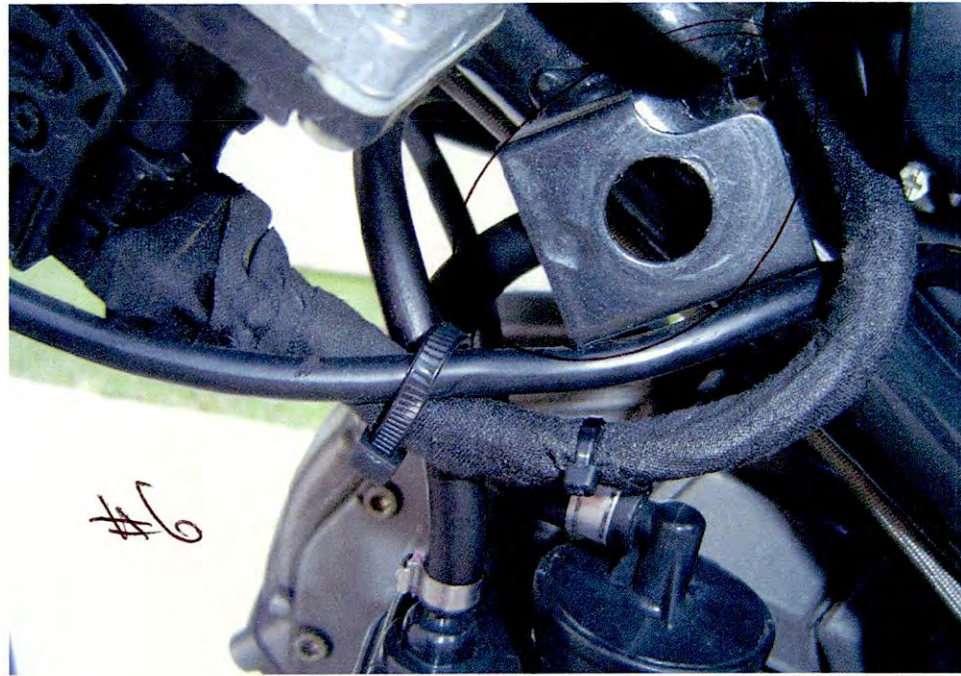
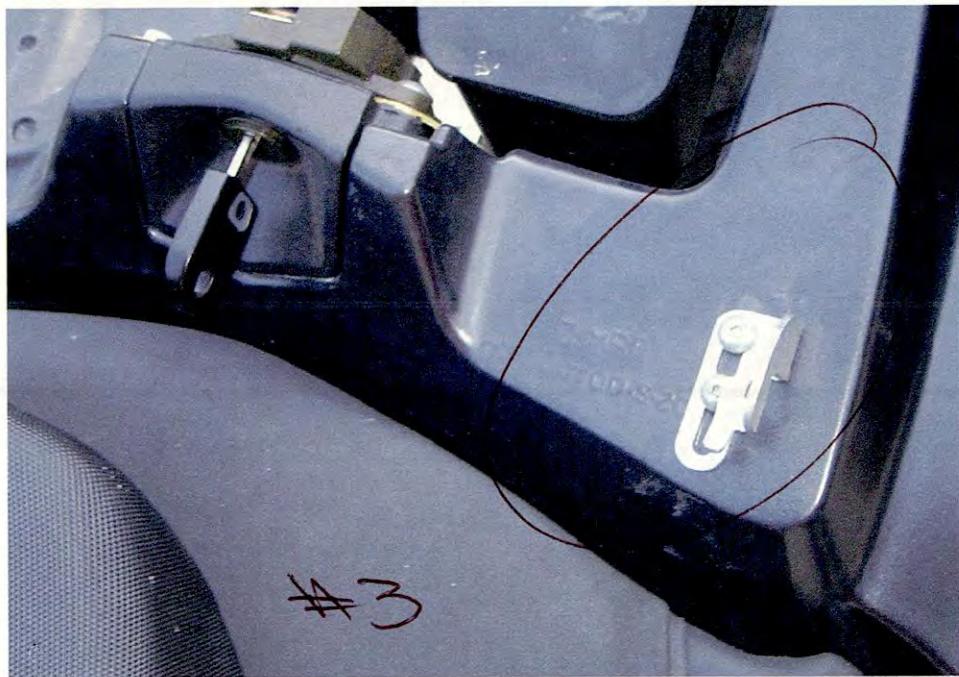
- Photo(s) #6 Left front side panel mount at frame and the corresponding pin/mount on the side panel. The bayonet style male pin attached to the side panel no longer aligns with this hole resulting in the inability to properly secure the panel, (retention safety clip Ducati PN# 79911901 can no longer be utilized) due to the vertical expansion of the tank.
