## #08243: Product Safety - Front Windshield Wiper Operation - Replace Module Cover - (Oct 30, 2008)

**Subject: 08243 — Front Windshield Wiper Operation – Replace Module Cover**

**Models: 2003 HUMMER H2**

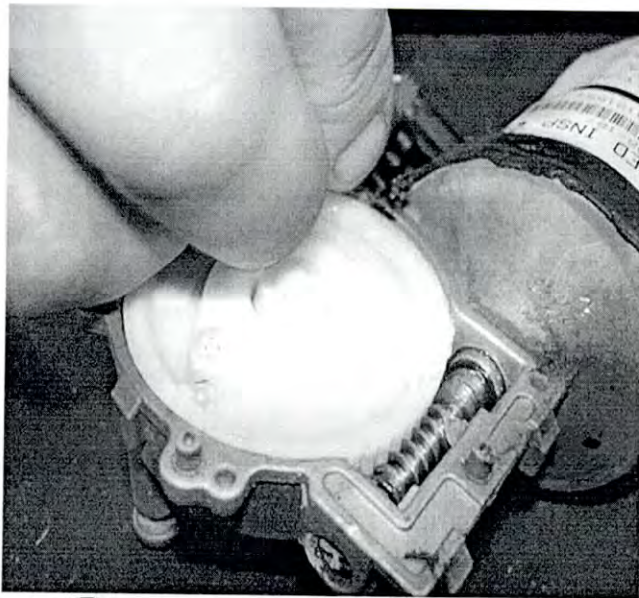
6. Release the five retainers (1) that retain the cover/module to the motor.

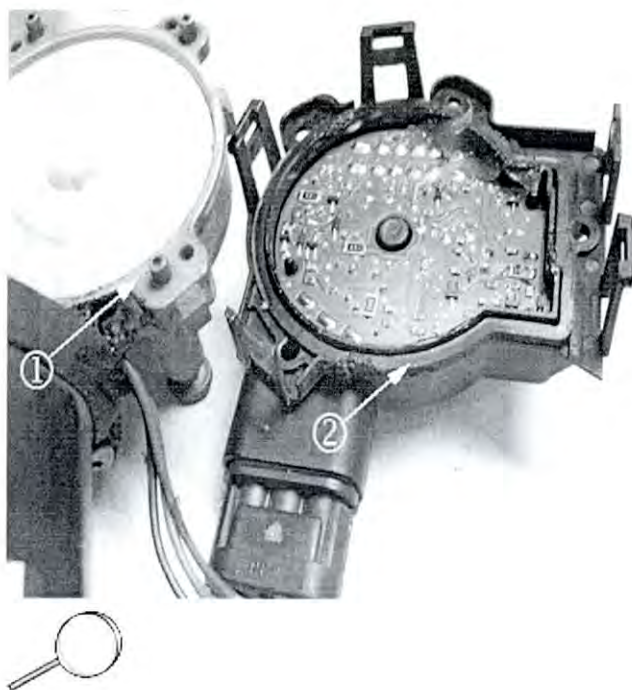
Wiper Motor Shown Out of Vehicle for Illustration Purposes Only

7. Inspect the plastic module cover (2) and metal module (1) sealing surfaces for butyl.
  - If butyl is on either sealing surface, discard the plastic cover and replace it with a new cover. Ensure that all of the butyl is removed from the metal sealing surface BEFORE installing a new cover. Use a flat-blade screw driver or razor blade to remove the butyl from the metal surface.
  - If no butyl is on either sealing surface, re-install the cover. Refer to Step 8.
8. Install the wiper cover/module. Align the retainer with the tang on the motor and push down.
9. Install the electrical connectors to the cover/module.
10. Make sure wipers are operational.
11. Install the air inlet grille panel. Align the air inlet grille to the vehicle and secure by pushing downward on the four retainers. Install the push in retainer and tighten the two end screws.
