| <b>INFORMATION ACT (FOIA) 5 U.S.C. 552(B)(6)</b><br>DOT Auto Safety Hotline<br><b>Vehicle Owner's Questionnaire</b><br><b>To Report Vehicle Safety Defects</b><br><b>1-888-DASH-2-DOT</b><br><b>(1-888-327-4236)</b><br><b>INTERNET: www.nhtsa.dot.gov/hotline</b> | | FOR AGENCY USE ONLY 100148<br>Date Received<br>17-JUL-2012<br>Repository <input type="checkbox"/><br>Reference No.<br>10466268 | |

## VEHICLE ANALYSIS – SDL# M48152.1

FILE # XXR343  
INSURED [REDACTED]  
VEHICLE 2003 GMC Sierra  
VIN 1GTHK29U83E [REDACTED]  
ODOMETER 33,338  
DATE OF LOSS October 21, 2011

Examine the Chevrolet and determine if there is evidence of a deficiency in the brake system. Determine if there is evidence of faulty service work performed by Connolly Chevrolet two days prior to the loss.

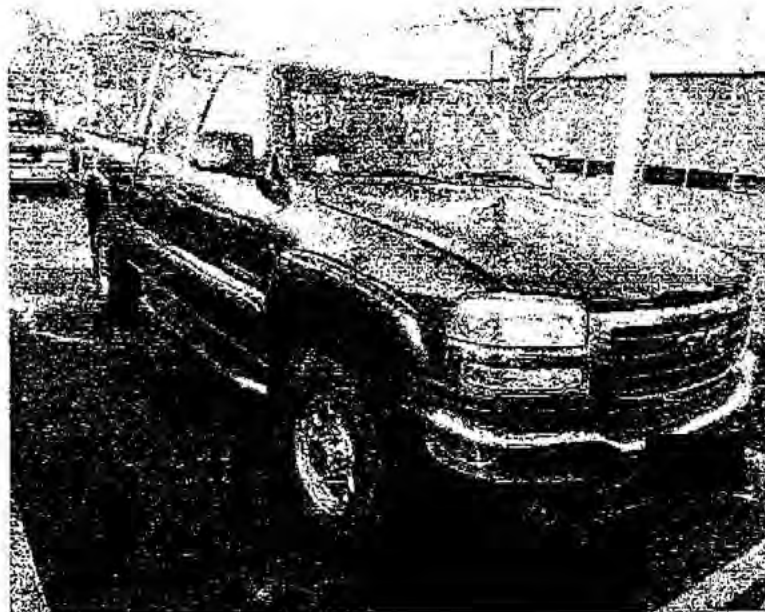
**2**

Right front view. The GMC sustained collision damage to the lower center of the front bumper.

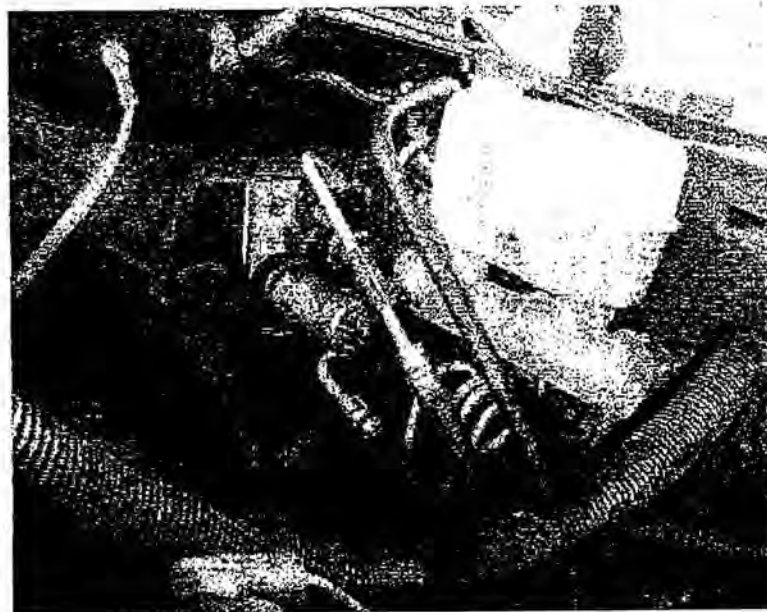
**14**

View of the brake master cylinder,  
fluid reservoir, and hydro-boost  
unit. The components remained  
properly assembled.

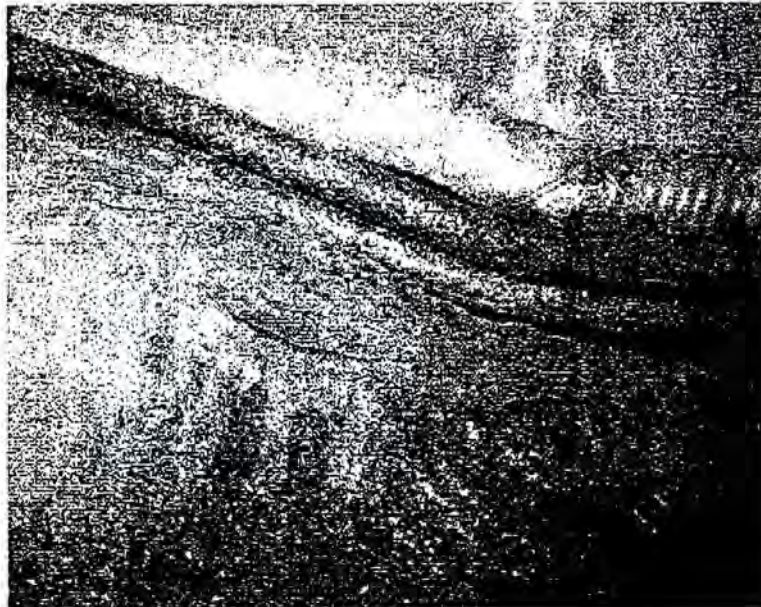
**24**

Closer view of the location of the failure in the brake line. It was not caused by faulty service work.

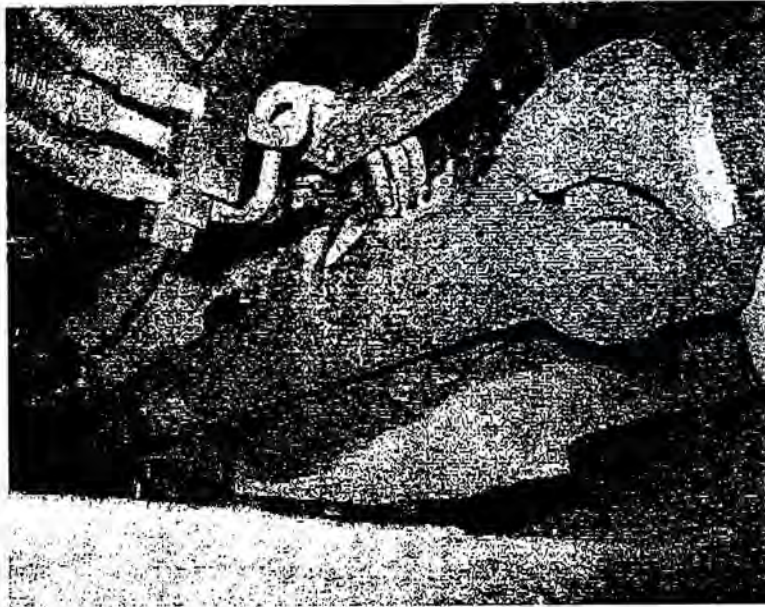
25

View of the extent of corrosion on other components on the undercarriage.
