<p>VEHICLE INFORMATION</p>			
<p>17 digit Vehicle Identification Number Located at bottom of windshield on driver's side 5RXTD2828D1</p>	<p>Make CRUISER RV</p>	<p>Model SHADOW CRUISER</p>	<p>Model Year 2013</p>
<p>Date Purchased 6/13/2012</p>	<p>Dealer's Name and Telephone Number AAS RV CENTER 248-375-5811</p>	<p>Engine: No: Cylinders</p>	<p>Fuel Type:</p>
<p>Original Owner <input checked="" type="checkbox"/></p>	<p>Dealer's City AUBURN HILLS</p>	<p>State MI</p>	<p>Zip Code 48326</p>
<p>Transmission Type <input type="checkbox"/> Antilock Brakes <input type="checkbox"/> Cruise Control</p>	<p>Powertrain</p>	<p>Multiple Failure:</p>	<p>Incident Date(s) 25 JUN 2012 23 JUL 2012</p>
<p>FAILED COMPONENT(S)/PART(S) INFORMATION</p>			
<p>Vehicle Component Codes: 980000 UNKNOWN OR OTHER, 072200 FUEL SYSTEM, GASOLINE, DELIVERY: HOSES, LINES/PIPING, AND FITTINGS</p>		<p>PROPANE</p>	<p>Failure Mileage 1000</p>

██████ – 2013 280QBS Shadow Cruiser Propane Line Disengagement

VIN #5RXTD2828D1██████

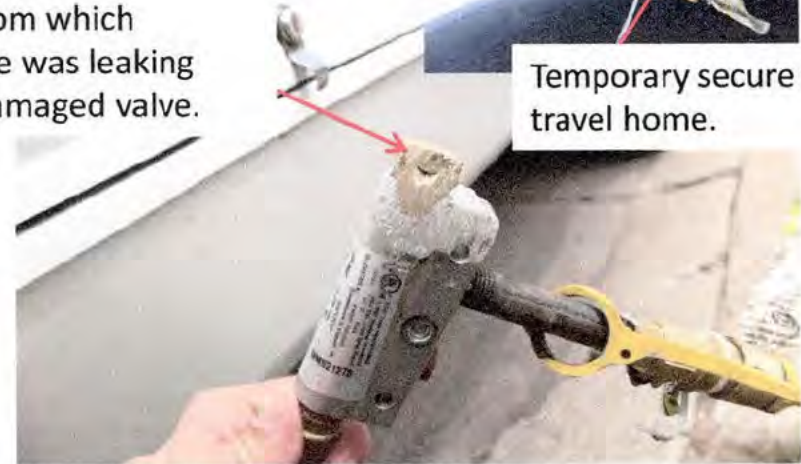
Temporary secure to travel home.

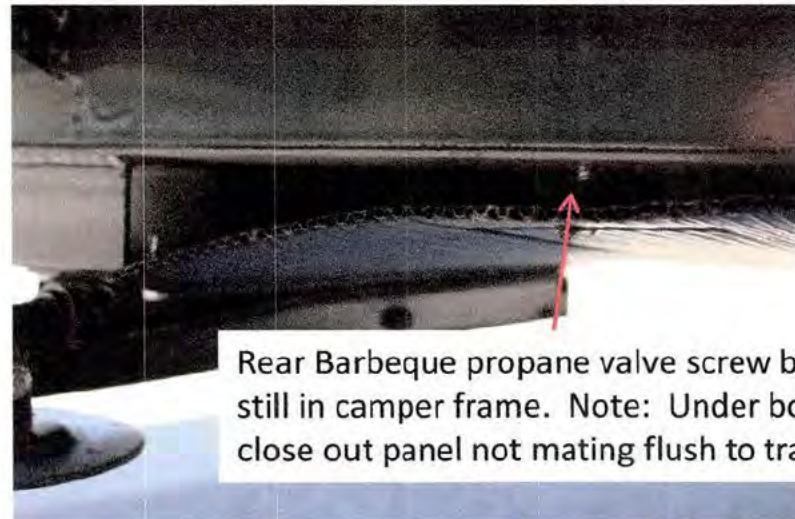
- Found the single bolt head holding the rear barbeque propane line and valve had broken off. The body of the bolt/screw was still secure in the camper frame.

Rear Barbeque propane valve screw body still in camper frame. Note: Under body close out panel not mating flush to trailer.

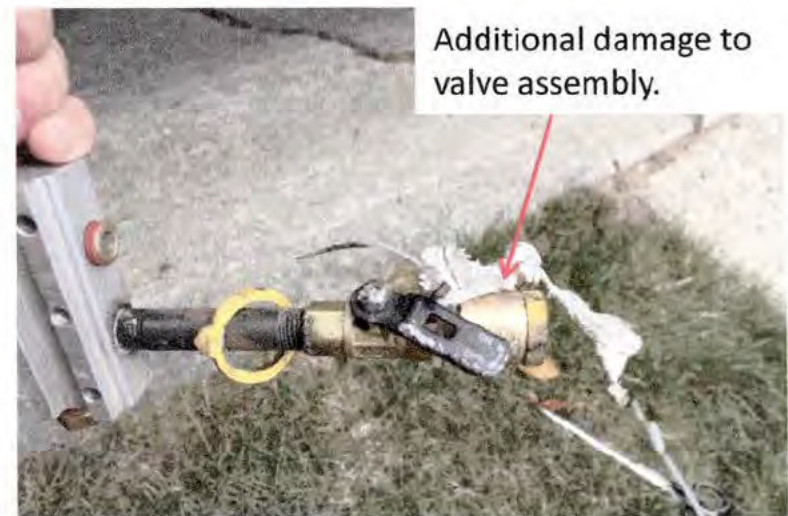
- The broken off bolt head allowed the propane valve and line to fall off the camper and drag on the pavement.
 - The propane valve was "ground down" allowing propane to freely escape from the valve at the contact location with the ground.

Additional damage to valve assembly.

- August 10, 2012
 - ██████ and ██████ traveled to Cruiser RV Factory in Howe, IN to pick up the camper.
 - Camper repairs not complete, but Cruiser RV had replaced the rear barbeque propane line valve and re-secured it and the propane feed line to the camper with numerous additional clips.

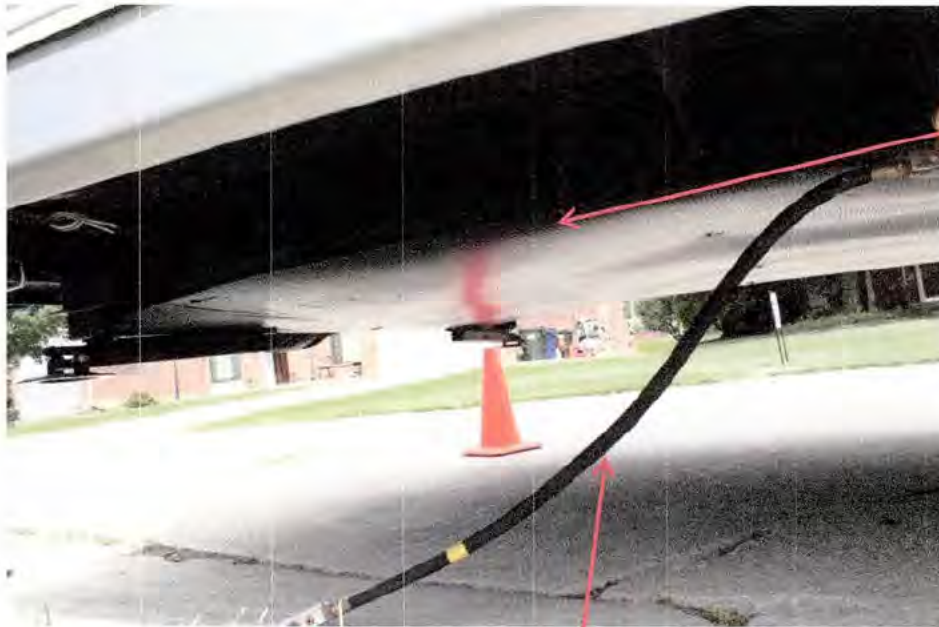
Note: other than the single bolts securing the rear exterior kitchen propane valve and the rear barbeque propane valve, there are no additional fasteners to secure campers propane line to underbody should the screw holding the valve fail. The unsupported span of fuel line allowed the valve to contact the ground with the bolt failure.

Rear barbeque propane valve

Propane line to rear barbeque

4. Top left entertainment cabinet door was damaged when slide out improperly extended. Replace door.
5. Propane gas line to rear exterior barbeque grill fell off the unit and dragged during travel. Replace the valve and re-secure the assembly to the trailer frame. Entire gas line needs additional fasteners to prevent reoccurrence. (see images in attached powerpoint presentation.)

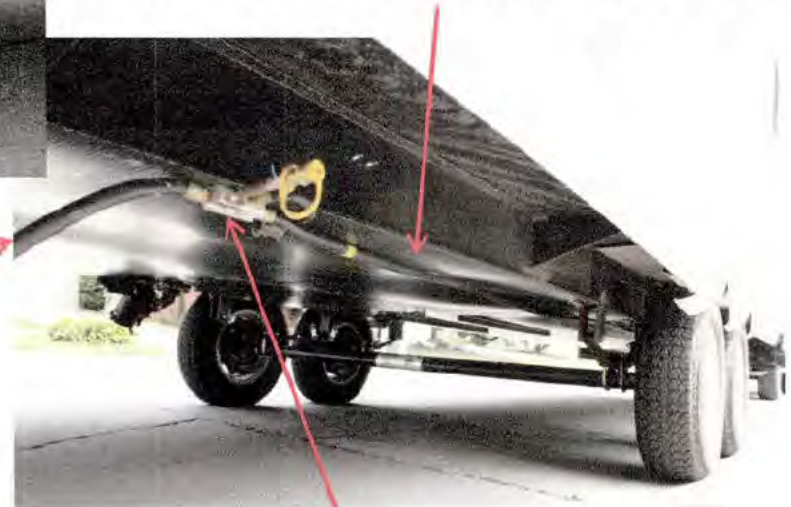
Exterior kitchen propane valve
