**BMW Turn signal / LH control problem**

**BMW Multi Controller Problem**

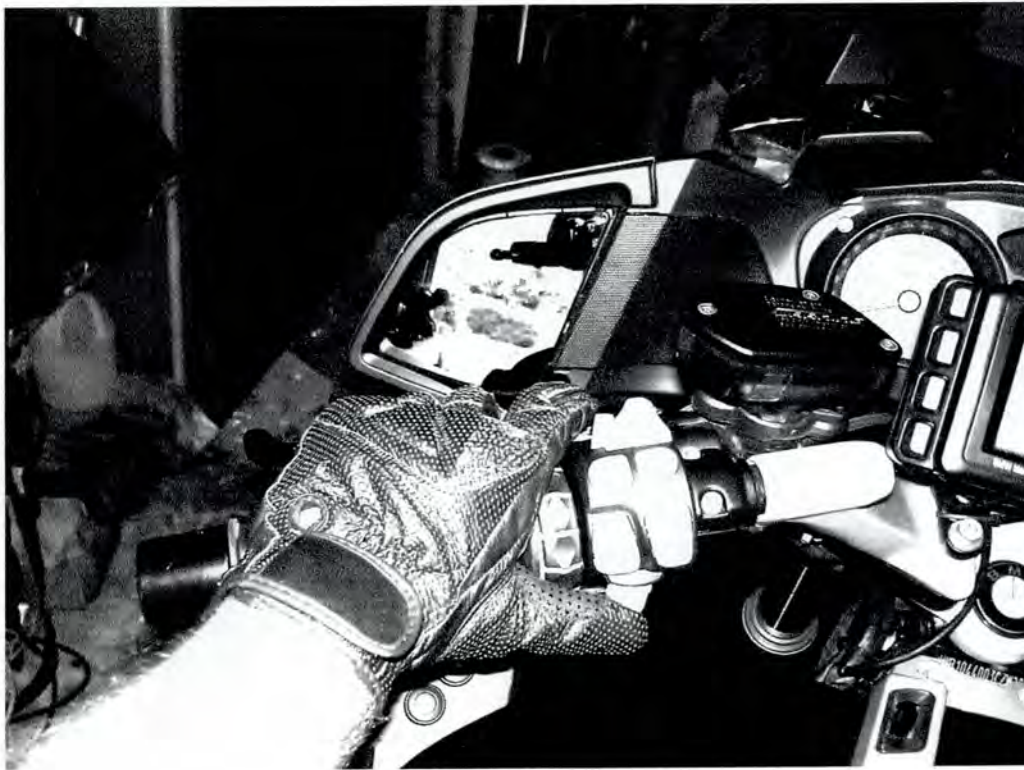
Note the 20.3 mm width the multi controller requires. This width should be reduced by at least 50% so the thumb can easily reach the turn signal.

- a. Change multi controller size. This should be retrofitted to ALL BMW motorcycles if the owner wishes.  
Suggestion: 8-10 mm W x 52 mm OD w/ NO finger grooves.
- b. Remove the entire communication system and multi controller. Give owners a credit for the amount of this system that can be used in the BMW dealership.
- c. Offer a cash refund and remove the communication system and multi controller.
- d. Redesign and retrofit a completely new communication control system in existing machines.

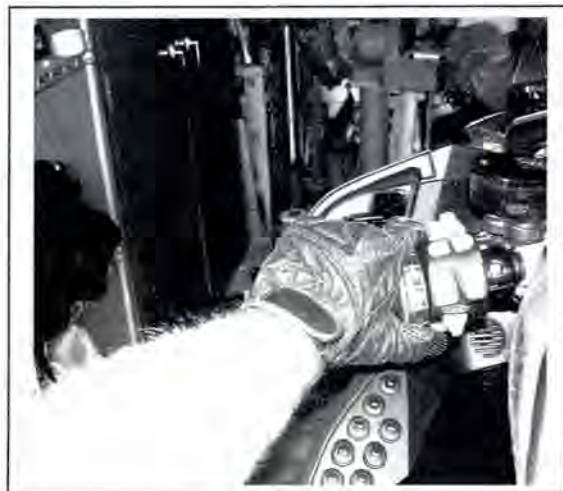
My previous, more detailed letter is included.  
*To the right is hand position for turn signal engagement. Note thumb does not grip signal enough to engage.*
