## Recall Campaign

NHTSA#: 12V-451

Replace the lora transfer switch

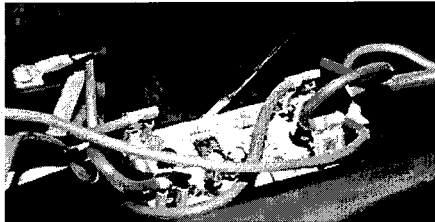
3. Remove the transfer switch cover and label the orange Romex cables entering the transfer switch. Using a "multi" meter set to the 200 volt A/C range **TEST** all circuits inside the transfer switch to verify that all power is turned off. The Romex cable connected to the power cord buss bar should be labeled "shore" and the cable connected to the control panel buss bar should be labeled "panel".
4. Loosen appropriate set screws and remove all wires entering the transfer switch.
5. Remove the screws that fasten the transfer switch box to the RV.
6. You will need to remove circuit board from the Iota transfer switch and return it to Jayco. To remove the board, insert a screwdriver in the recessed space at the top of the board and gently pry it towards the bottom of the box and up. Once the board is loose, remove the wires by pulling up at the terminal. Discard the old transfer switch.
