| <p>U.S. Department of Transportation<br/>National Highway Traffic Safety Administration</p> | | <p>INFORMATION ACT (EOIA), 5 U.S.C. 552(B)(6)</p> <p>DOT Auto Safety Hotline</p> <p><b>Vehicle Owner's Questionnaire</b><br/>To Report Vehicle Safety Defects<br/>1-888-DASH-2-DOT<br/>(1-888-327-4236)<br/>INTERNET: www.nhtsa.dot.gov/hotline</p> | | <p>FOR AGENCY USE ONLY 100148</p> | |
| <p>17 digit Vehicle Identification Number Located at bottom of windshield on driver's side</p> <p>JTDZN3EUXC3</p> | | <p>Make</p> <p>TOYOTA</p> | | <p>Model</p> <p>PRIUS V</p> | |
| <p>Model Year</p> <p>2012</p> | | <p>Date Purchased</p> | | <p>Dealer's Name and Telephone Number</p> | |
| <p>Vehicle Component Code: 140000 AIR BAGS</p> | | | | <p>Failure Mileage</p> <p>30150</p> | |

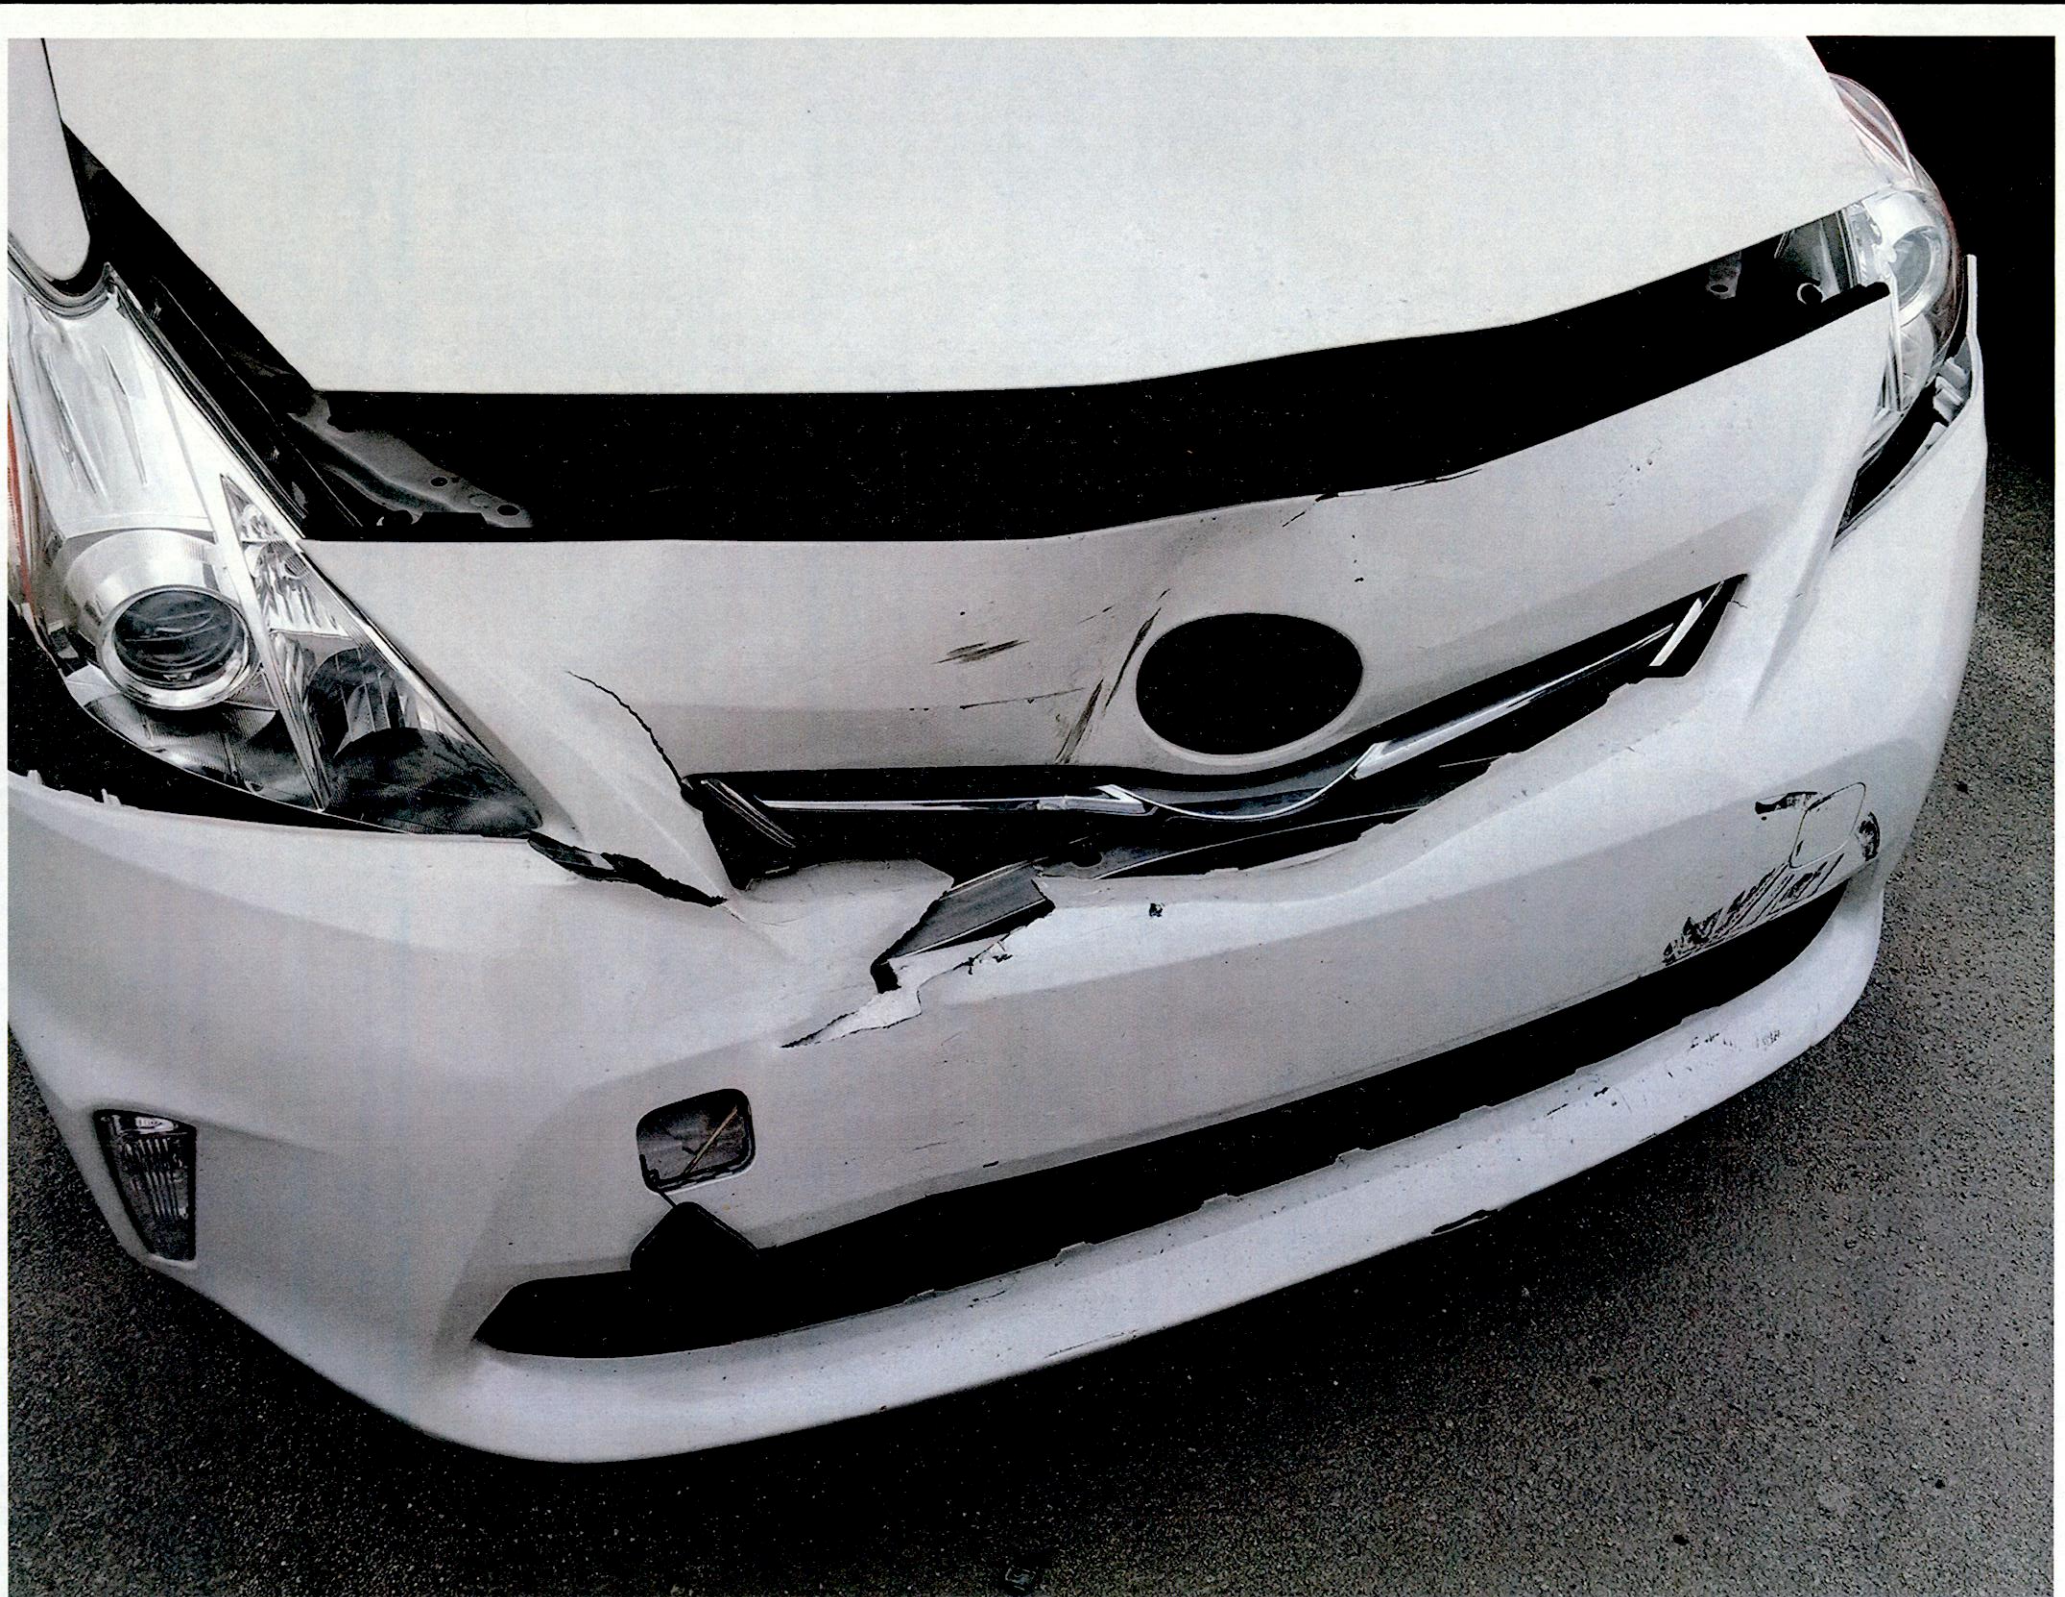
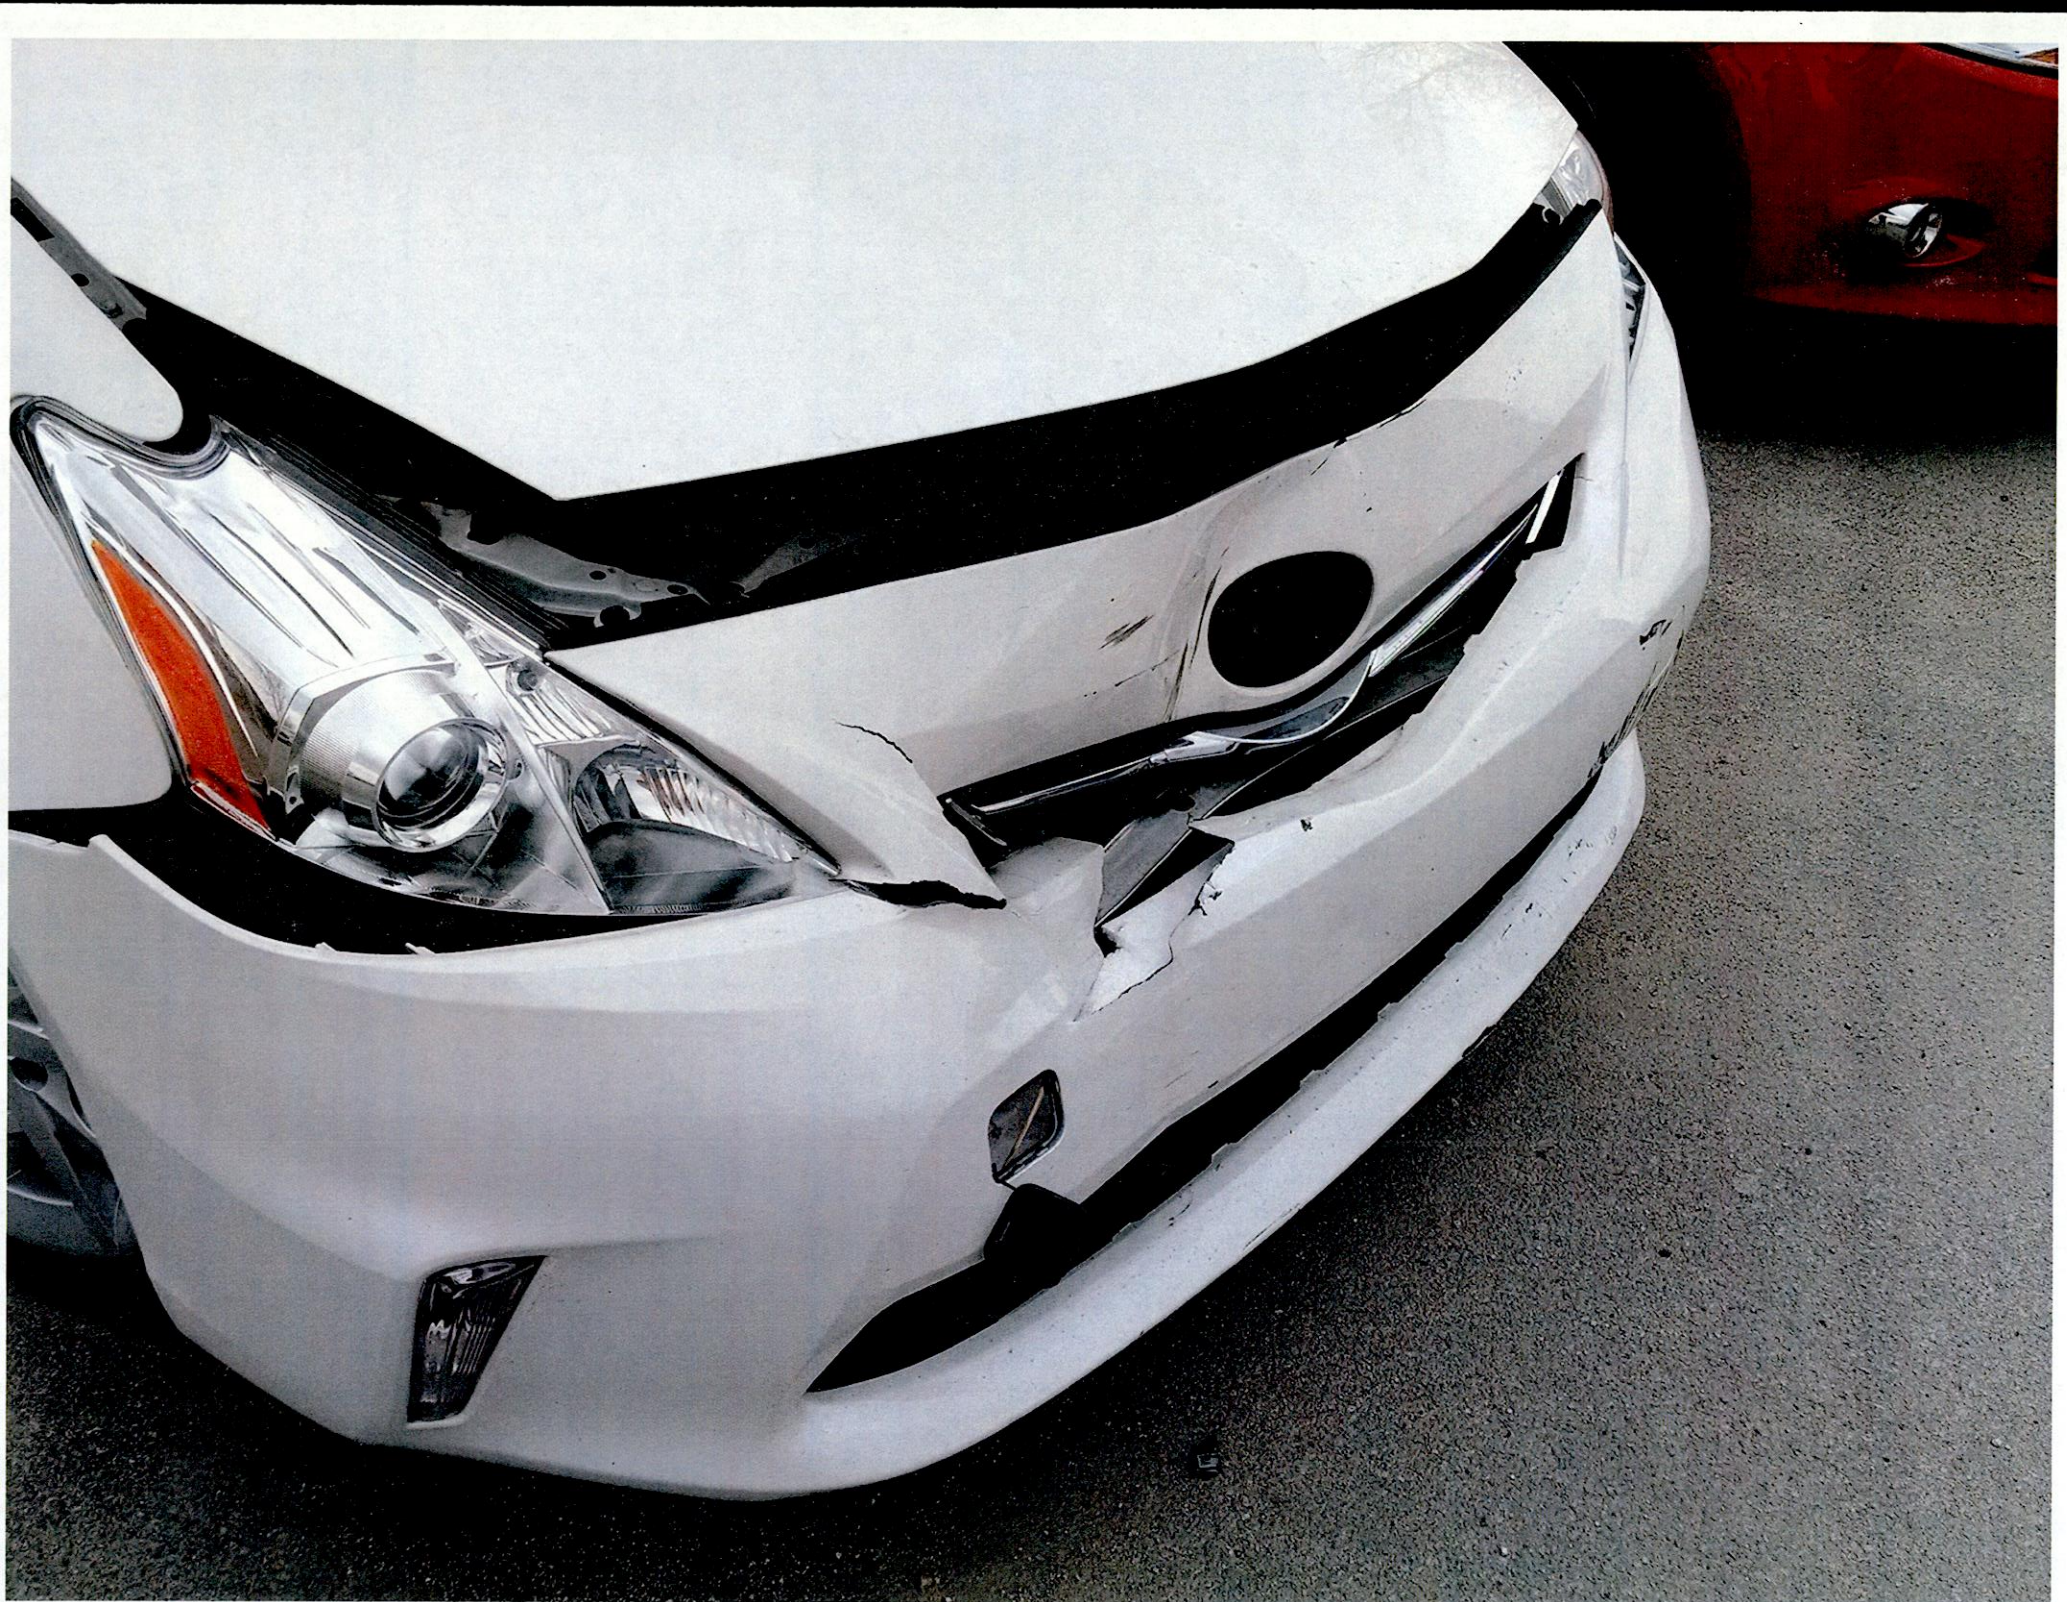
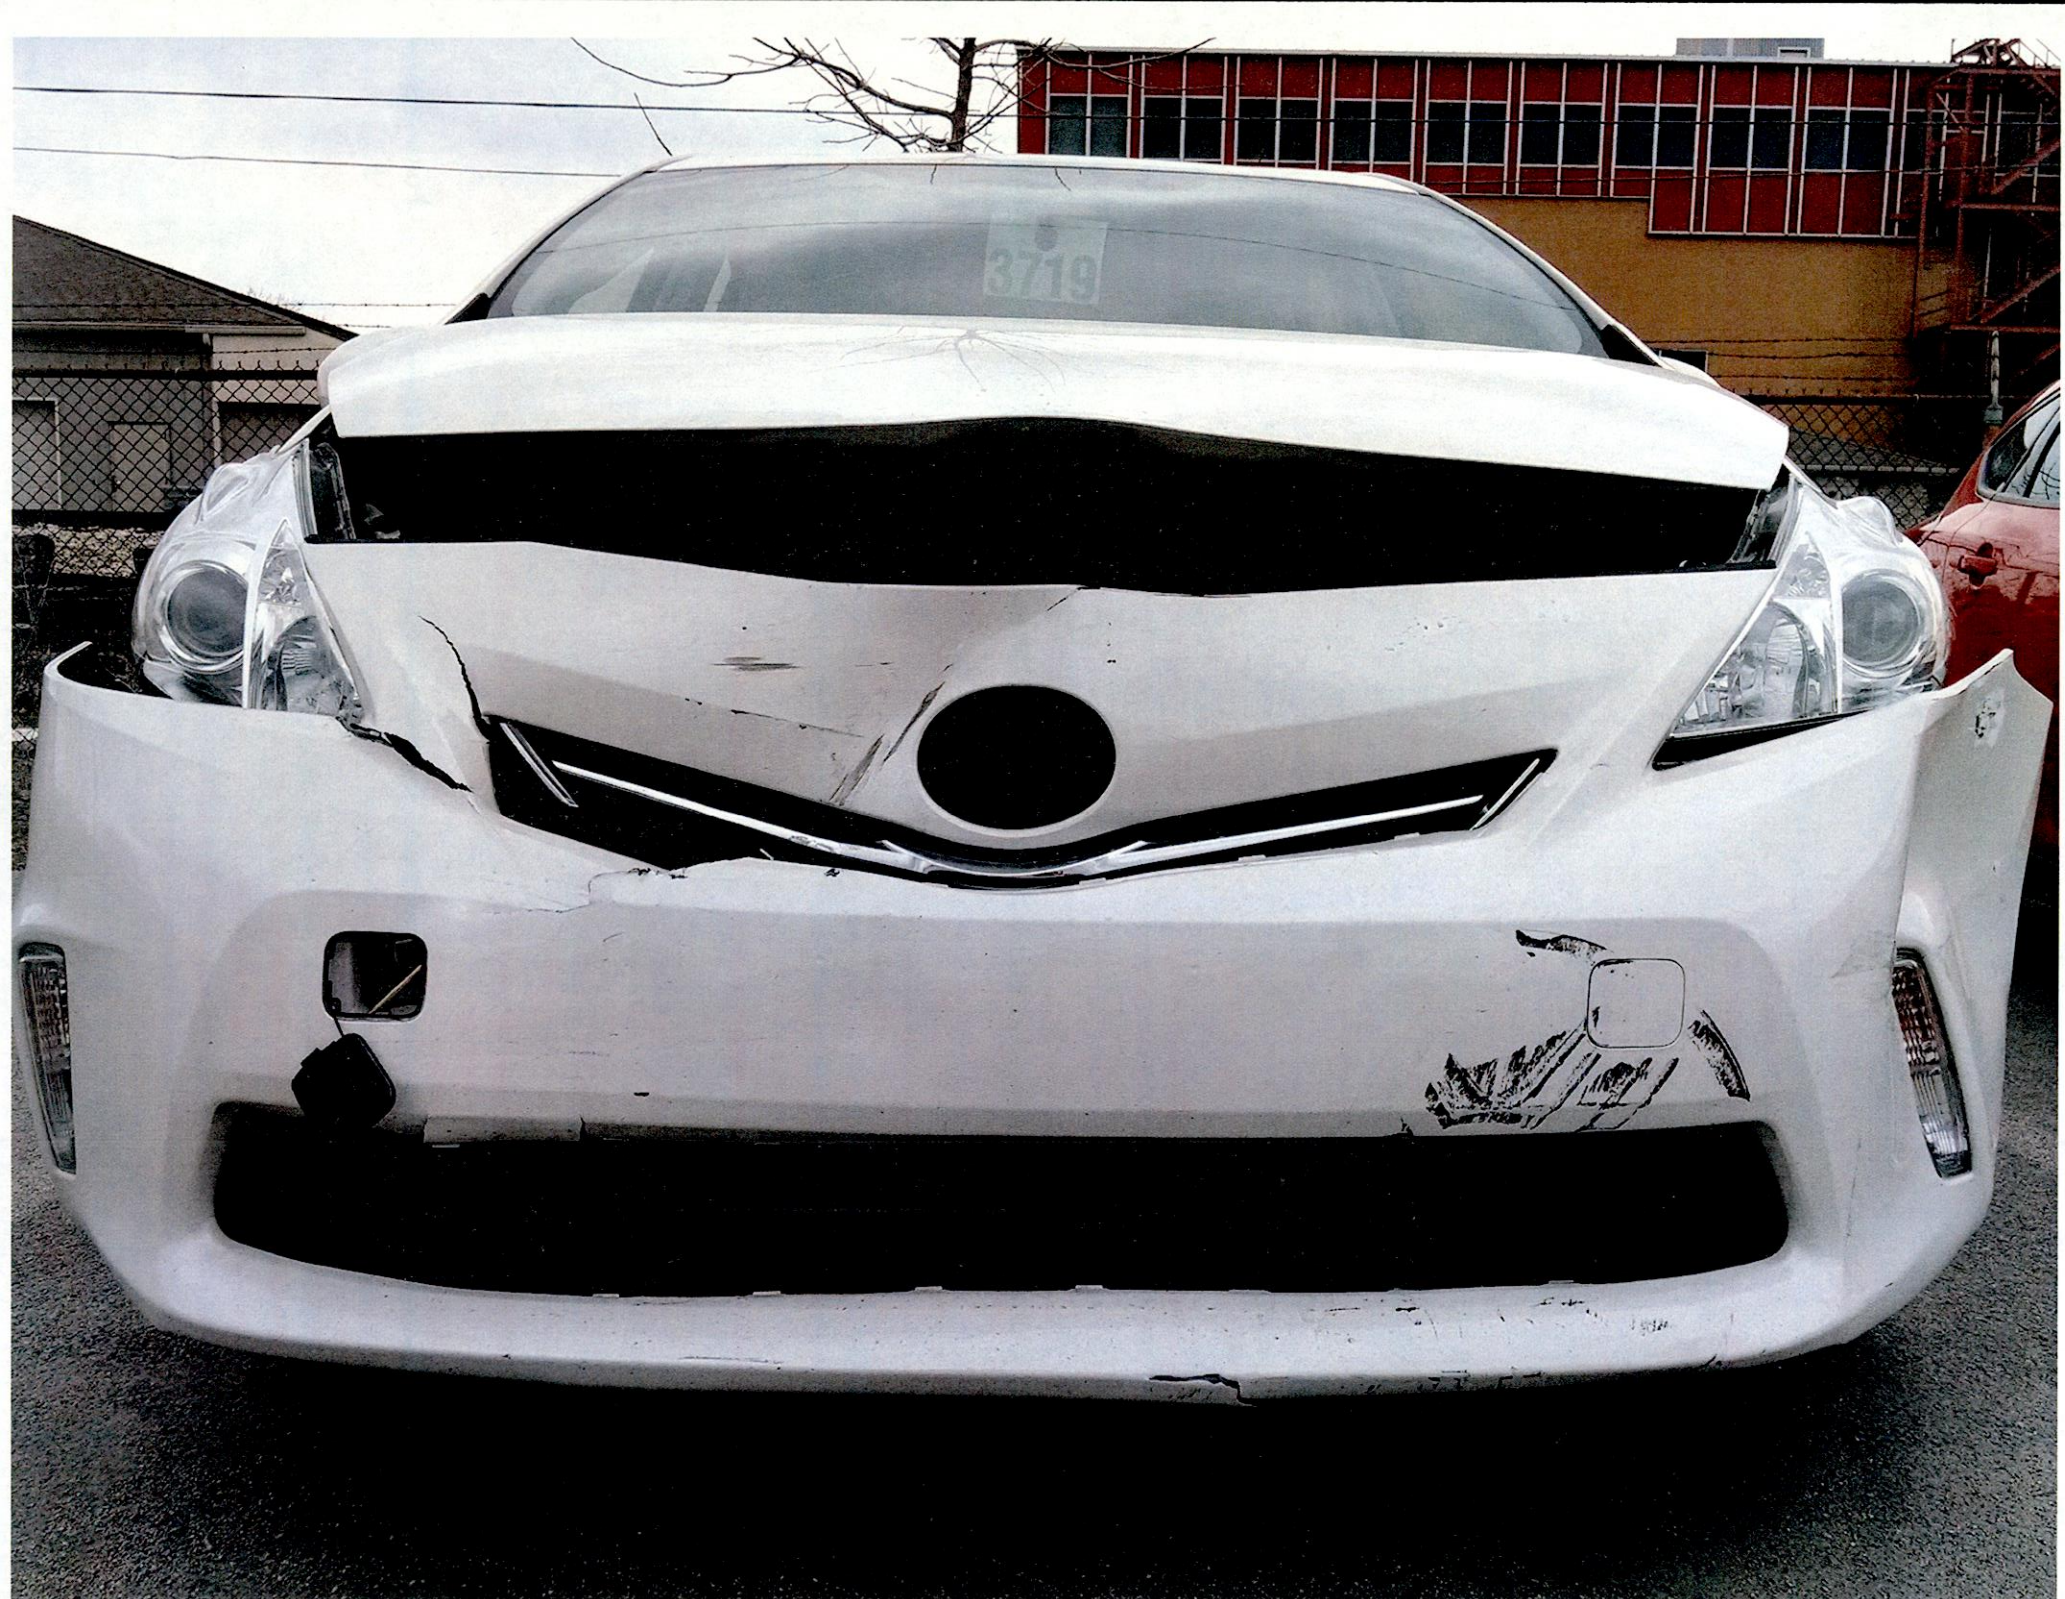
Enclosed please find a police report,  
black box information from my Prius V and photos  
that I took of my damaged auto.

VEHICLE WAS INSPECTED AT DEFOUW BODYSHOP, 320 SAGAMORE PARKWAY, LAFAYETTE, INDIANA 47905 765-449-2800. THE VEHICLE HAD A GLANCING TYPE IMPACT ACROSS THE FRONT END OF THE VEHICLE, THE BRUNT OF THE IMPACT WAS AT RIGHT CORNER, THE GRILLE AND FRONT BUMPER FASCIA WAS DAMAGED, THE FRONT WINDSHIELD WAS CRACKED ON THE RIGHT LOWER CORNER.
