**DOT Auto Safety Hotline**  
**Vehicle Owner's Questionnaire**  
**To Report Vehicle Safety Defects**  
**1-888-DASH-2-DOT**  
**(1-888-327-4236)**  
**INTERNET: www.nhtsa.dot.gov/hotline**

2016 Polaris SLINGSHOT ALL OPTIONS (T16AAS/AAP)

## 2016 POLARIS SLINGSHOT ALL OPTIONS (T16AAS/AAP) DRIVE TRAIN, RIGHT ANGLE GEARCASE ASM. ALL OPTIONS

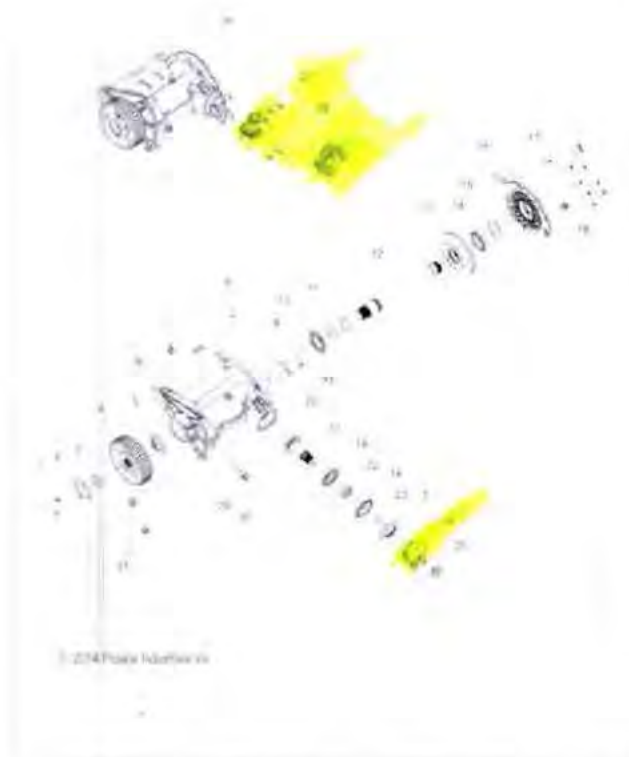
### DRIVE TRAIN, RIGHT ANGLE GEARCASE ASM. ALL OPTIONS

The support brackets aren't shown in this diagram but my mechanic at Perfection Drive Line thinks they are probably included in the prop shaft assembly

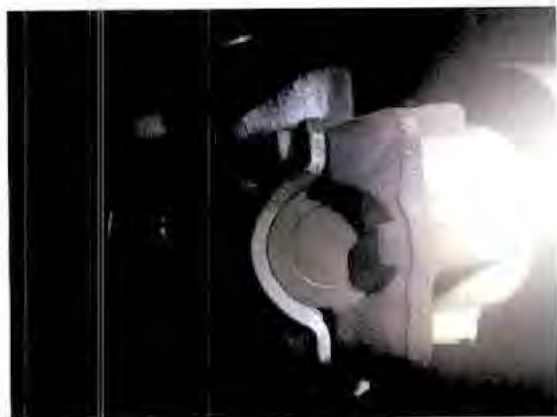
This is a photo  
showing the brackets that  
are missing from the parts  
diagram

Teardown/Comments: Found pretty bad leak at pinion seal, appears to be a common problem with many other owners, and may need yoke replaced along with seal to fix leak properly. Also found u-joint straps don't fit yoke/u-joint properly, and cannot be tightened all the way down to yoke. One strap on each side was not seated on one side, so bolts were not all the way down; one broke off in attempt to tighten before actual issue was discovered. After modifying straps, was able to get one most of the way tight, but other side is still not completely seated on yoke. Need to find out if new straps, yoke, u-joint, etc., are available to correct this issue, as well as the leak.

| PARTS | | LABOR |
|---|---|---|
| Bolt/Supplies | | Check leak. Check u-joint bolt tightness. Remove broken bolt and replace. Slightly modify straps for better seating. Reassemble. |
