**Forest River, Inc. installed SUBURBANS Furnace illegally, creating another Life Threatening Code Violation, in our R-POD.**

Recreational Vehicle manufacturer **Forest River, Inc.** installed SUBURBANS Furnace CROSSWISE in our RV rather than as required LENGTHWISE.

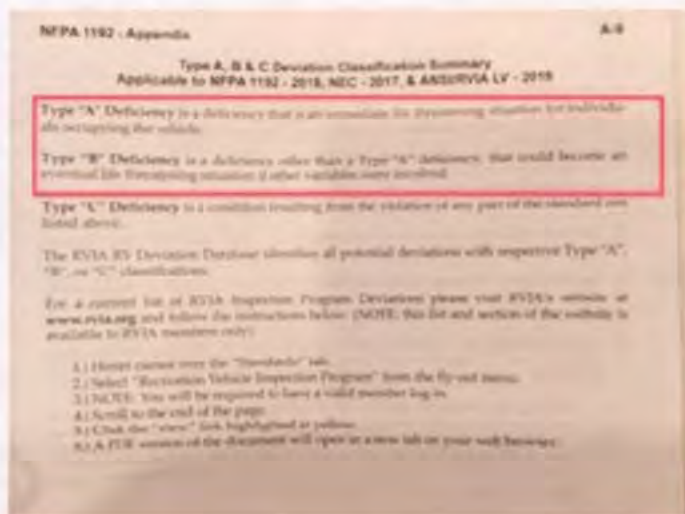
1. **SUBURBANS Propane Furnace** was installed incorrectly creating a life threatening code violation as per SUBURBANS INSTALLATION MANUAL. **TO INSTALL THE FURNACE. 1. Locate the furnace near lengthwise center of the coach. (It was Installed Crosswise). .....**

RVIA (Recreational Vehicle Industry Association). RVIA determined this to be a **Type "A" Deficiency**. **Type "A" Deficiency is a deficiency that is an immediate life threatening situation for individuals occupying the vehicle.**

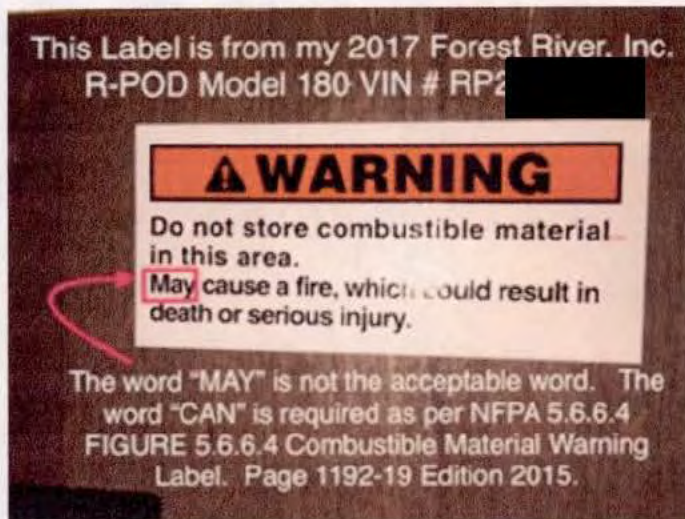
This next photo shows the required **Label** Forest River, Inc. placed on the beds frame cabinet. Unfortunately it's hidden by our bed spread. Please see photo of the bed spread.

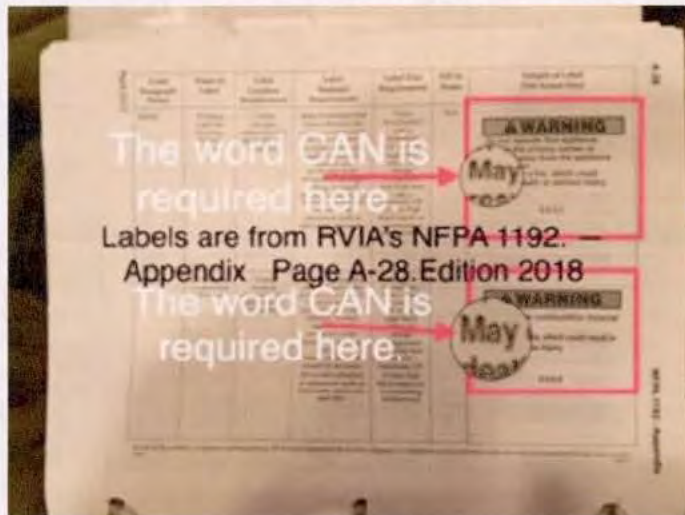
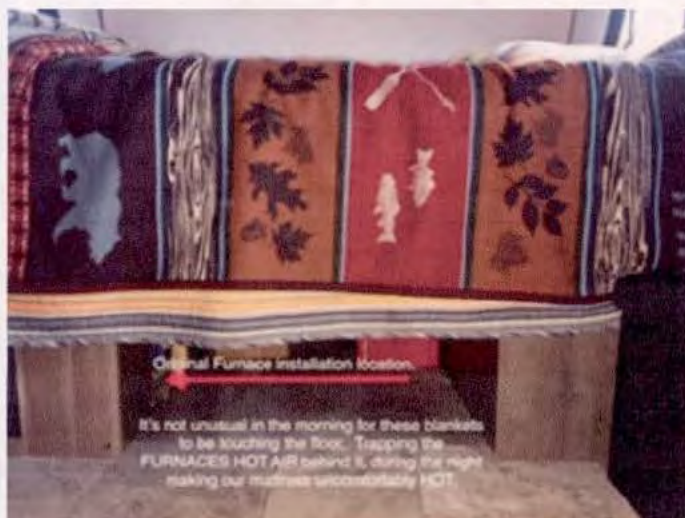
I took this next photo of the inspection requirements found in  
RVIA's NFPA 1192 HANDBOOK GUIDE (Label in photo above).

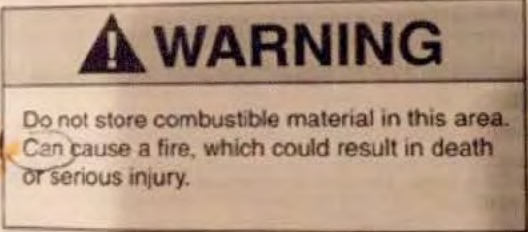
**FIGURE 5.6.6.4** Combustible Material Warning Label.

**5.6.6.4** A warning label, with the word "Warning" with letters a minimum of 1/8 in. (6 mm) high and body text a minimum of 1/8 in. (3 mm) high on a contrasting background, shall be affixed in a visible location adjacent to the applicable appliance(s) and shall read as shown in Figure 5.6.6.4.

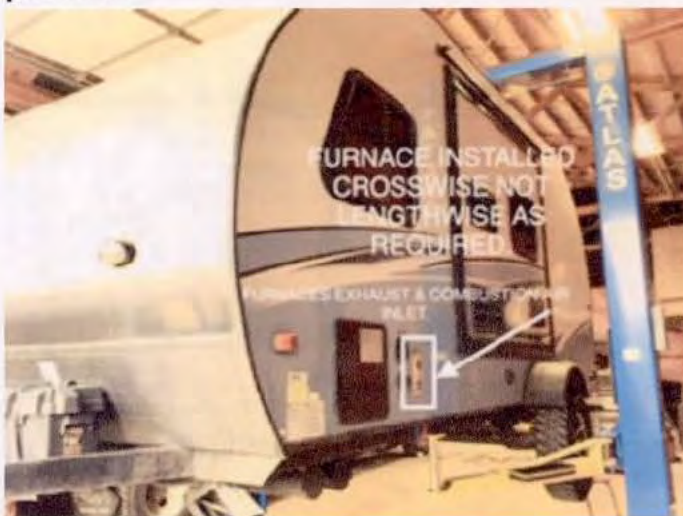
Next photo shows the furnace combustion air inlet and exhaust ports.

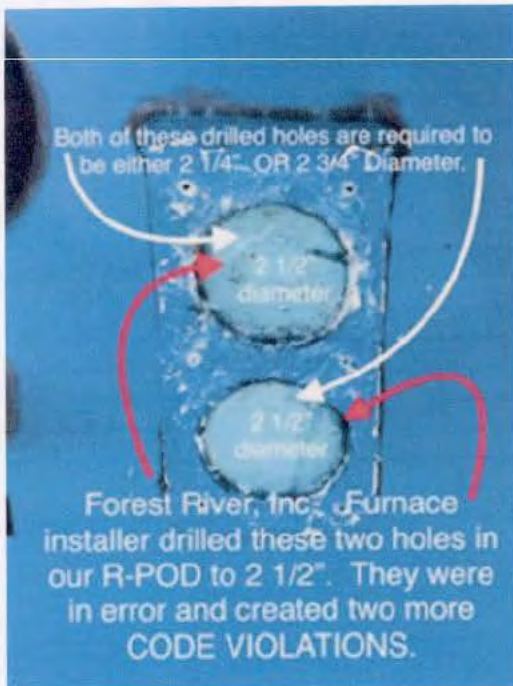
Forest River, Inc. failed to cut the correct sized holes when installing furnace.
