NEF-D10  
CL-11175611-5327

RE: Motorhome Fire Safety Defect

RE: File # [REDACTED] (Safety Issue)

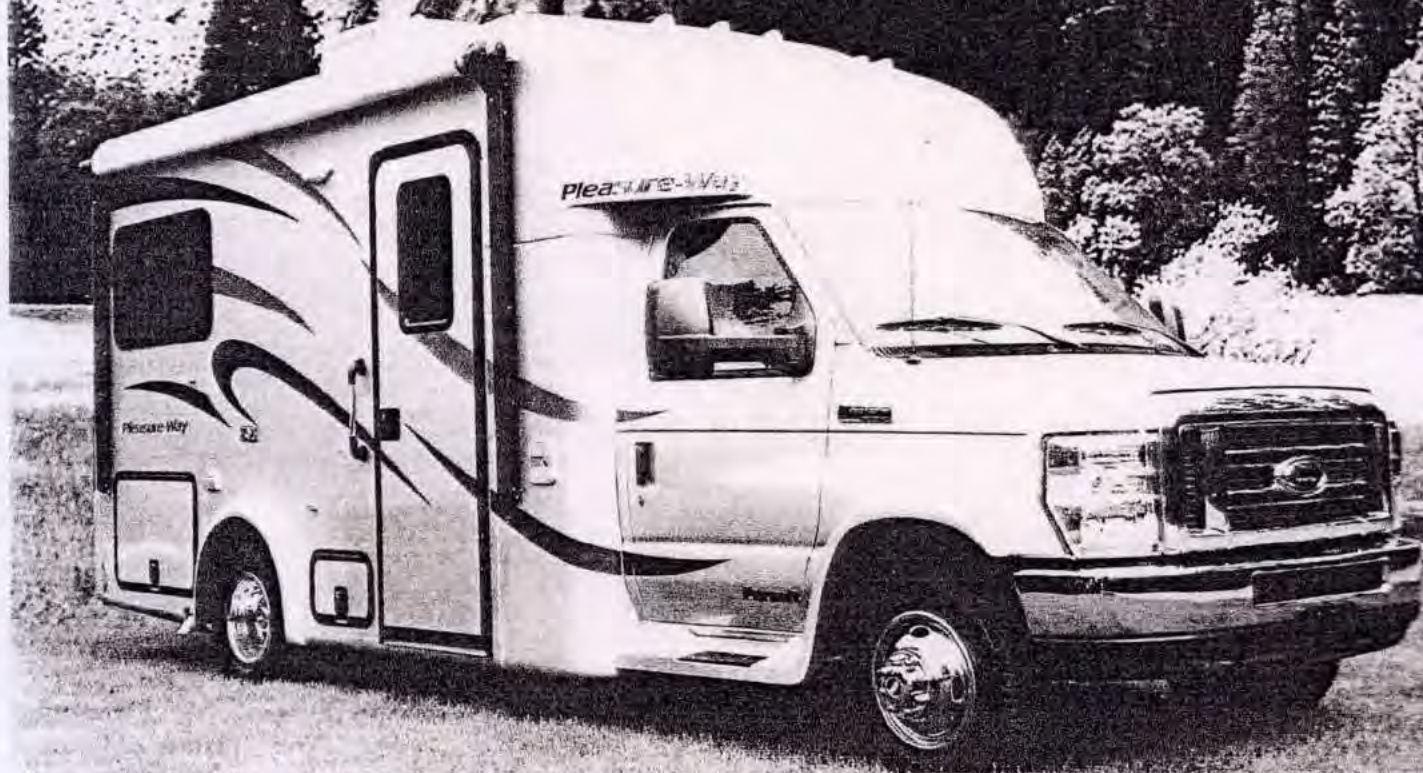
Motorhome Side View Photo Copy

VIN# → 1FDWE3FS5D  
2F1DPRS28FR

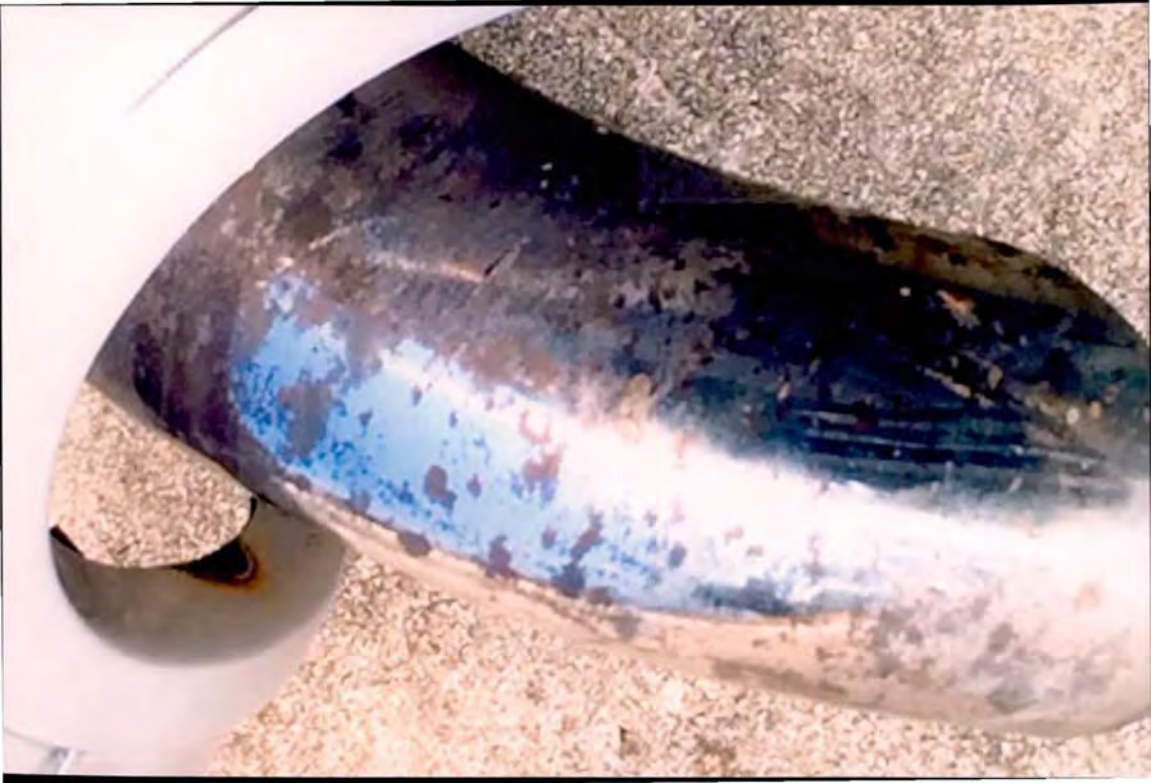
Dec. 2018  
photo which  
shows EARLY  
RECURRING IN THE  
EXACT (SAME)  
SAME LOCATION  
AS BEFORE, 2016-  
2017.

Now for the second time the tailpipe's intense heat, with only one (1) inch separation, is torching the very same area again. Rather than explain the problem by phone, I drove over 100 miles to the dealer's service department in order to show them exactly what was occurring. That date was 10-23-18, and I requested a resolution. I expected no work to be done at that time. However, I was chastised for showing up without an appointment although no other customers were present. The dealer's warranty representative impolitely refused to provide her business card at my request. Much later from other resources I determined her name is Tracey McRodelen. While still there Tracey did make a single photo isolating the charred damage. I insisted that more photos should be made. She did not comply, saying they were unnecessary. Other photos would have showed that the tailpipe was centered in its opening and not touching any surrounding parts. Also, she could have pushed her ballpoint pen against the tailpipe confirming it was not loose or dangling. These minor chores requiring less than 5 minutes and could have saved me another 100 mile trip to their service department and a half day of my time.

Solution: Reroute the rear part of the exhaust pipe, using needed heat deflectors, to a safe open space. It can easily be done at a minimal expense. I will not accept any substitute! The old adage "an ounce of prevention is worth a pound of cure" remains applicable.

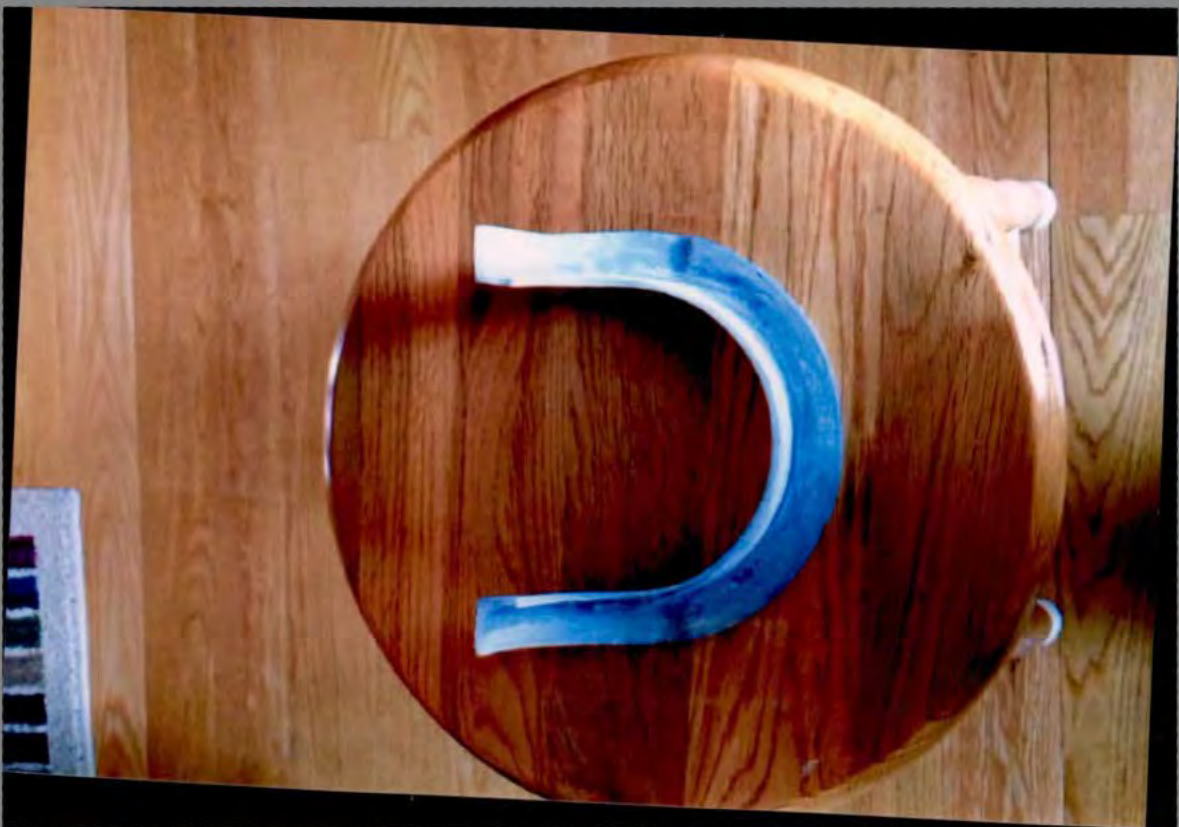
BACK SIDE  
OF NEW DETACHED  
EXHAUST FLANGE

The unpainted replacement exhaust flange arrived 11-9-18. I promptly made an appointment for 10 am, 11-26-18, and I arrived there about 15 minutes early (another 100 mile trip). The technicians

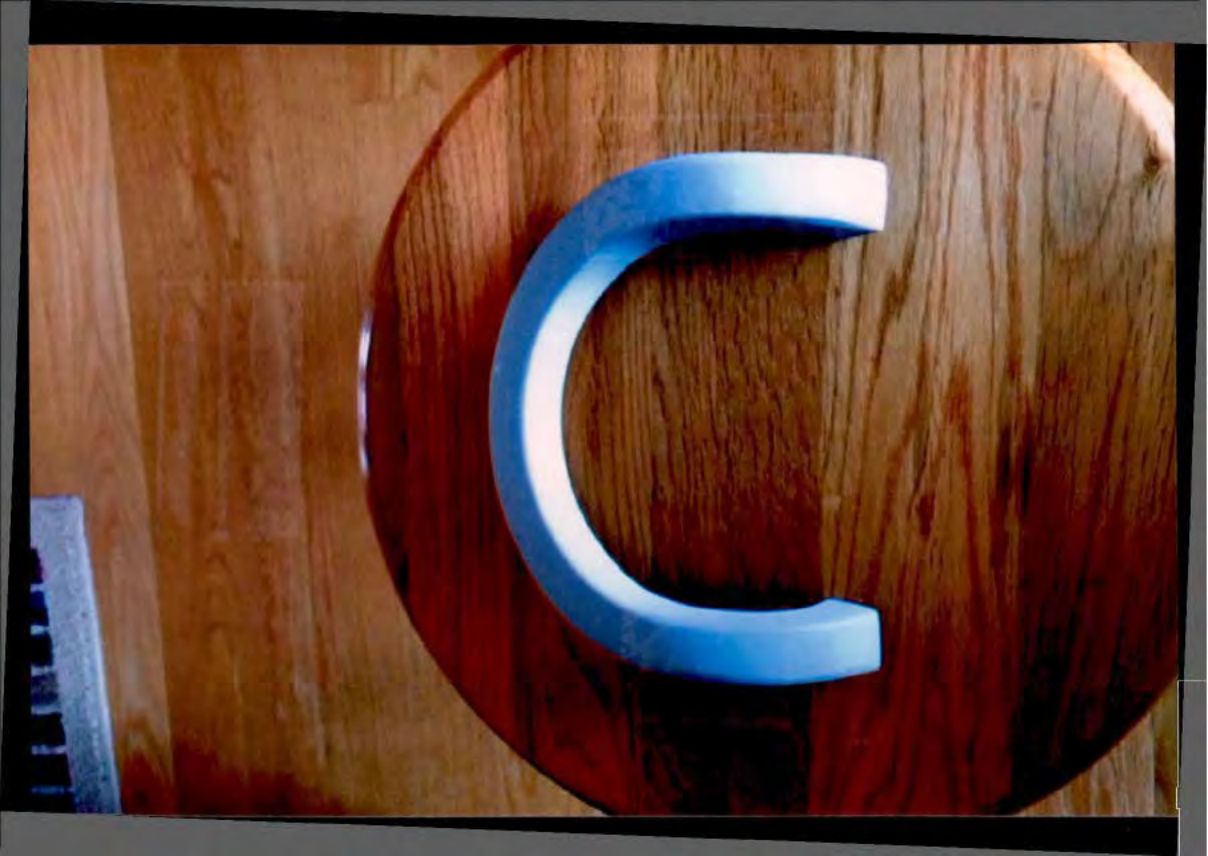
FRONT SIDE  
OF NEW DETACHED  
EXHAUST FLANGE

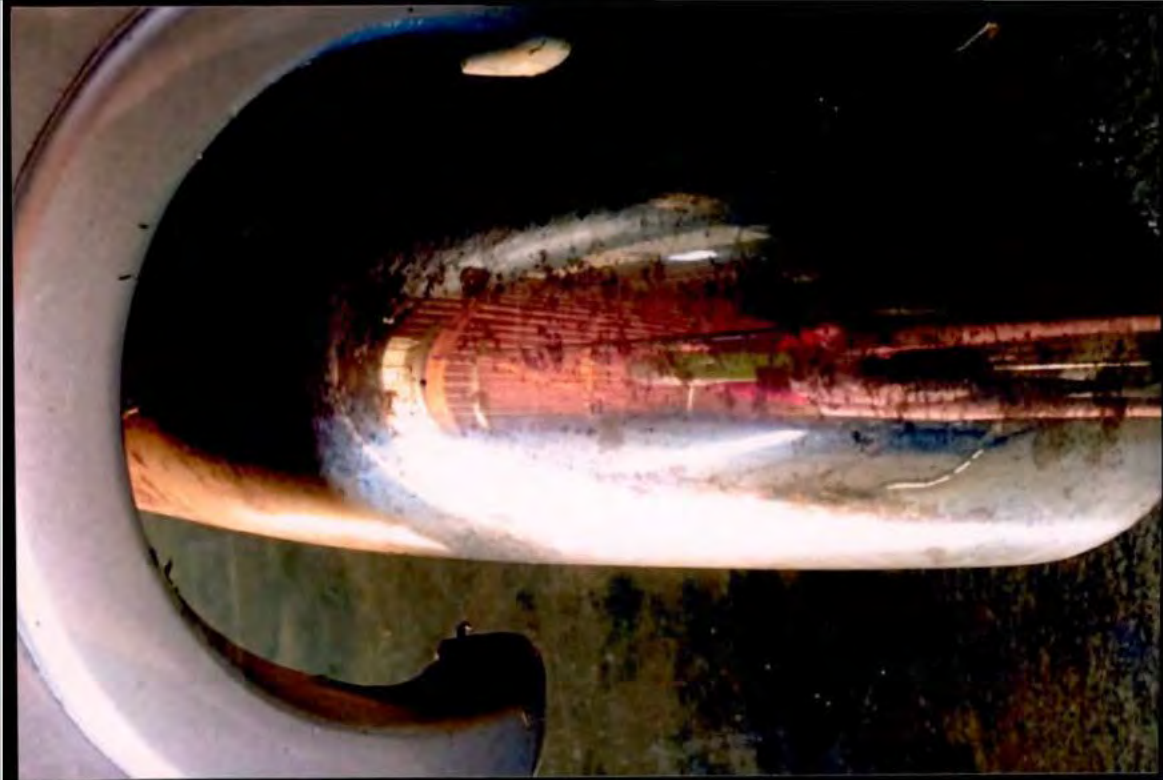
The tailpipe, just over 9 inches in circumference passes to the outside through a "U" shaped opening in the fiberglass sidewall. To the rear of the tailpipe there is only one (1) inch of clearance and cooling space between the flange and pipe. This is where the burning takes place. To the front there is also only one (1) inch of cooling space. The top has just slightly over one (1) inch cooling space. The "U" shaped bottom is open. It is not equipped with any type of heat deflectors at this confined critical point. See detailed photos attached. Around this exhaust opening there is a decorative fiberglass exhaust flange which is bonded to the all fiberglass body. I have included a photo of an unattached flange part for your review. Because of the confined space, intense exhaust heat and the rearward wind force while traveling at highway speed, the rear of the flange was burned to a crisp during the spring and summer of 2017 (see attached photo).

ANOTHER 2017  
PHOTO SHOWING  
BURIED AREA  
TO VIEWER'S  
LEFT, TOWARD  
REAR OF RV.

After much wrangling, resistance and delay the manufacturer allowed the dealer to replace the damaged flange under warranty. However, they refused to address the burning cause and solution which is to reroute the rear part of the exhaust pipe to a safe and open

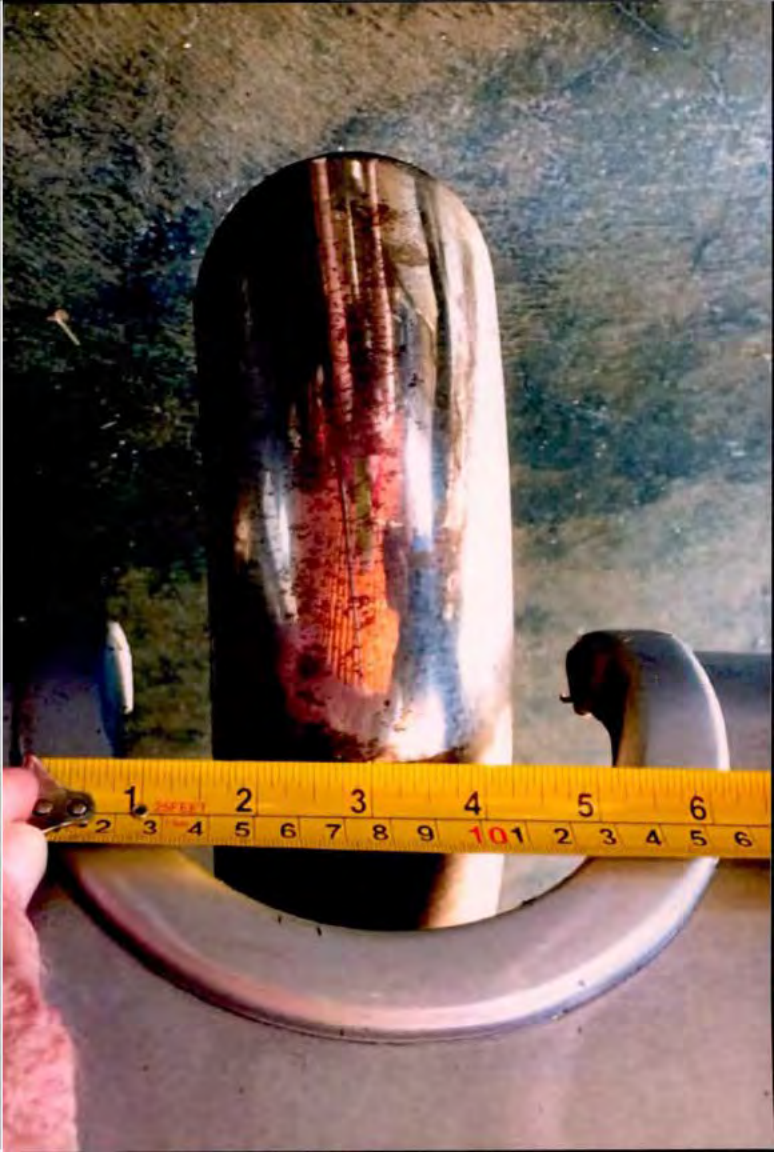
2017 Photo  
With MEASUREMENTS  
BURNED AREA  
TO YOUR LEFT IS  
TOWARD THE REAR  
OF THE RV. THIS  
FLANGE WAS REMOVED  
AND REPLACED.
