**DOT Auto Safety Hotline**  
**Vehicle Owner's Questionnaire**  
**To Report Vehicle Safety Defects**  
**1-888-DASH-2-DOT**  
**(1-888-327-4236)**  
**INTERNET: www.nhtsa.dot.gov/hotline**

Reference No.  
11321023

TL\* THE CONTACT OWNED A 2017 BMW I3. THE CONTACT STATED THAT WHILE AT A COMPLETE STOP, HIS VEHICLE ACCELERATED INDEPENDENTLY INTO ON COMING TRAFFIC WITHOUT WARNING. AS THE CONTACT STRUGGLED TO REGAIN CONTROL OF THE VEHICLE, HE STEERED THE VEHICLE INTO A WOODED AREA WHERE HE HIT A TRASH DUMPSTER. THE AIR BAGS DID NOT DEPLOY UPON IMPACT. THE CONTACT SUFFERED A HEADACHE AND INJURIES TO HIS BACK AND NECK AREA. THE CONTACT DID NOT RECEIVE MEDICAL ATTENTION AT THE SCENE. THE POLICE WAS CALLED; HOWEVER, THE CONTACT NEVER RECEIVED A POLICE REPORT. THE VEHICLE WAS TOWED TO BMW OF BUENA PARK (6750 AUTO CENTER DR, BUENA PARK, CA 90621) TO BE INVESTIGATED. THE CONTACT WAS UNABLE TO STATE WHAT THE INVESTIGATION FOUND; HOWEVER, THE INVESTIGATION DID DEEM THE VEHICLE A TOTAL LOSS. THE MANUFACTURER WAS INFORMED OF THE FAILURE AND AGREED TO PAY FOR A RENTAL VEHICLE. THE MANUFACTURER OFFERED NO FURTHER ASSISTANCE. THE FAILURE MILEAGE WAS APPROXIMATELY 26,680.

#### MY INTAKE ON BOSCH

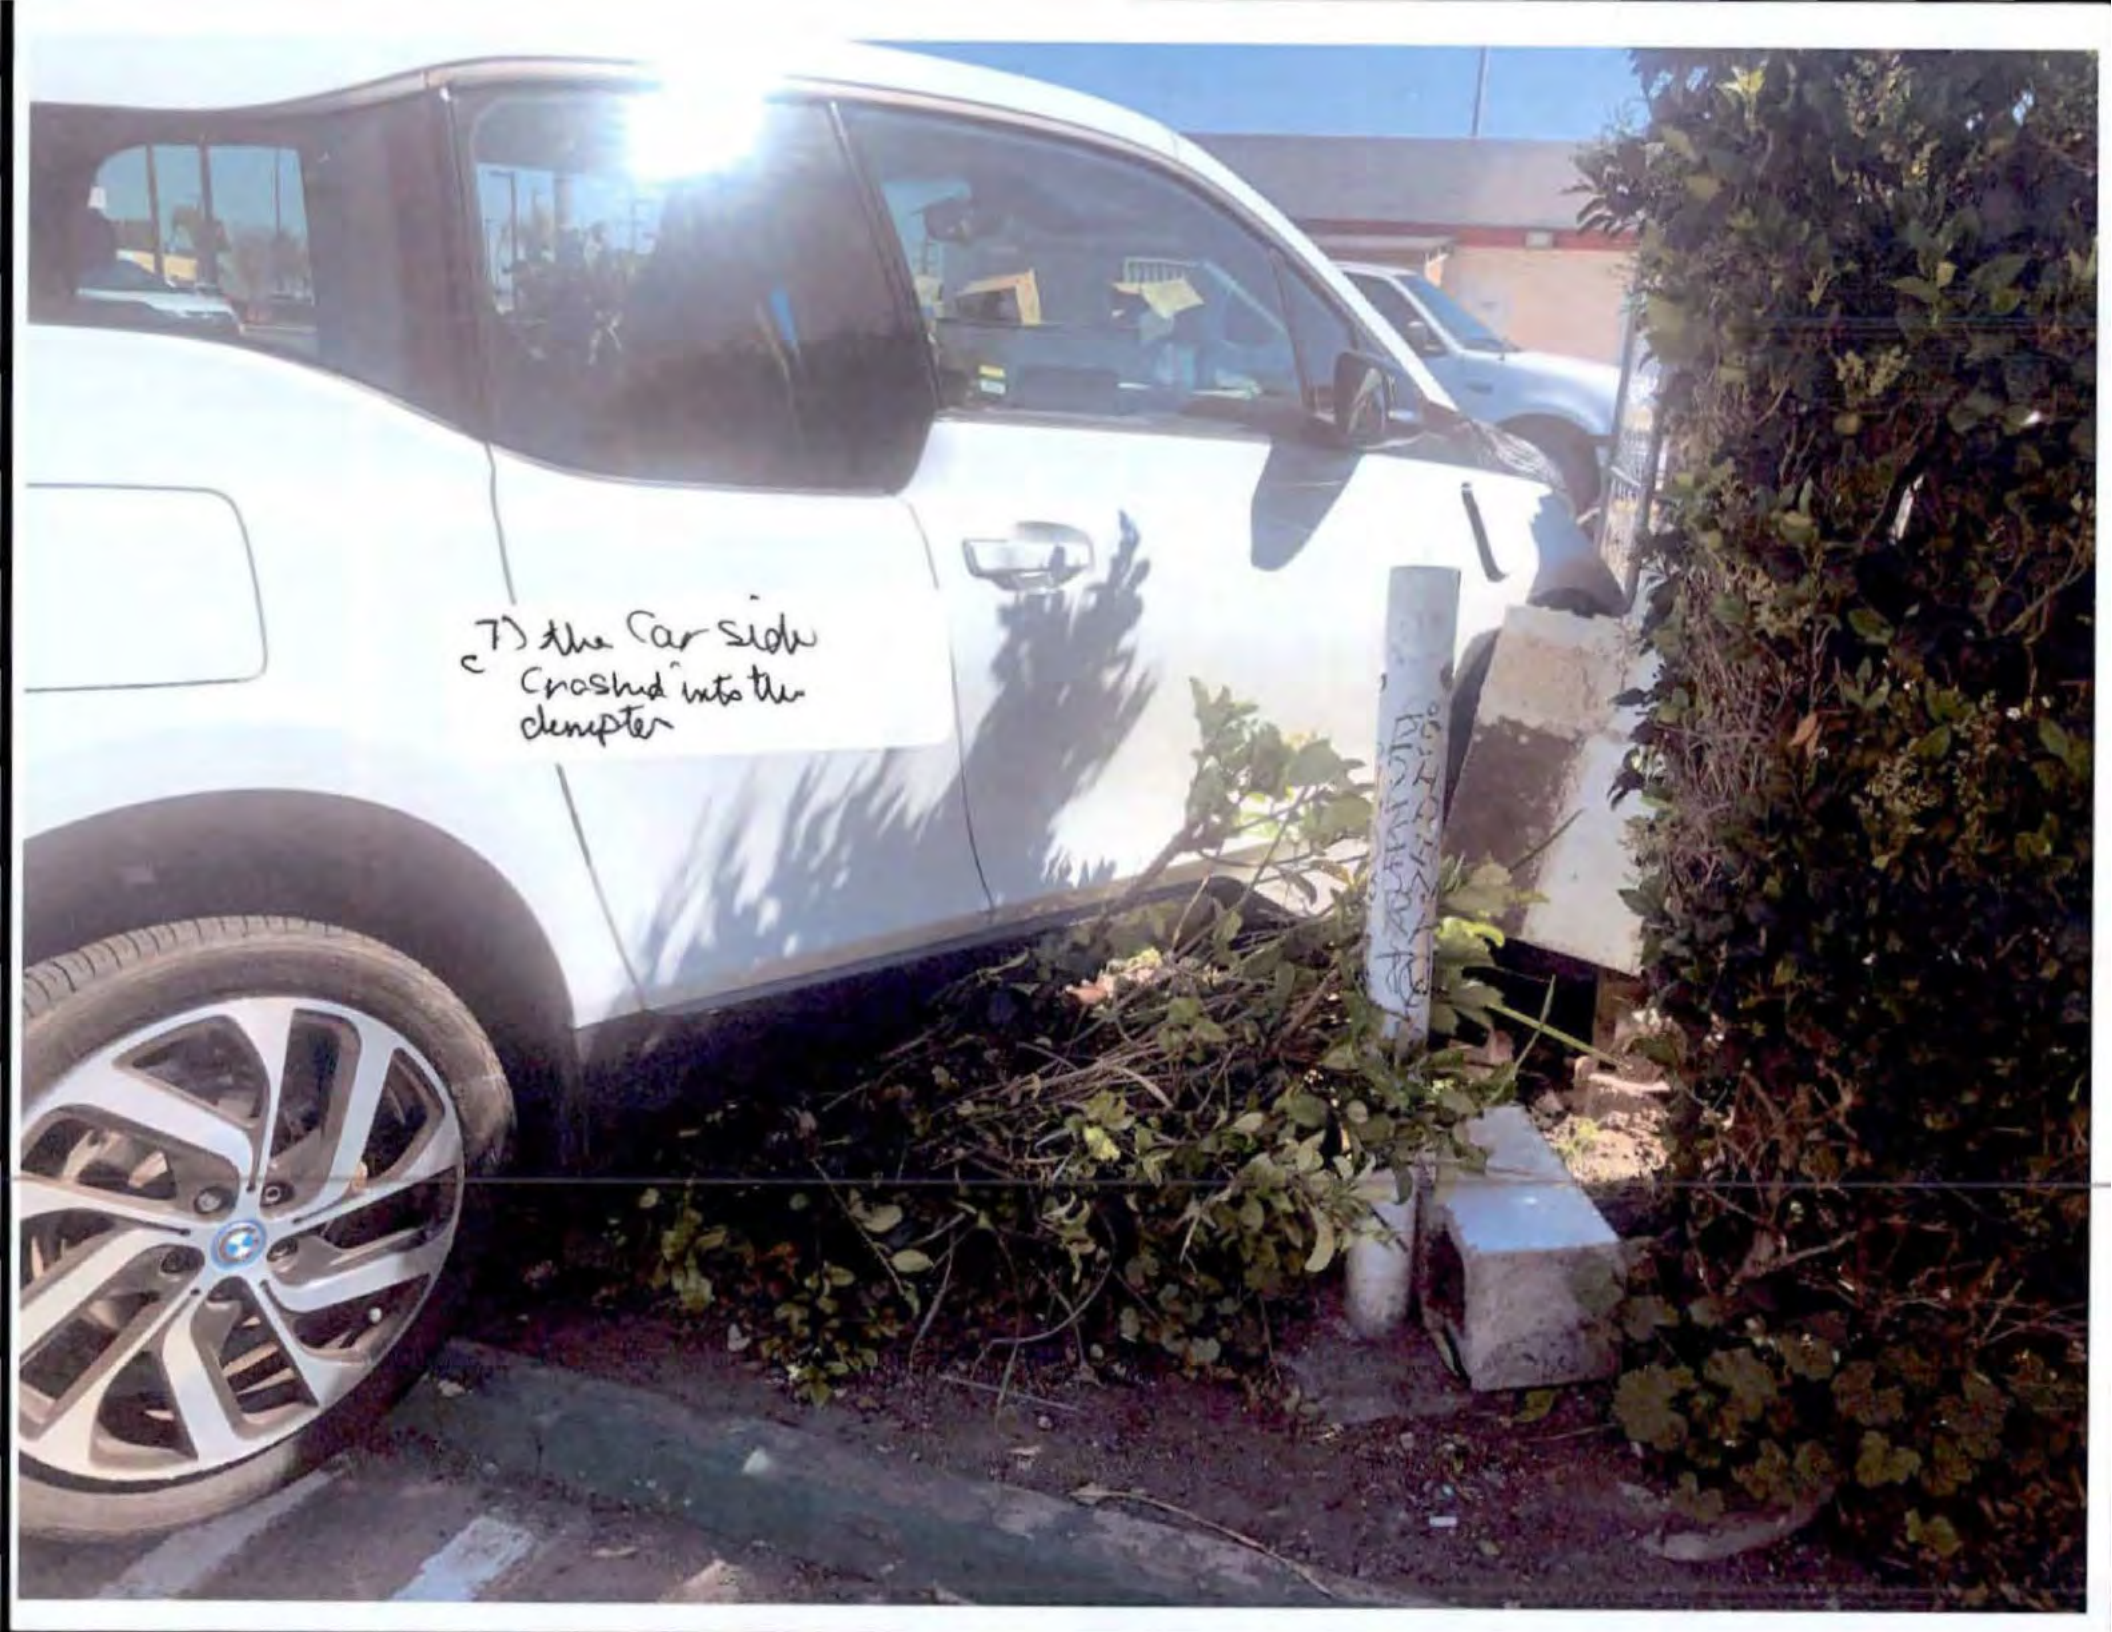
A photograph of a white BMW car that has crashed into a concrete demeter post. The car is positioned on the left side of the frame, with its front end and driver's side visible. The driver's side door is open, and the interior is visible through the window. The car's front wheel is on the left, and the front end is angled towards the right. The concrete demeter post is located on the right side of the frame, and the car's front end is crashed into it. The post is a vertical concrete pillar with some graffiti on it. The car's front end is crushed against the post, and the front wheel is visible. The background shows some greenery and a building. The text "The Car side crashed into the demeter" is written on the car's door.

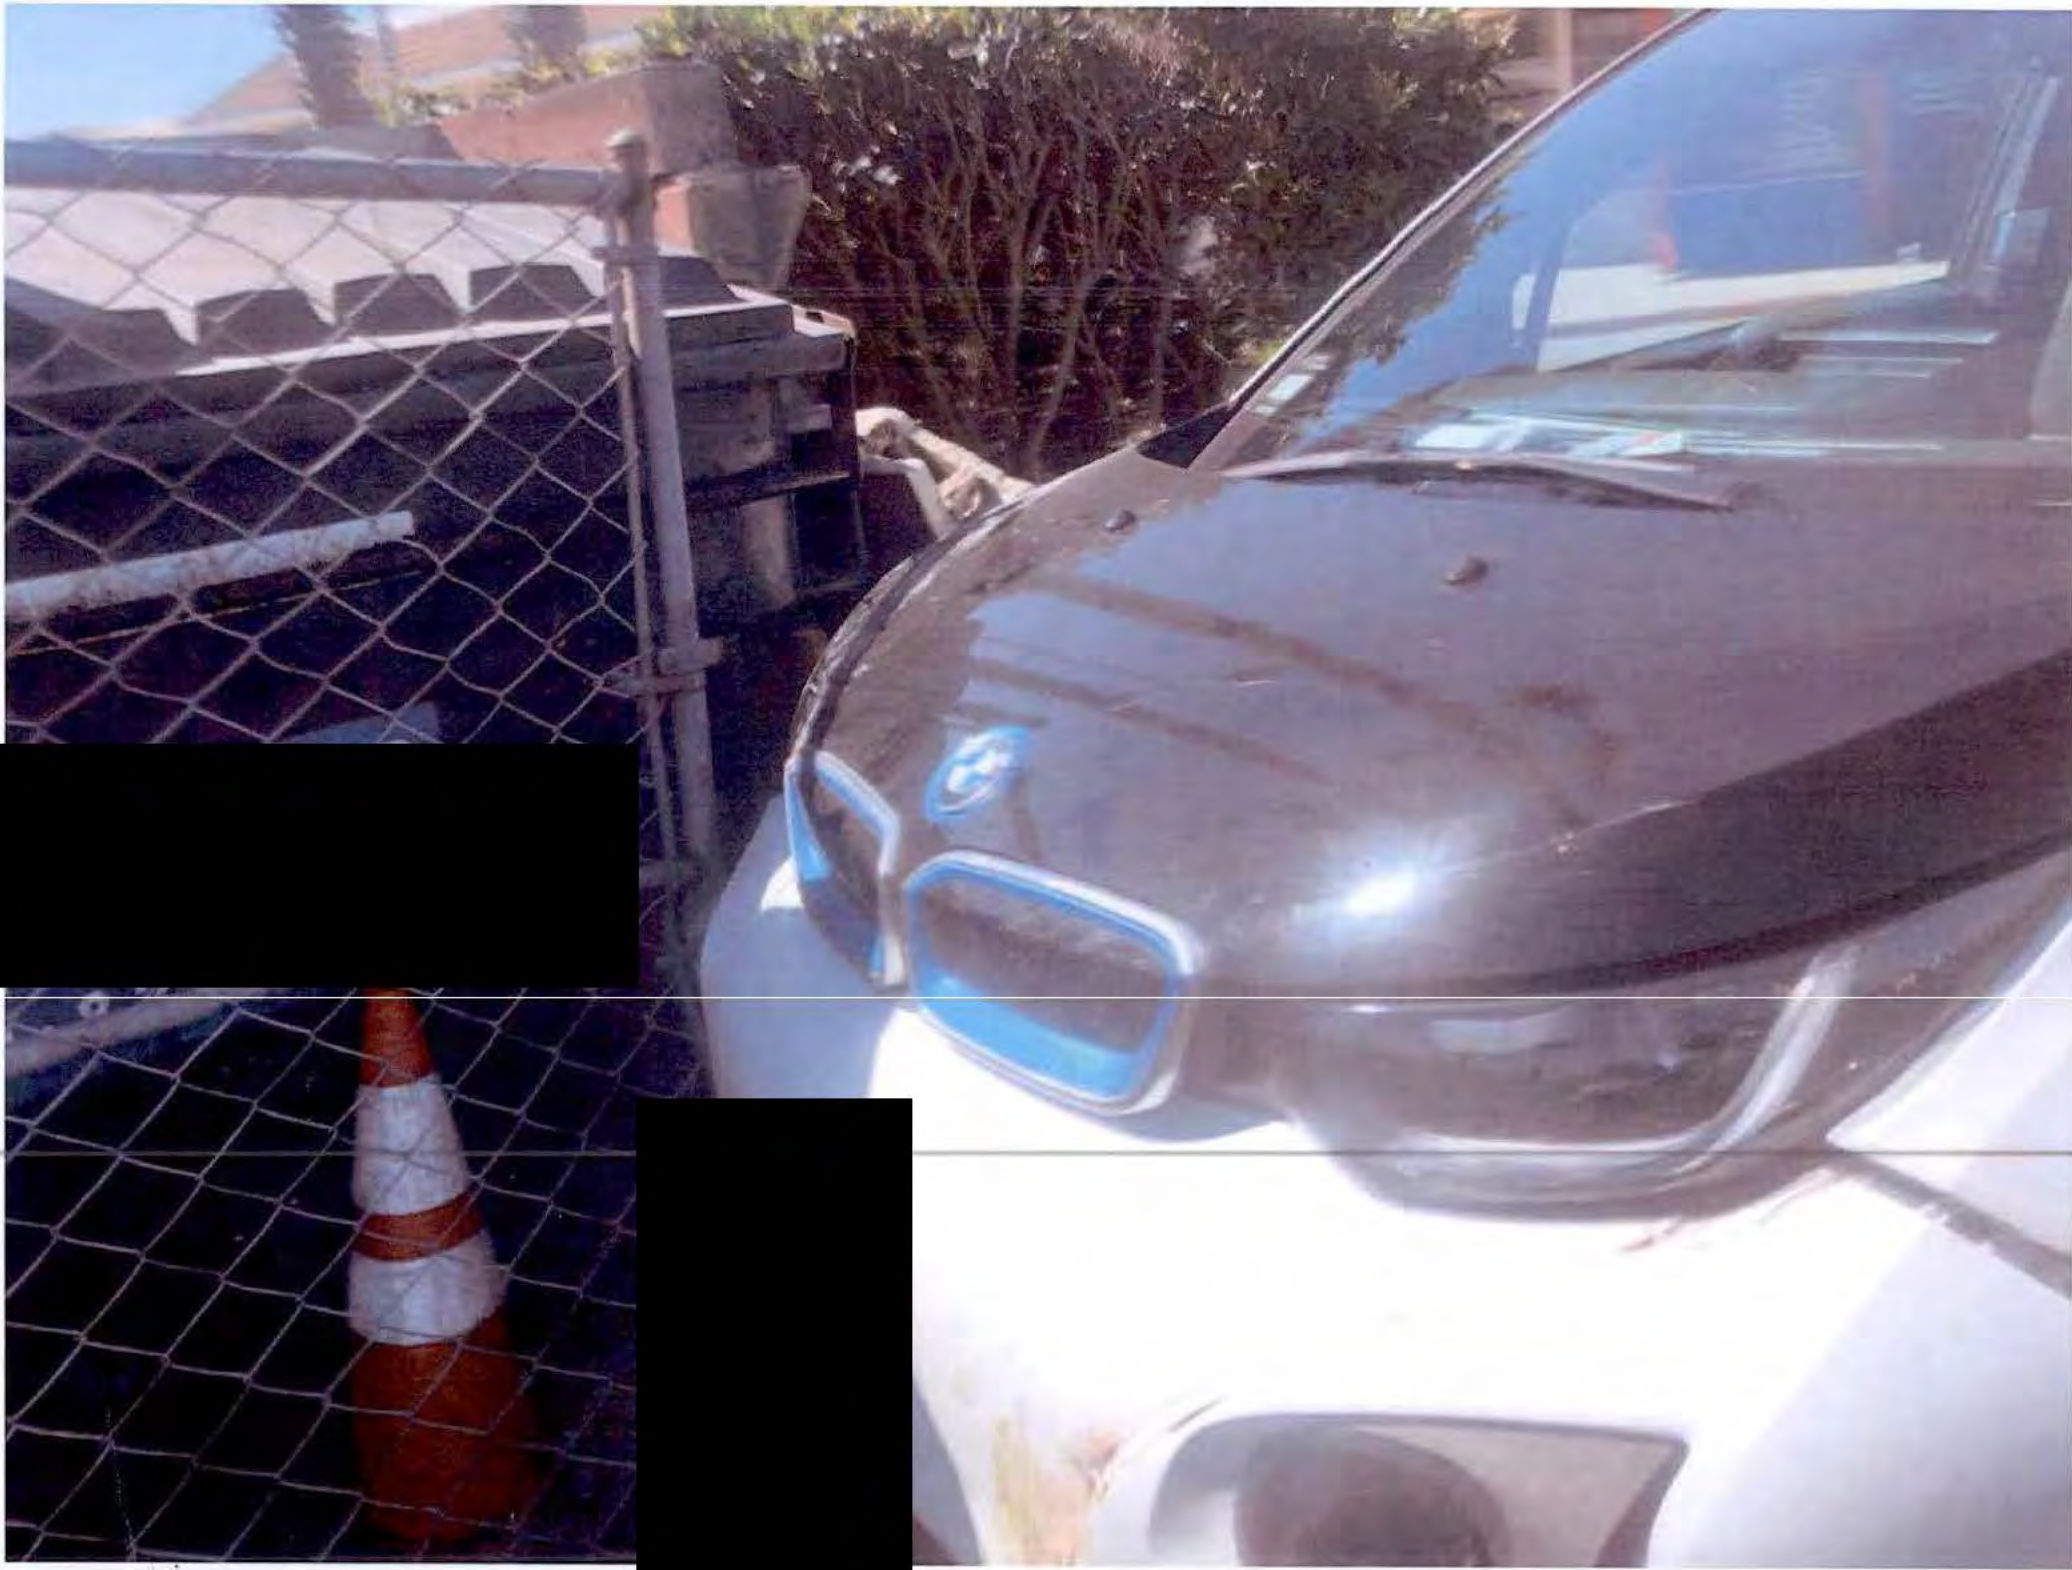
The Car side  
crashed into the  
demeter
