| National Highway Traffic Safety Administration (1-888-327-4236) INTERNET: www.nhtsa.dot.gov/hotline | | FOR AGENCY USE ONLY 100148 | |
| 17 digit Vehicle Identification Number Located at bottom of windshield on driver's side 5FNRL5H88G [REDACTED] | | MAKE HONDA | Model ODYSSEY |
| The contact owns a 2016 Honda Odyssey. The contact stated while driving approximately 70 MPH, the vehicle jerked violently. The check engine warning light was flashing. The contact exited the highway. The contact called the local dealer and the vehicle was taken to be diagnosed. The contact was informed that the cylinder failed and the vehicle loss engine compression. The vehicle was not repaired. The manufacturer was contacted and informed the contact that the repair was not covered under warranty. The failure mileage was approximately 111,000. | | | |

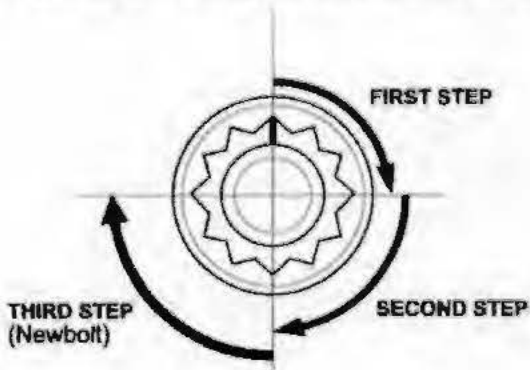
NOTE: Below are the head bolt torque specifications for reinstallation.

- First step: torque the cylinder bolts in sequence to **29 N•m (22 lb-ft)**.
- Second step: tighten in sequence an additional **90 degrees**.
- Third step: tighten in sequence an additional **90 degrees**.
- If the bolts are new, tighten an additional **90 degrees**.

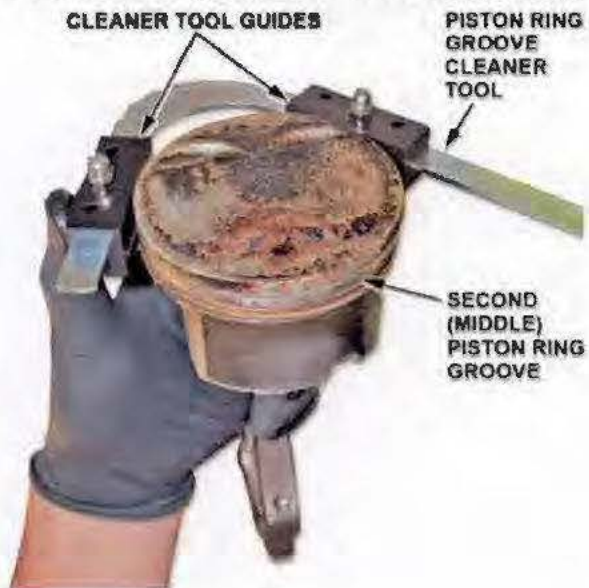
2. Spray the piston head and piston ring grooves thoroughly with Honda throttle plate cleaner.
3. While holding the piston upright in your left hand, take the piston ring groove cleaner tool in your right hand and line up the cleaner tool guides with the second (middle) piston ring groove.

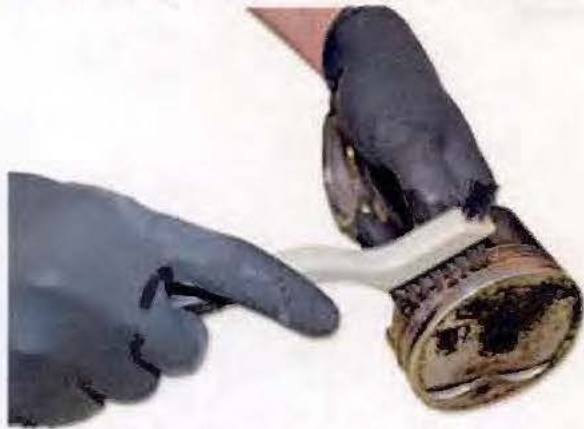
54K PISTON

NOTE: Below are some examples of before and after pictures. Depending on mileage and running conditions, the pistons will achieve different levels of cleanliness.

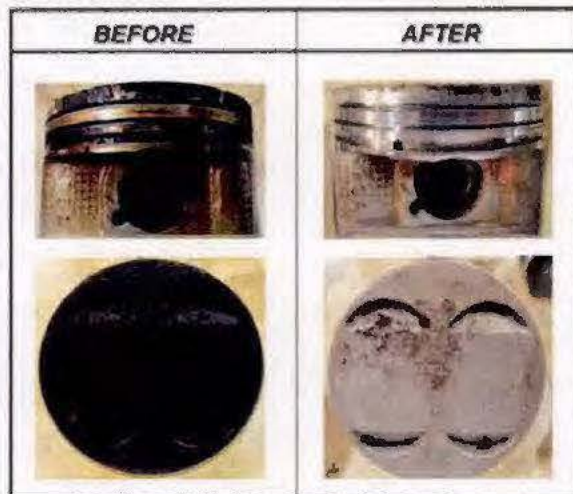
87K PISTON

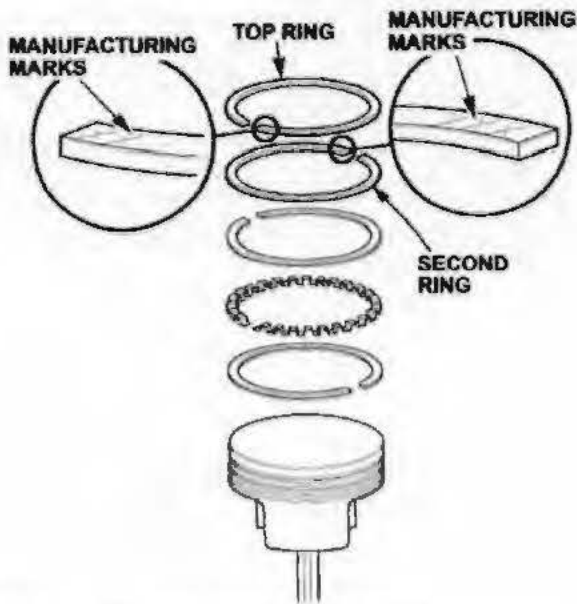
9. Install the piston rings as shown.

NOTE: The first (top) ring has a **1D** manufacturing mark and the second (middle) ring has an **SPR** manufacturing mark. The manufacturing marks must be facing upward.

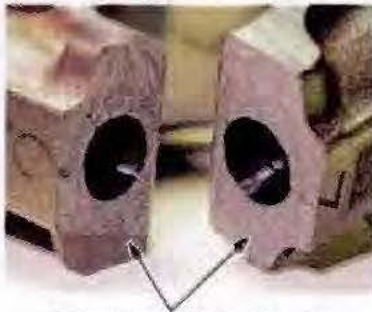
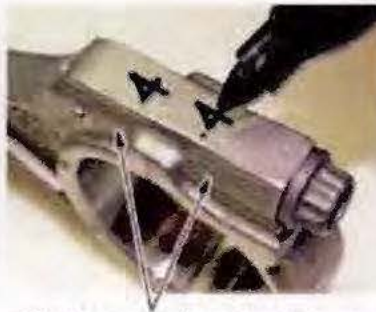
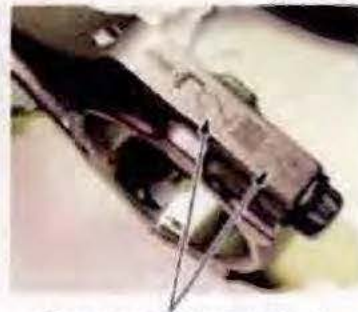
- Before removing the rod caps, use a grease pencil or suitable marking pen to mark each cap and its corresponding connecting rod with the cylinder number it came from.
- Do not confuse the existing marking on the side of the connecting rod and rod cap with a cylinder number. They are just manufacturing marks referring to the size of the big end of the rod.
- Installing a rod cap incorrectly will result in engine knock and/or engine failure. Remove and mark one rod assembly at a time to make sure it is assembled correctly.
- When torquing the rod cap bolts, refer to the service information for details.
- Click [HERE](#) to go to the Tech2Tech® video "Tips When Working with Fracture Rods".

The uneven mating surfaces are uniquely matched and not interchangeable.

Mark the connecting rod and rod cap with the cylinder number.

These are manufacturing marks, and do not indicate the cylinder number.

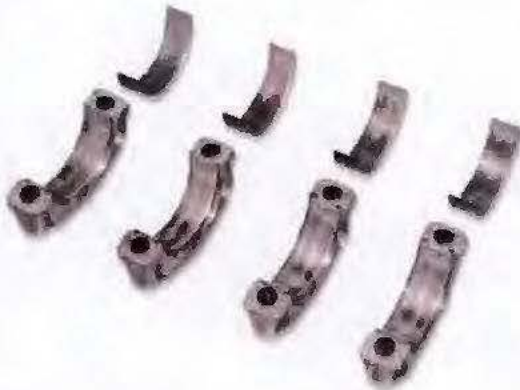
50. Visually inspect all the connecting rod bearing for signs of damage.

- If your fingernail catches on a scratch or groove in the bearing, replace it. Pictured are normal reusable rod bearings after about 35,000 miles. Some discoloration is normal and does not require replacement.
- If the bearings look like they must be replaced, contact your DPSM for authorization.

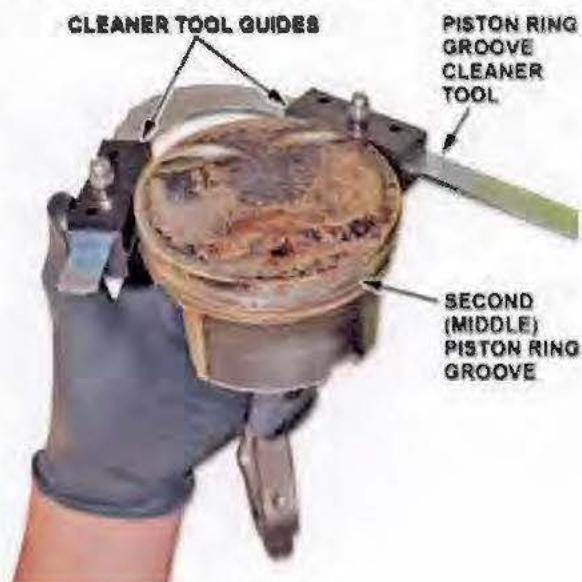
2. Spray the piston head and piston ring grooves thoroughly with Honda throttle plate cleaner.
3. While holding the piston upright in your left hand, take the piston ring groove cleaner tool in your right hand and line up the cleaner tool guides with the second (middle) piston ring groove.

4. Press the handle on the piston ring groove cleaner tool and slide the cleaning bit onto the appropriate piston ring grooves.

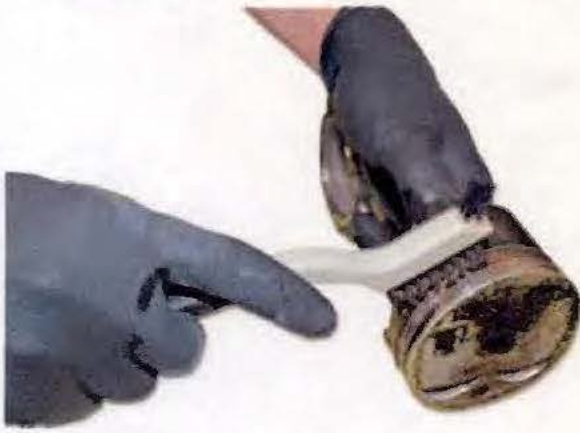
Below are some examples of before and after pictures. Depending on mileage and running conditions, the pistons will achieve different levels of cleanliness.
