From: [REDACTED]
 To: [EVOQ \(NHTSA\)](#); [REDACTED]
 Cc: [NHTSA ODI CRD](#); [REDACTED]
 Subject: ODI-11436024
 Date: Tuesday, October 12, 2021 3:47:07 PM
 Attachments: [REDACTED]

I was driving when the rear of my car began vibrating, then fishtailing and I lost control and hit a curb resulting in mostly forward damage. In reviewing the Preliminary Estimate from the auto-shop and insurance adjuster, there was quite a bit of damage to the Rear Suspension including a broken Trailing arm lock nut, washer, and bolt, as well as the Protector lining, lower control arm, its lock nut and the control arm mount bolt. The broken rear axle components caused me to lose control of my vehicle resulting in forward impact with a curb. My car was deemed a total loss with \$28K in estimated repairs.

Image Report

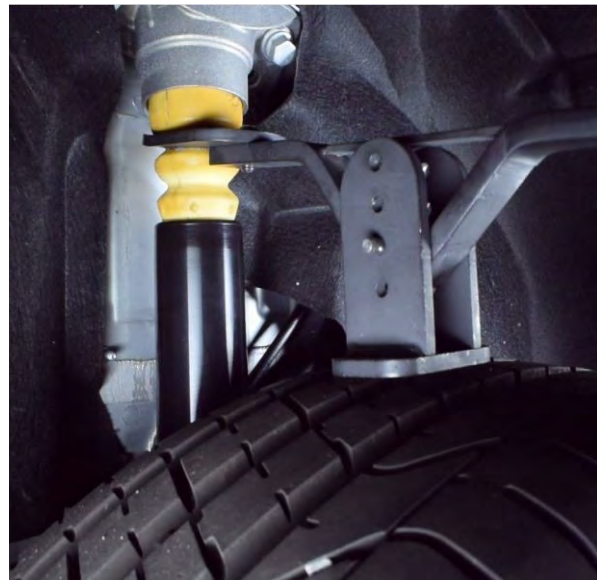
Figure 2. The SET900 tool being used to install a rear bump stop.

1. Clean the top of the rear bump stops and coat with tire mounting paste.
 2. Use the SET900 special tool to fully press the rear bump stops into the upper shock mounts (Figure 2).
- The purpose of the tool is to properly seat the rear bump stops in the rear shock mounts (Figure 3), which will prevent them from dropping out of the rear upper shock mounts and causing the noise.
