U.S. Department of Transportation National Highway Traffic Safety Administration	DOT Auto Safety Hotline Vehicle Owner's Questionnaire To Report Vehicle Safety Defects 1-888-DASH-2-DOT (1-888-327-4236) INTERNET: www.nhtsa.dot.gov/hotline			FOR AGENCY USE ONLY 100148	
	Date Received 04-FEB-2022		Repository <input type="checkbox"/>		
Reference No. 11450361					
OWNER INFORMATION (Type or Print)					
Name	[REDACTED]			Daytime Telephone Number	E-mail Address
Address	[REDACTED]			[REDACTED]	[REDACTED]
City	NORTH ATTLEBORO	State	MA	ZIP Code	[REDACTED]
<i>The information you provide will be used to identify potential safety-related defects. We may share your information with the applicable vehicle manufacturer during an investigation or recall in accordance with the routine uses described in the agency's Privacy Act notice. See 49 FR 53971 (Sep. 3, 2004).</i>					
VEHICLE INFORMATION					
17 digit Vehicle Identification Number Located at bottom of windshield on driver's side KM8R4DHE3NU [REDACTED]		MAKE HYUNDAI	Model PALISADE	Model Year 2022

Automobile Status Report

2022 Hyundai PALISADE

Multi-Point Inspection Form

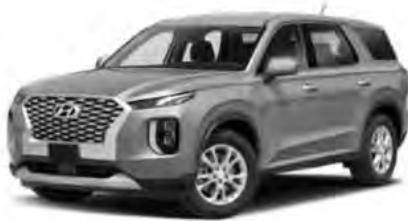
[Other]: Wiring repair. throttle body wiring harness is chewed through wire in new pigtail harness solder and shrink wrap connections

[Other]: wiring repair. bank 2 intake camshaft sensor wiring is chewed completely through. repair wiring harness and test vehicle for operation
