**From:** [REDACTED]  
**Sent:** Friday, October 7, 2022 6:03 PM  
**To:** vsh@dot.gov  
**Subject:** ODI#11488415 ONAN GENERATOR PROPANE HOSES FAILING  
**Attachments:** Onan generator hose replacement on-line email.docx

**From:** [REDACTED]  
**Sent:** Friday, October 7, 2022 5:11 PM  
**To:** 'Winnebago Motorhome Customer Care' <customercare@winnebagoind.com>  
**Subject:** SAFTEY ISSUES WITH ONAN GENERATOR PROPANE HOSES FAILING

Technical Service Bulletin: TSB200040	Released Date: 26-Feb-2020
HGJBB Crank but No Start or Hard Start Due to Leaking LP Hoses

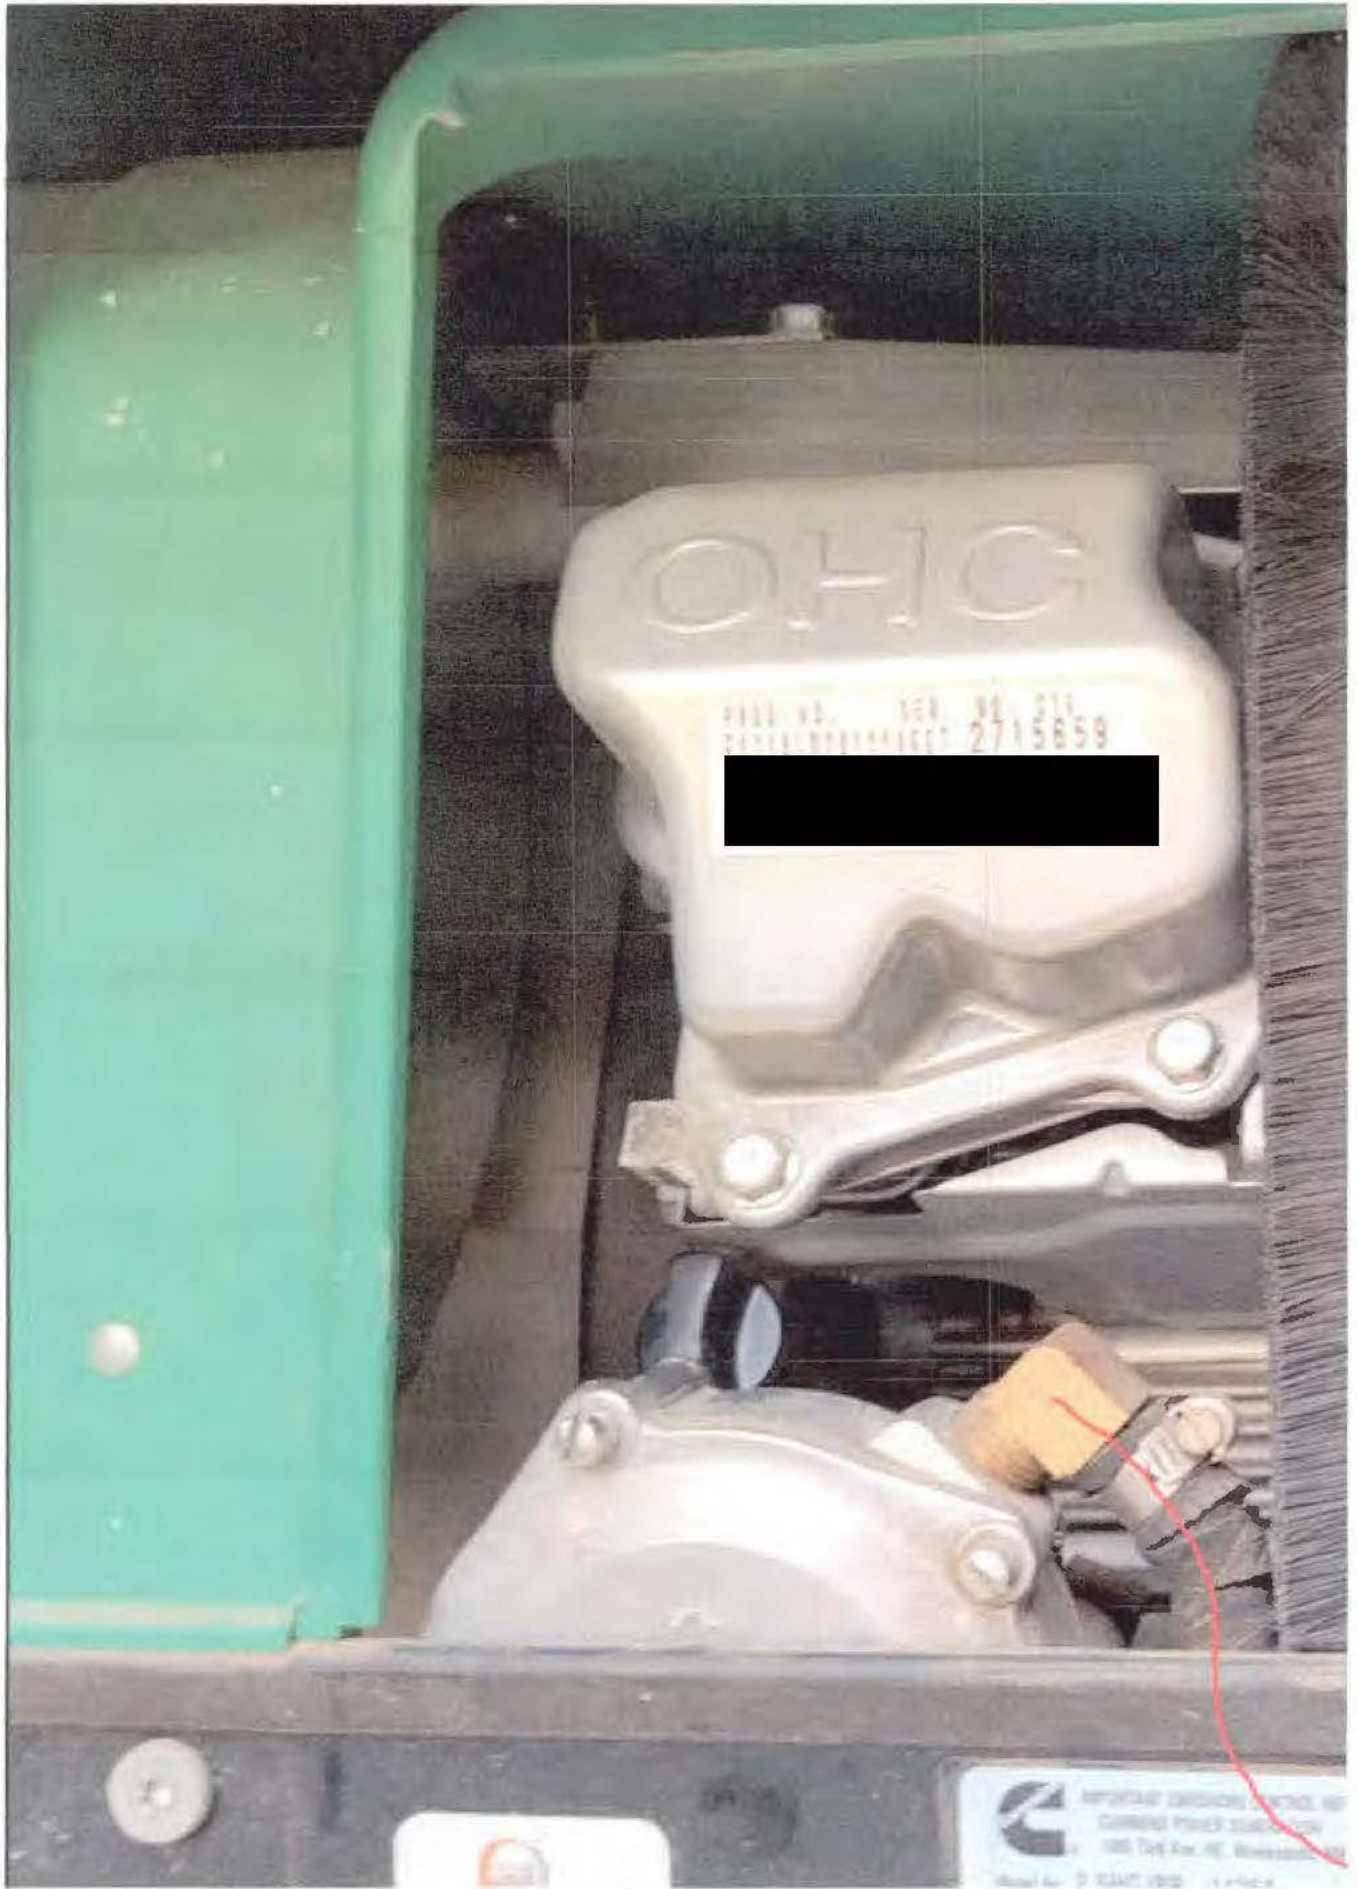
- A. On my ONAN 2500 LP generator, the rubber propane lines (one high pressure from the solenoid to the regulator and one low pressure going from the regulator to the carburetor) have degraded and were leaking causing the generator to not start.

- D. It only leaked when the generator was running or attempting to start since the hoses were downstream from the solenoid valve. In my situation the leak prevented the starting but propane was being released as long as I held down the starter. If the generator can run with a slow leak, propane will accumulate around the RV creating a major safety hazard.
- E. Also I have never seen a propane line designed with hose clamps, only threaded fittings pressed on to the hose.
- F. I THINK THIS IS AN IMMEDIATE SAFETY ISSUE.

**CAUSE** ES206 9/8/22  
 GENERATOR WILL NOT START.  
 FAULT 38 OCCURING.  
 CHECKED IGNITION SPARK, OK  
 LP FUEL HOSES CRACKED AND LEAKING.  
 UNIT WILL REQUIRE FUEL HOSE REPLACEMENT.  
 LP HOSES

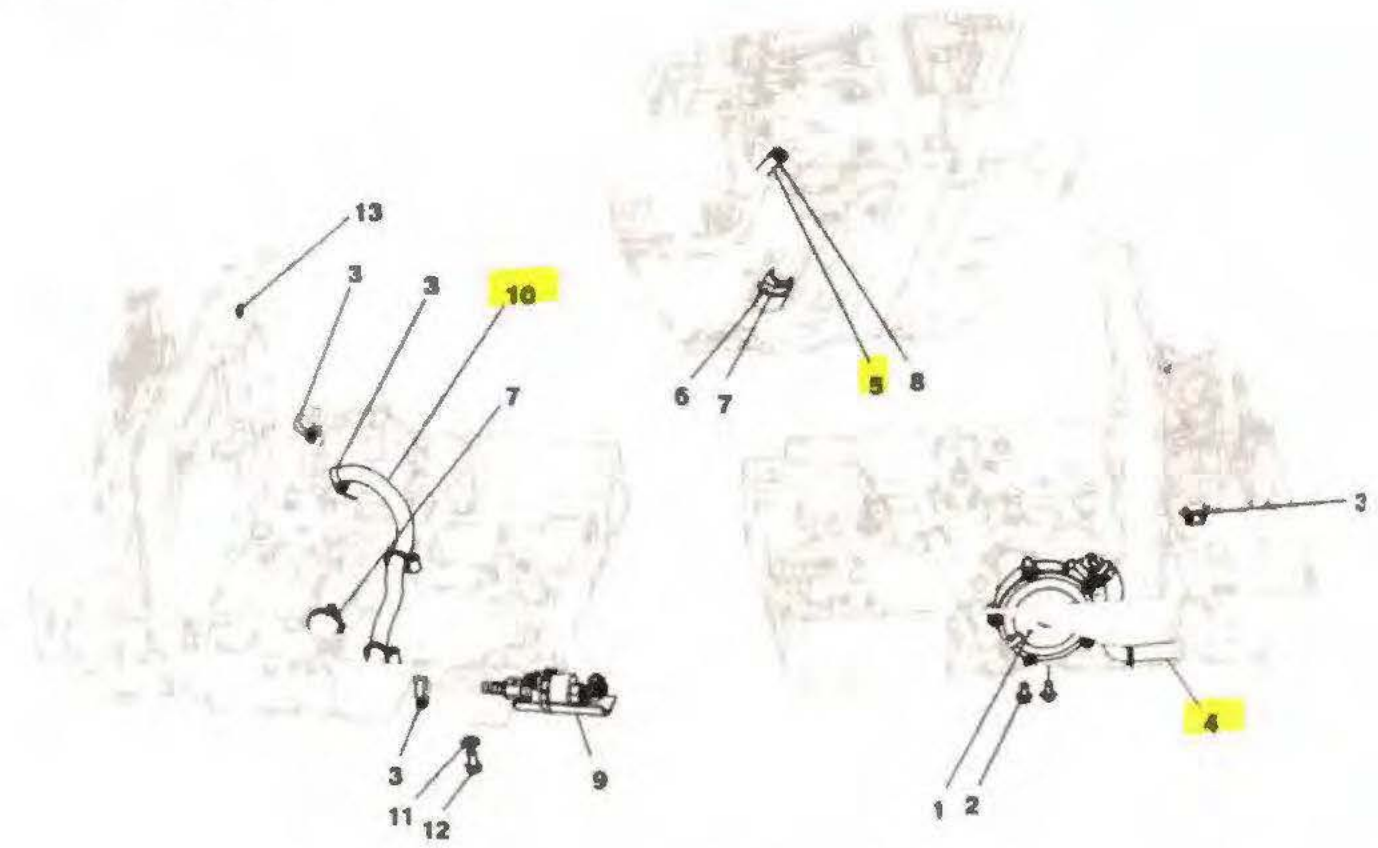
## Fuel System - LP

Item	Part No.	Description	Qty
1	A034R584	Regulator, Fuel	1
2	821-0010	Screw, Locking	2
3	503-2309	Clamp	4
4	A041E044	Hose, Fuel	1
5	A043A369	Hose, Vent	1
6	148-1343	Filter, Vent	1
7	332-3388	Tie, Cable	2
8	503-0731	Clamp	1
9	A046B282	Kit, Fuel Solenoid (See Page 14 for Service Parts)	1
10	A041E042	Hose, Fuel	1
11	528-2100	Washer, Flat	1
12	800-2056	Screw, Hex Head	1
13	517-0131	Plug, Hole	1

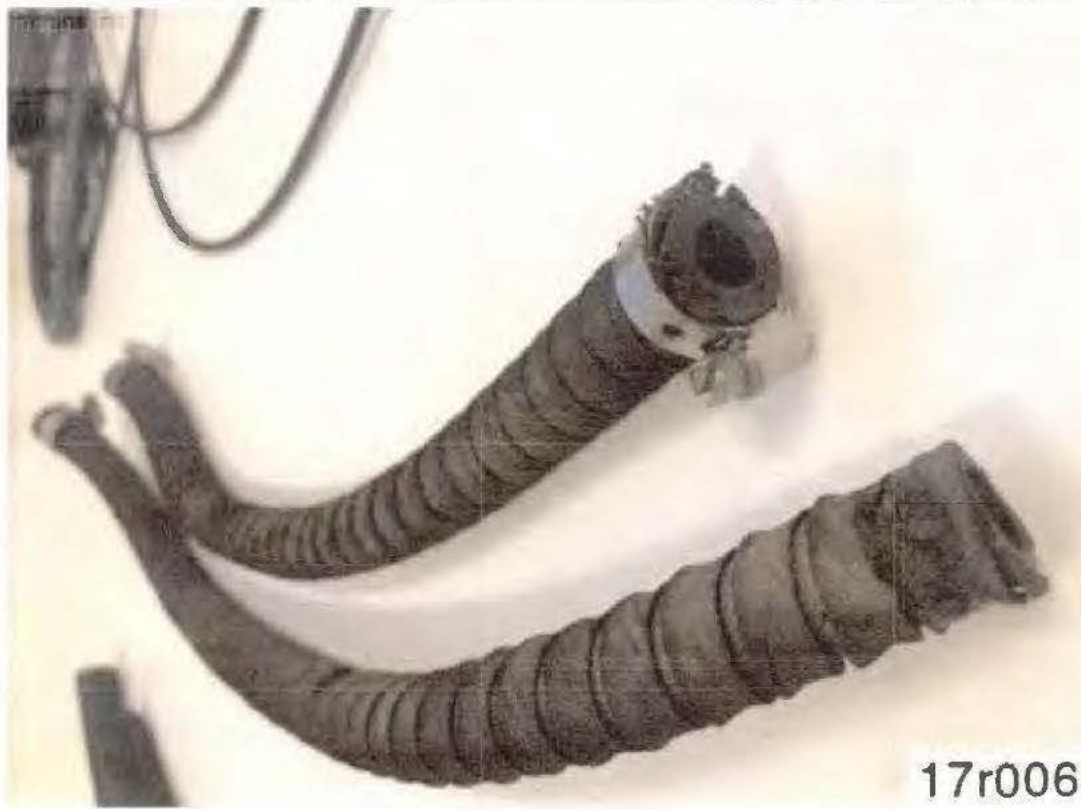
Figure 2, Old LP Fuel Hoses that are Susceptible to Cracking

- The liquid propane (LP) hoses carrying LP to and from the regulator can crack and deteriorate over time due to age and environmental stress. The cracked hoses pull in excess air, resulting in a lean mixture which can cause the symptoms stated above.

The new hoses should appear visibly different than the older hoses (which were susceptible to cracking). Refer to Figure 2 and Figure 3 for the differences in the fuel hoses appearance.

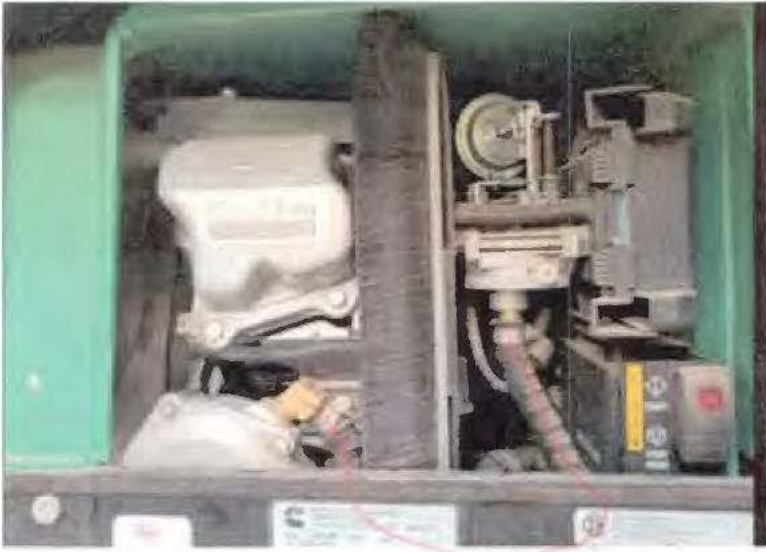
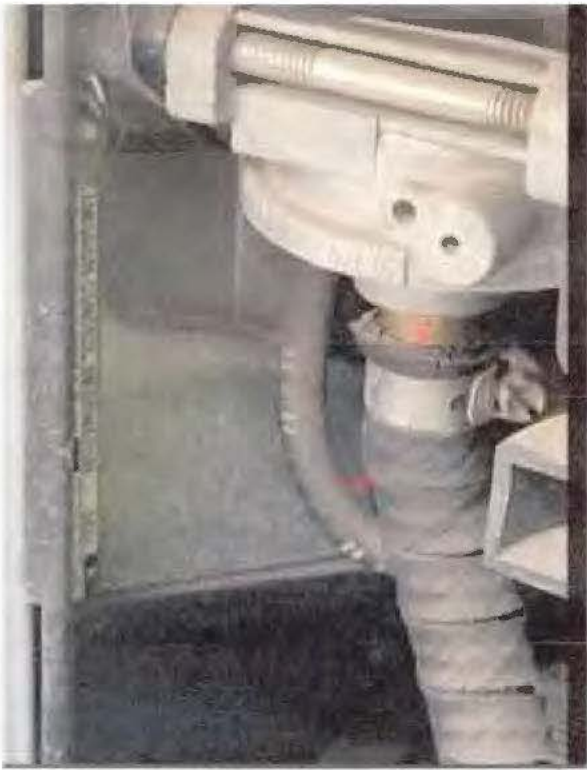
- A. On my ONAN 2500 LP generator, the rubber propane lines (one high pressure from the solenoid to the regulator and one low pressure going from the regulator to the carburetor) have degraded and were leaking causing the generator to not start.

- E. Also I have never seen a propane line designed with hose clamps, only threaded fittings pressed on to the hose.
- F. I THINK THIS IS AN IMMEDIATE SAFETY ISSUE.

- heaters uses threaded brass fittings that are pressed on to the hose. My photos will show how the hoses are all cracked above the hose fitting.

**CORRECTION** ES206 REMOVED LP FUEL HOSES.  
 INSTALLED NEW FUEL HOSES.  
 STARTED GENERATOR AND RAN IN CHASSIS FOR 1/2 HR.  
 RAN CORRECTLY.  
 LP HOSES

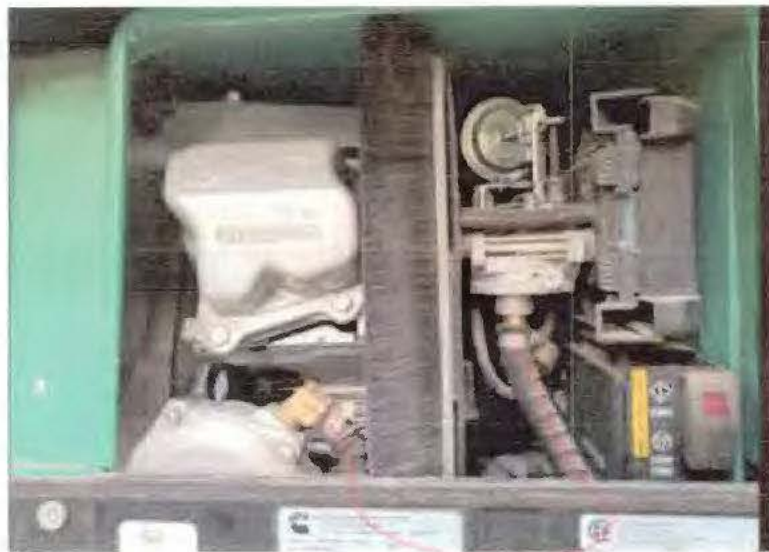
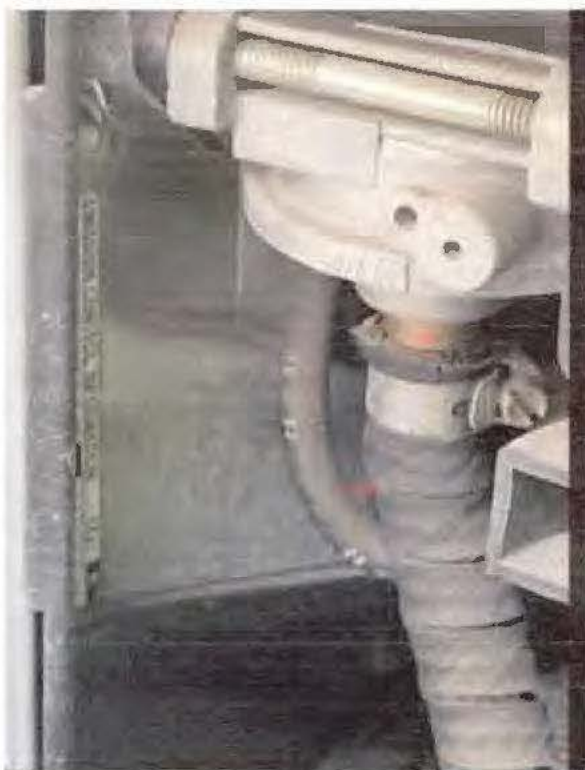
Here is the serial number and a picture of the low pressure hose with hose clamps.
