2021 Keystone Fifth Wheel RV Avalanche 312RS
V.I.N. 4YDF31223M [REDACTED]

Defective Hot Water Heater

Hot Water Heater Chop Shop Installation

Left Rear RV Slide Topper Cover Hazard Details

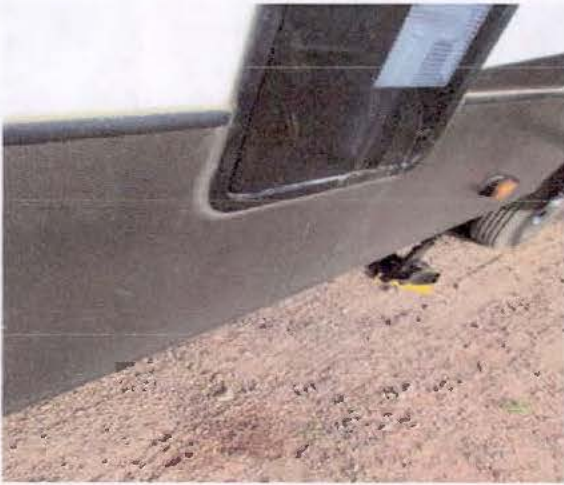
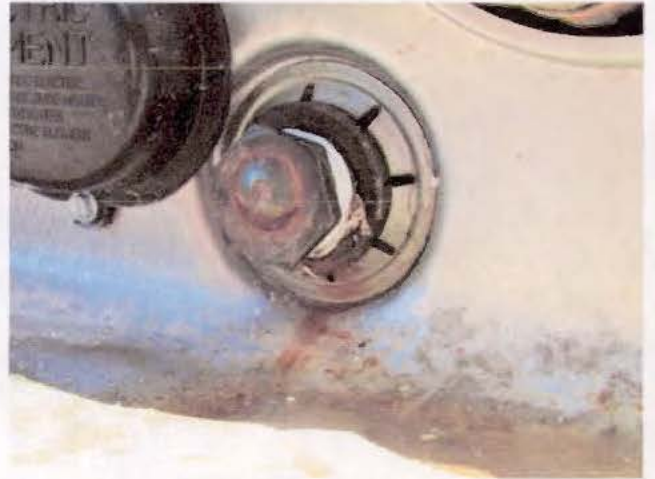
Hot Water Heater not as listed by Keystone Manufacturing. New RV owner's inspection found it to be six gallons less capacity, used condition, and defective. Rocky Mountain RV Warranty & Safety Inspection done on September 2, 2022. This also has not been fixed/replaced to this date.

While trying to get correct information for the hot water heater, Service Manager Franklin states RV Manufactures are allowed to make changes in equipment details stated in RV model literature. Since there is a difference of six gallons recovery capacity, it clearly is another inferior, and defective downgrade.

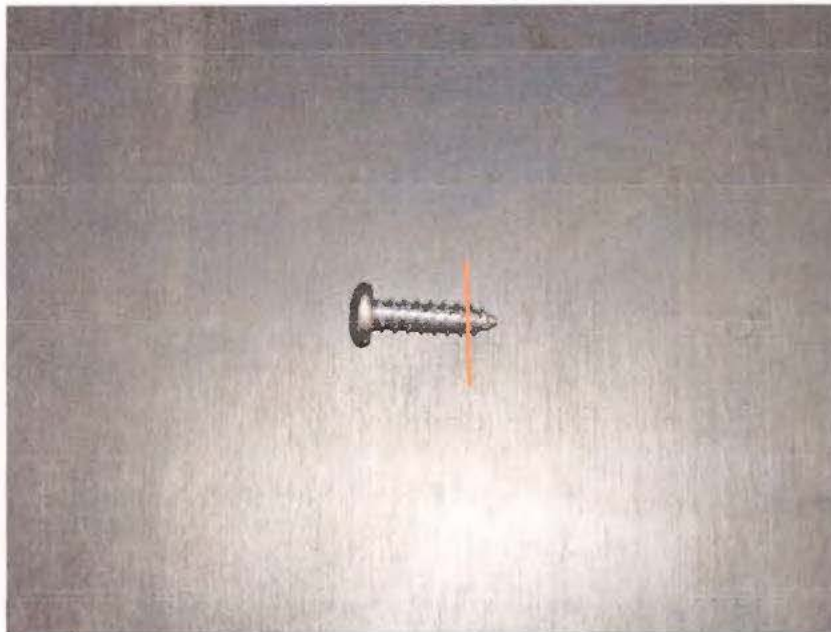
One screw found on ground. One found hanging by two end threads in top side one of the wall brackets. Improper installation caused damage and separation at brackets.
