**SUBJECT: Customer Satisfaction Program 22N12**  
 Certain 2015-2018 Model Year Edge, 2019-2020 Fusion and MKZ Vehicles Equipped with a 2.0L EcoBoost Engine and 6F35 Transmission  
 Rattle Noise at the Transmission Bellhousing Area – Flexplate Cracks

**Customer Satisfaction Program 22N12**

## CERTAIN 2015-2018 MODEL YEAR EDGE, 2019-2020 FUSION AND MKZ VEHICLES EQUIPPED WITH A 2.0L ECOBOOST ENGINE AND 6F35 TRANSMISSION RATTLE NOISE AT THE TRANSMISSION BELLHOUSING AREA — FLEXPLATE CRACKS

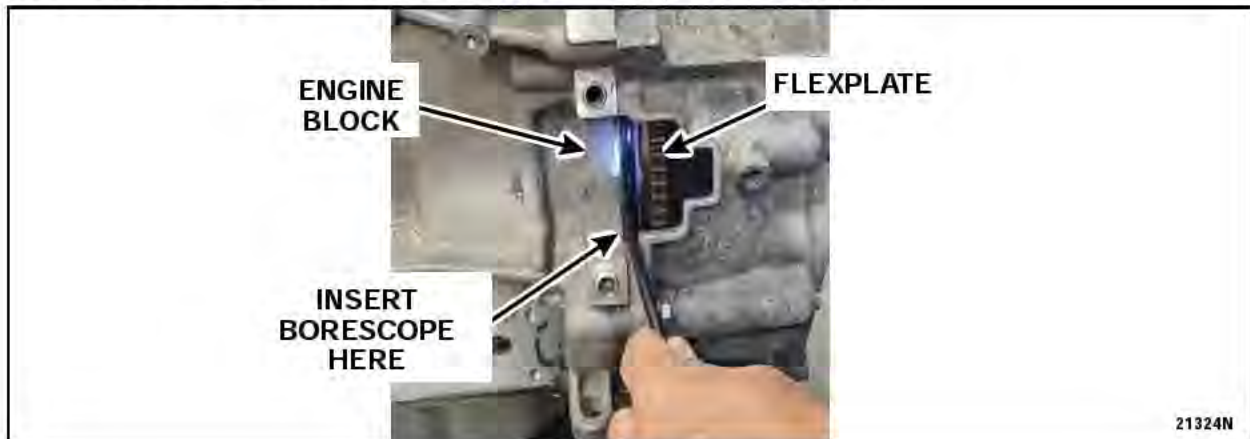
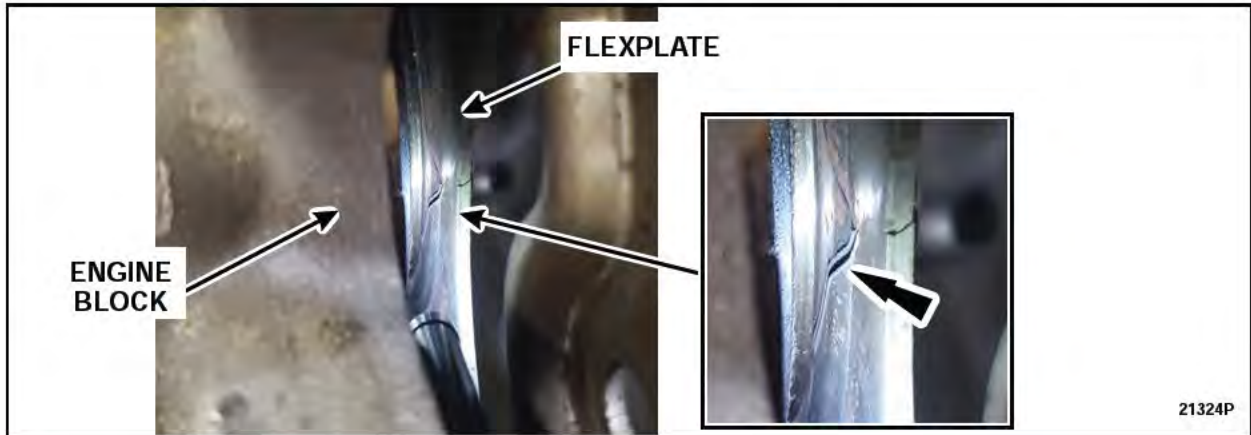
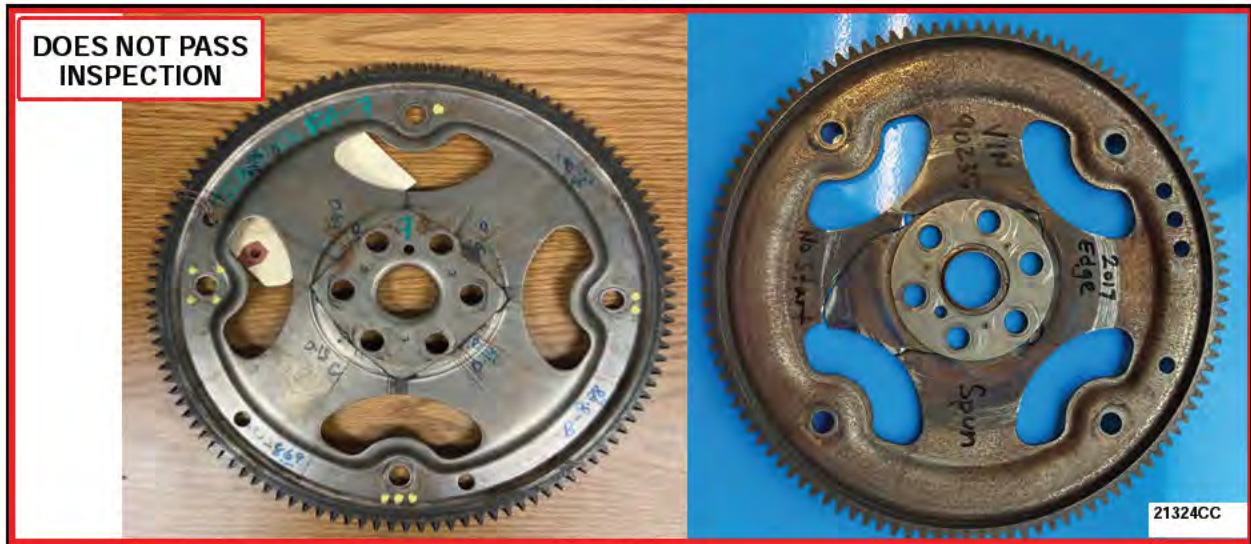
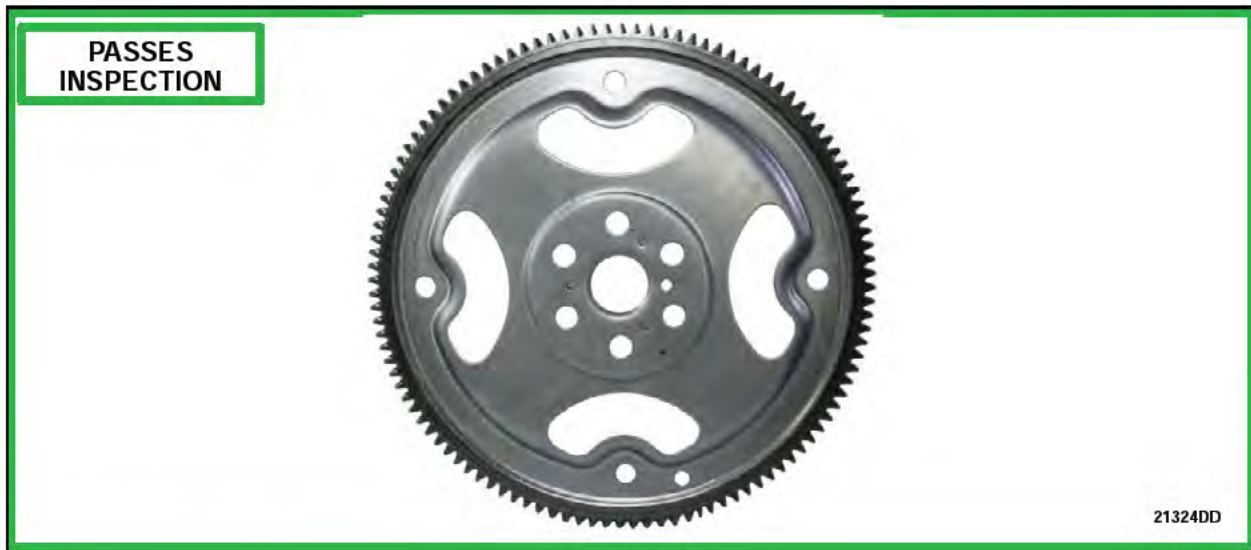
**FIGURE 2**

6. Remove the starter motor. Please follow WSM procedures in section 303-06.
7. Placing a borescope between the engine block and flexplate, inspect the flexplate for cracks near the crankshaft. Are there any cracks present in the flexplate? See Figures 2 through 5.

**NOTE:** It may be necessary to rotate the engine crank to find the cracks in the flexplate.

No - Flexplate is NOT cracked. Reinstall the starter motor. Please follow WSM procedures in section 303-06. No further action is necessary, the recall is complete.  
Yes - Take a picture of the suspect flexplate and submit the picture to the SSSC for further review, and repair direction if necessary.  
Proceed to Step 8 **ONLY AFTER APPROVAL** has been given by the SSSC.

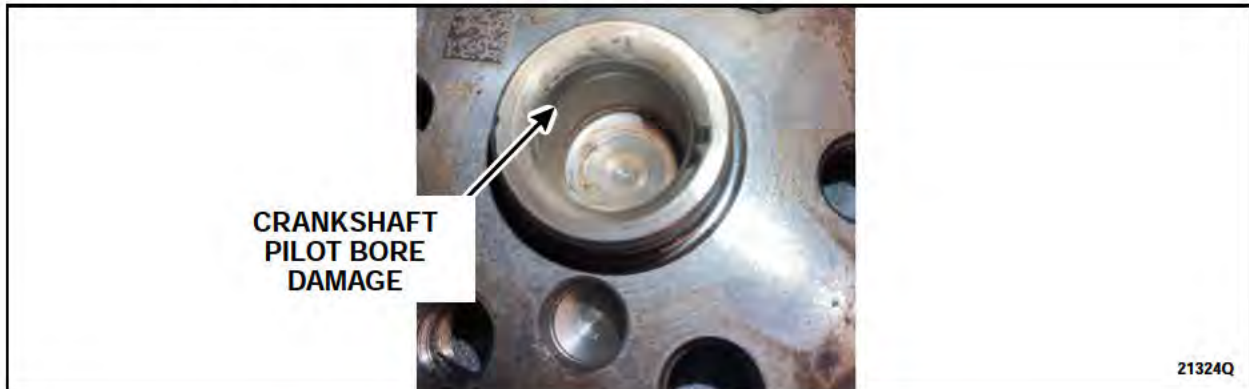
**FIGURE 6**

8. Once approval has been given by the SSSC, remove the transmission and inspect the engine block mounting face for the presence of dowel pins. If the dowel pins are not present in the engine block, inspect the transmission for the dowel pins. If the dowel pins are present in the transmission, remove the dowel pins and reinstall into the engine block prior to transmission installation. Refer to WSM, Section 307-01A.
9. Replace the torque converter, flexplate, flexplate bolts, and transmission front pump. Refer to WSM, Section 307-01A for torque converter and transmission front pump replacement and Section 303-01A for flexplate and flexplate bolt replacement. If dowel pins are damaged or missing, replace as needed.
10. Inspect for damage on the crankshaft pilot bore. Is there damage? See Figure 6.

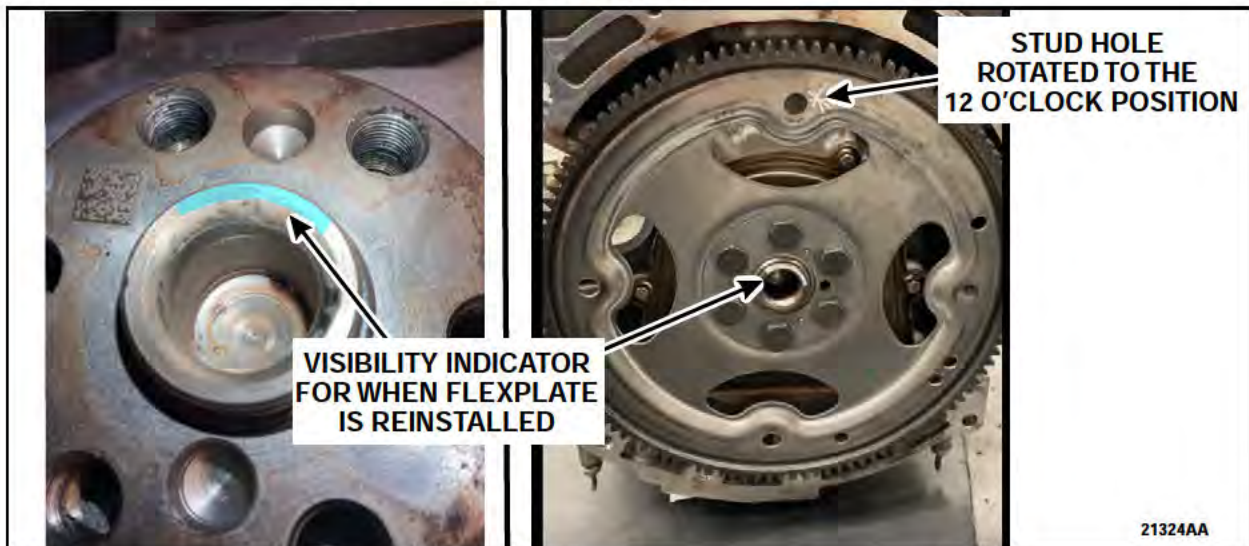
**FIGURE 7**

Yes - Rotate the stud hole nearest to the 12 O'Clock upright position so that the damaged part of the crankshaft pilot bore is at the 12 O'Clock position. This is important to ensure minimal imbalance. Proceed to step 11. See Figure 7.

**NOTE:** The flexplate can be installed in multiple positions.

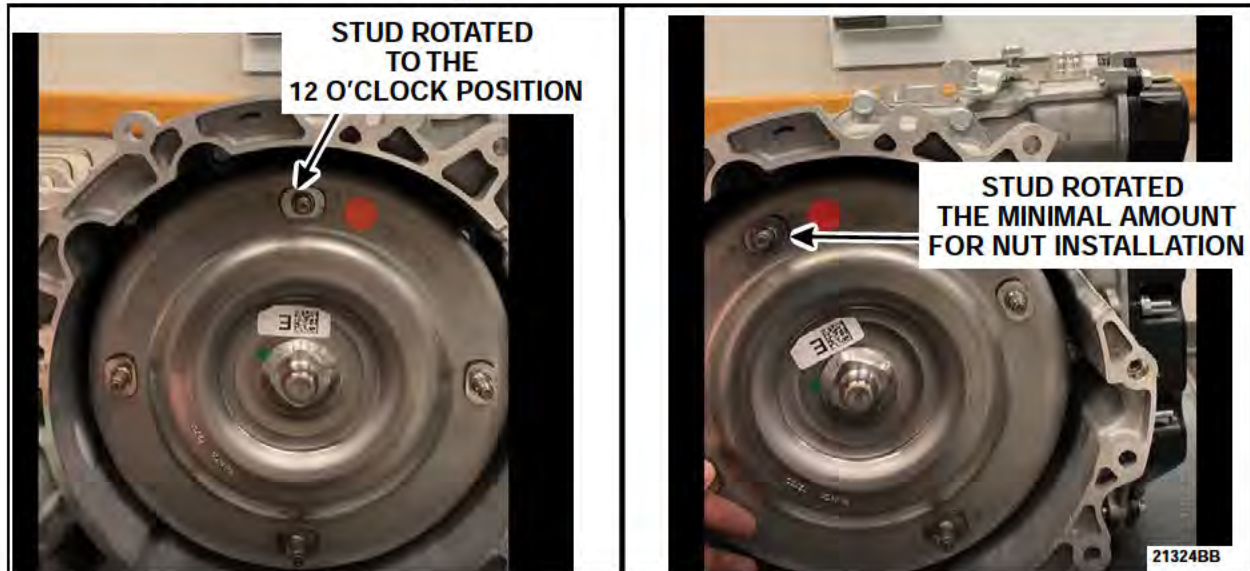
FIGURE 8

**NOTE:** When tightening the torque converter nuts, rotate the nearest stud the minimal amount to the window and install nut. See Figure 8.
