From: [Ambrose, Ann-Marie L](#)
To: [EVOO \(NHTSA\)](#); [Robertson, Faithia \(NHTSA\)](#); [Lewis, Br](#)
Cc: [NHTSA ODI CED](#); [Strasser-King, Marion C](#)
Subject: ODI- 11547934
Date: Friday, October 6, 2023 2:38:55 PM

From: [REDACTED]
Sent: Thursday, October 5, 2023 10:53 AM
To: nhtsa.webmaster@dot.gov
Subject: NHTSA Tracking Number 11547934

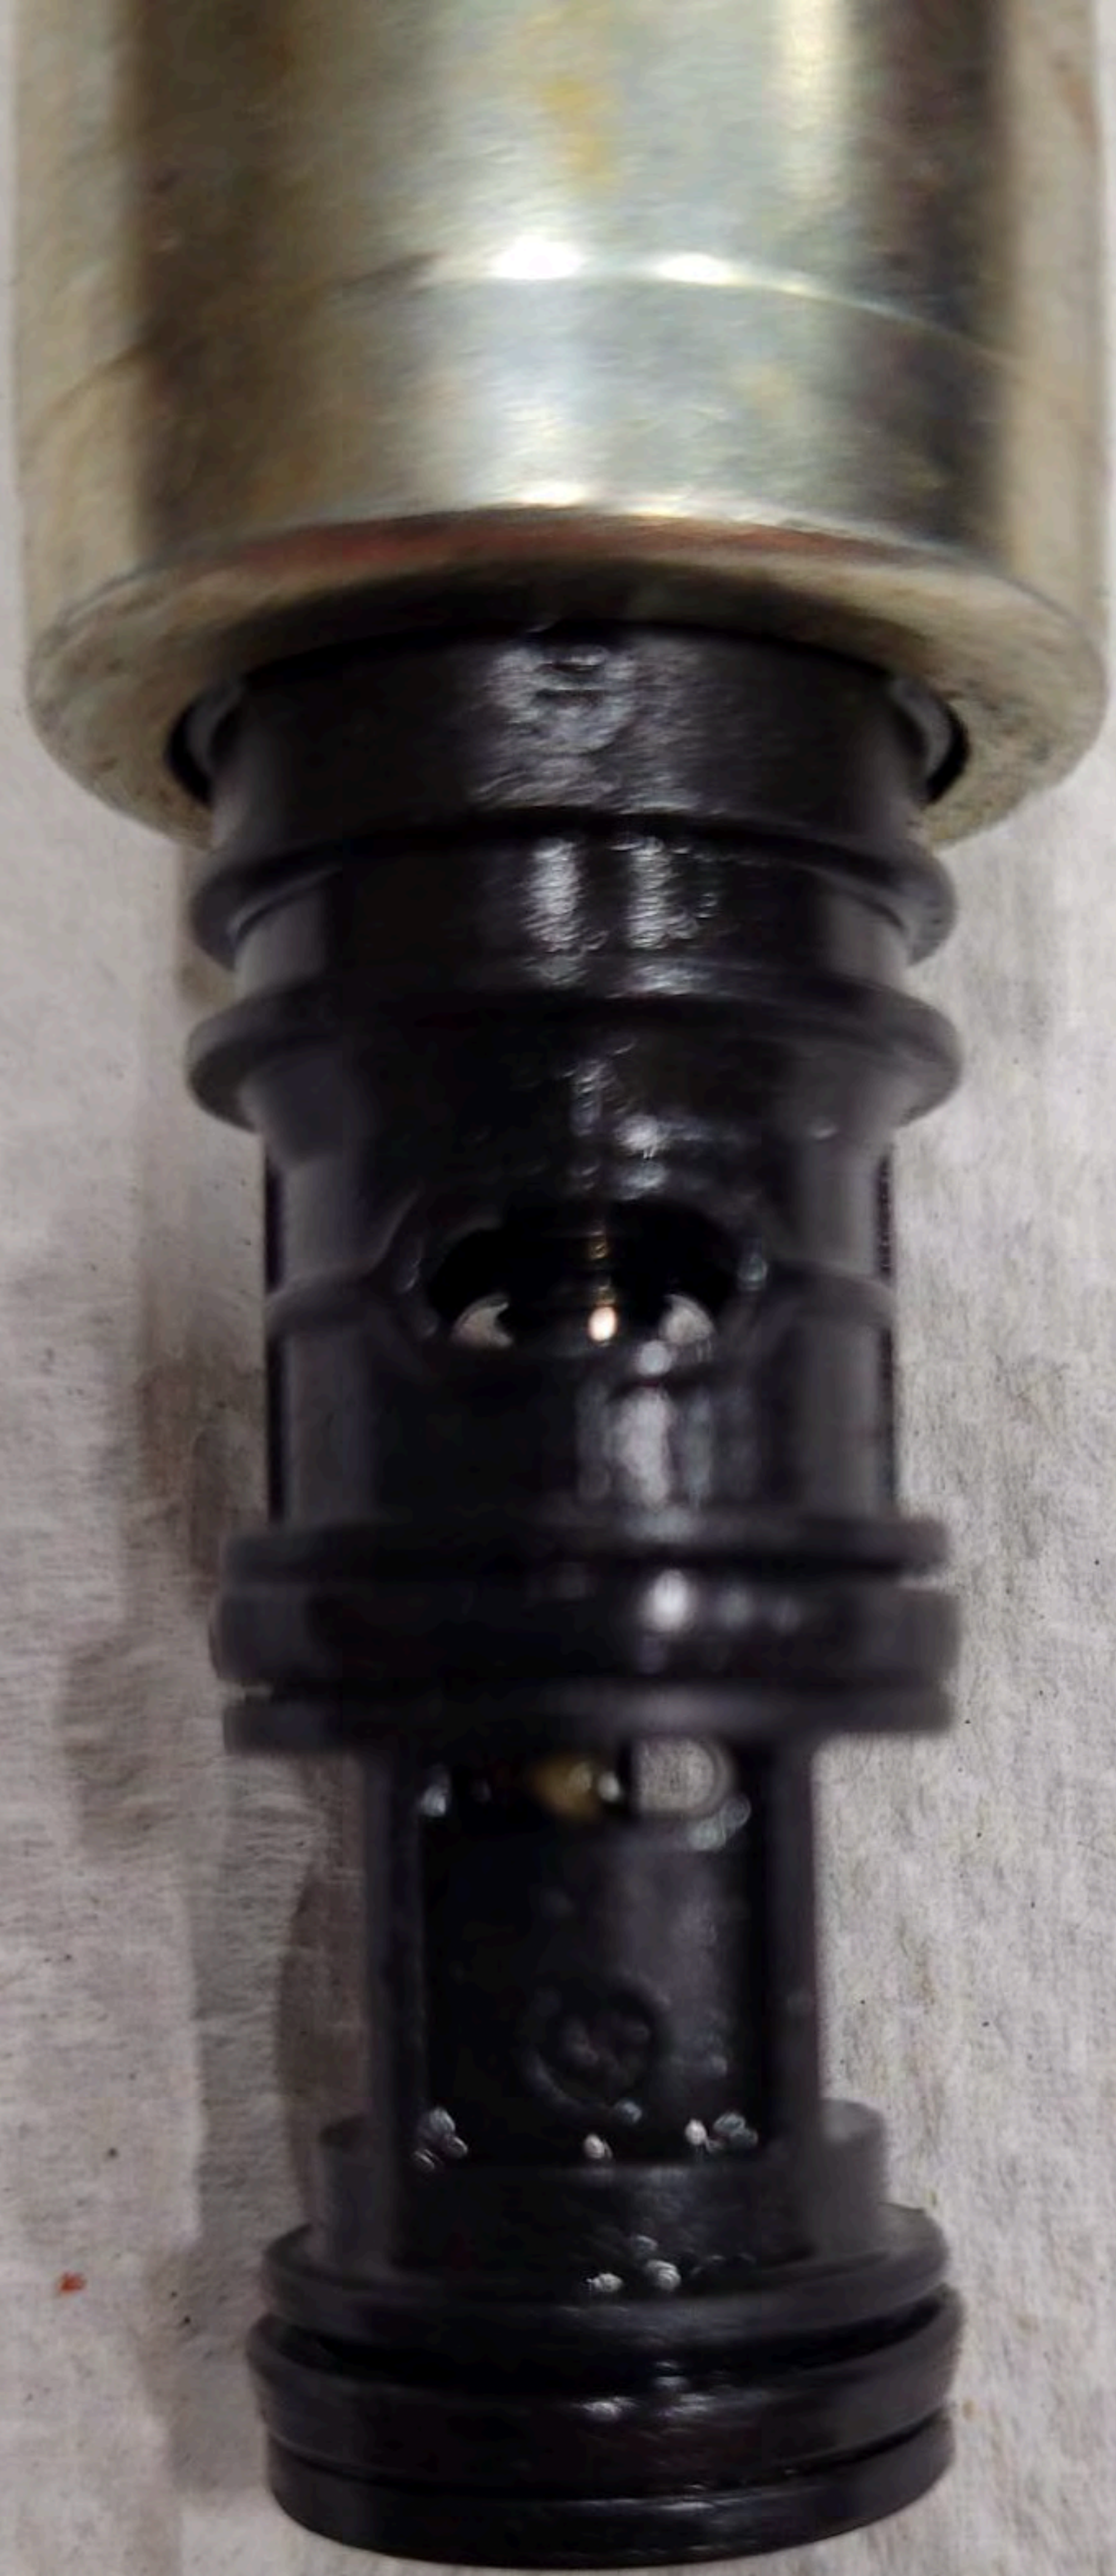
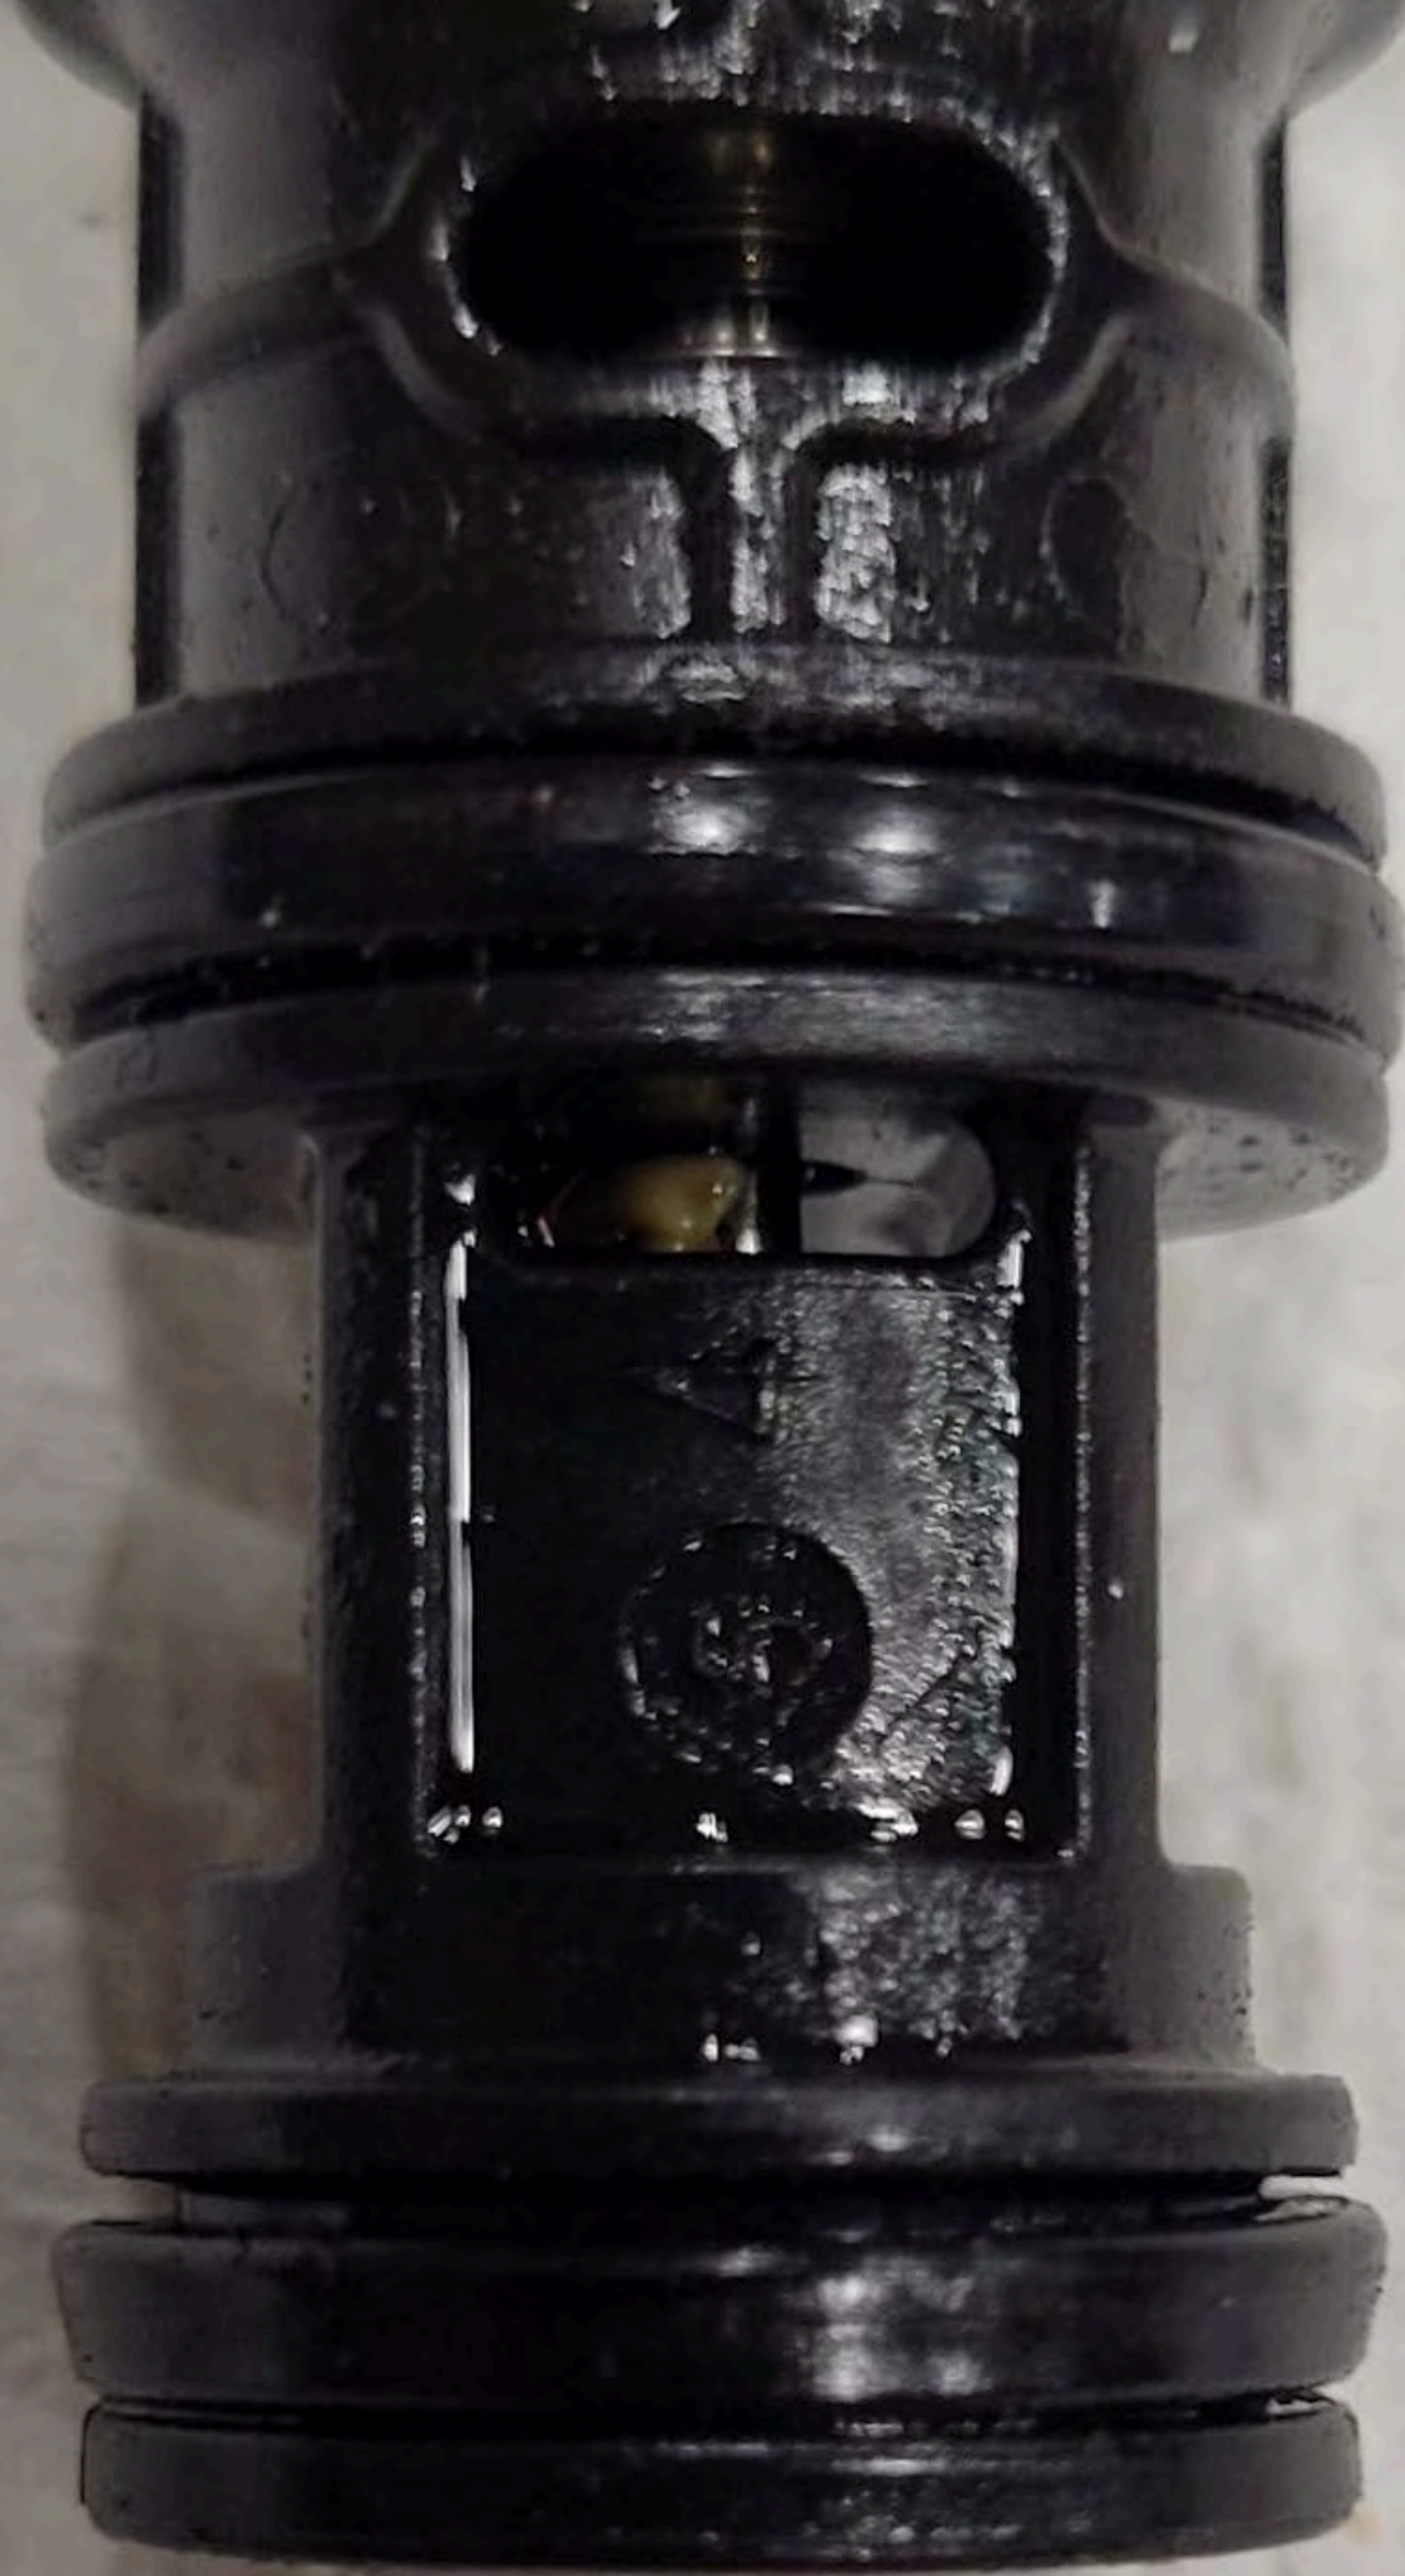
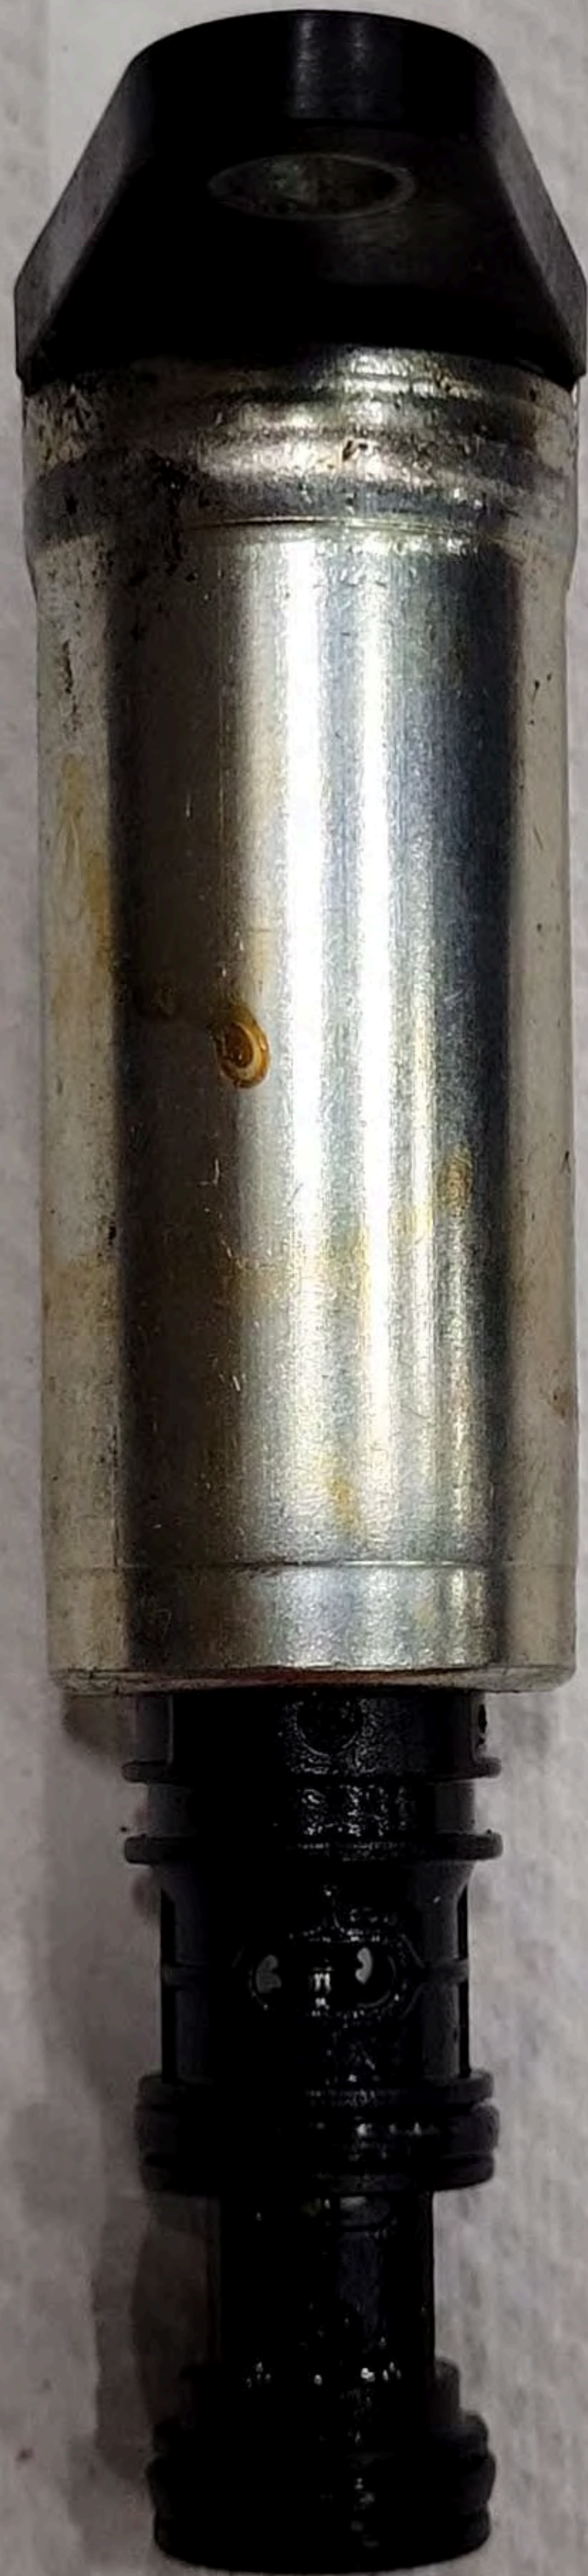
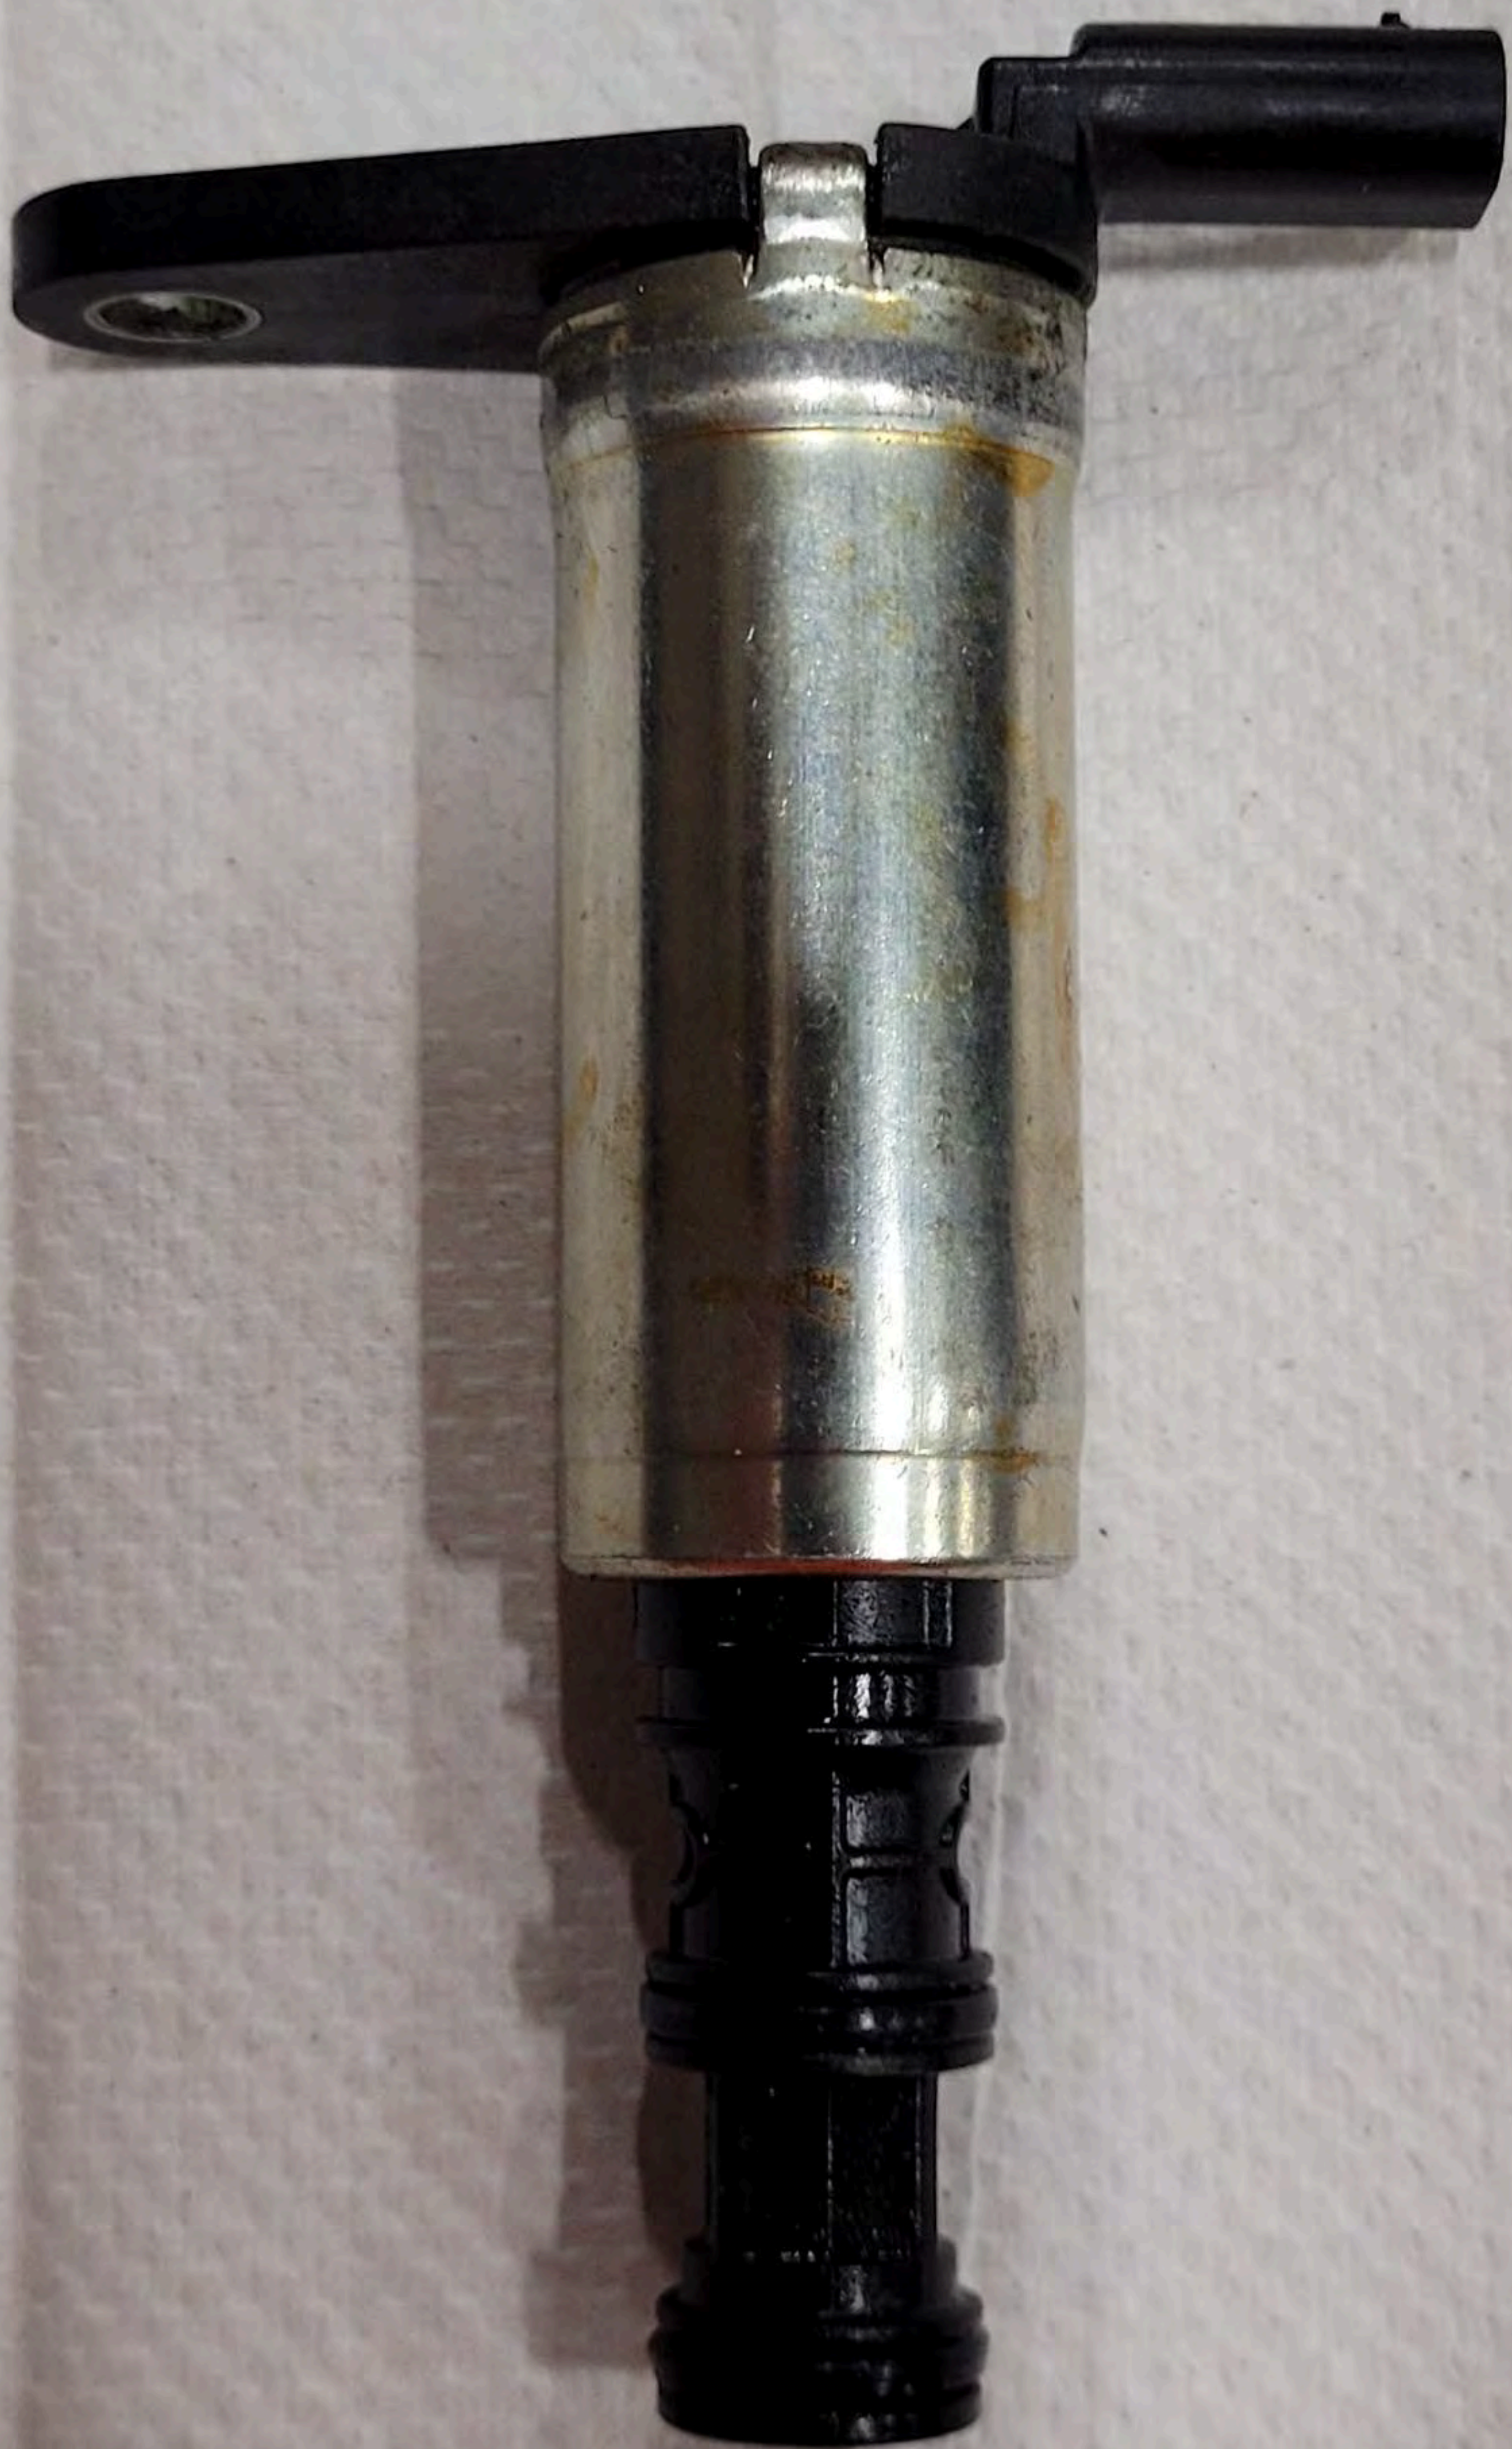
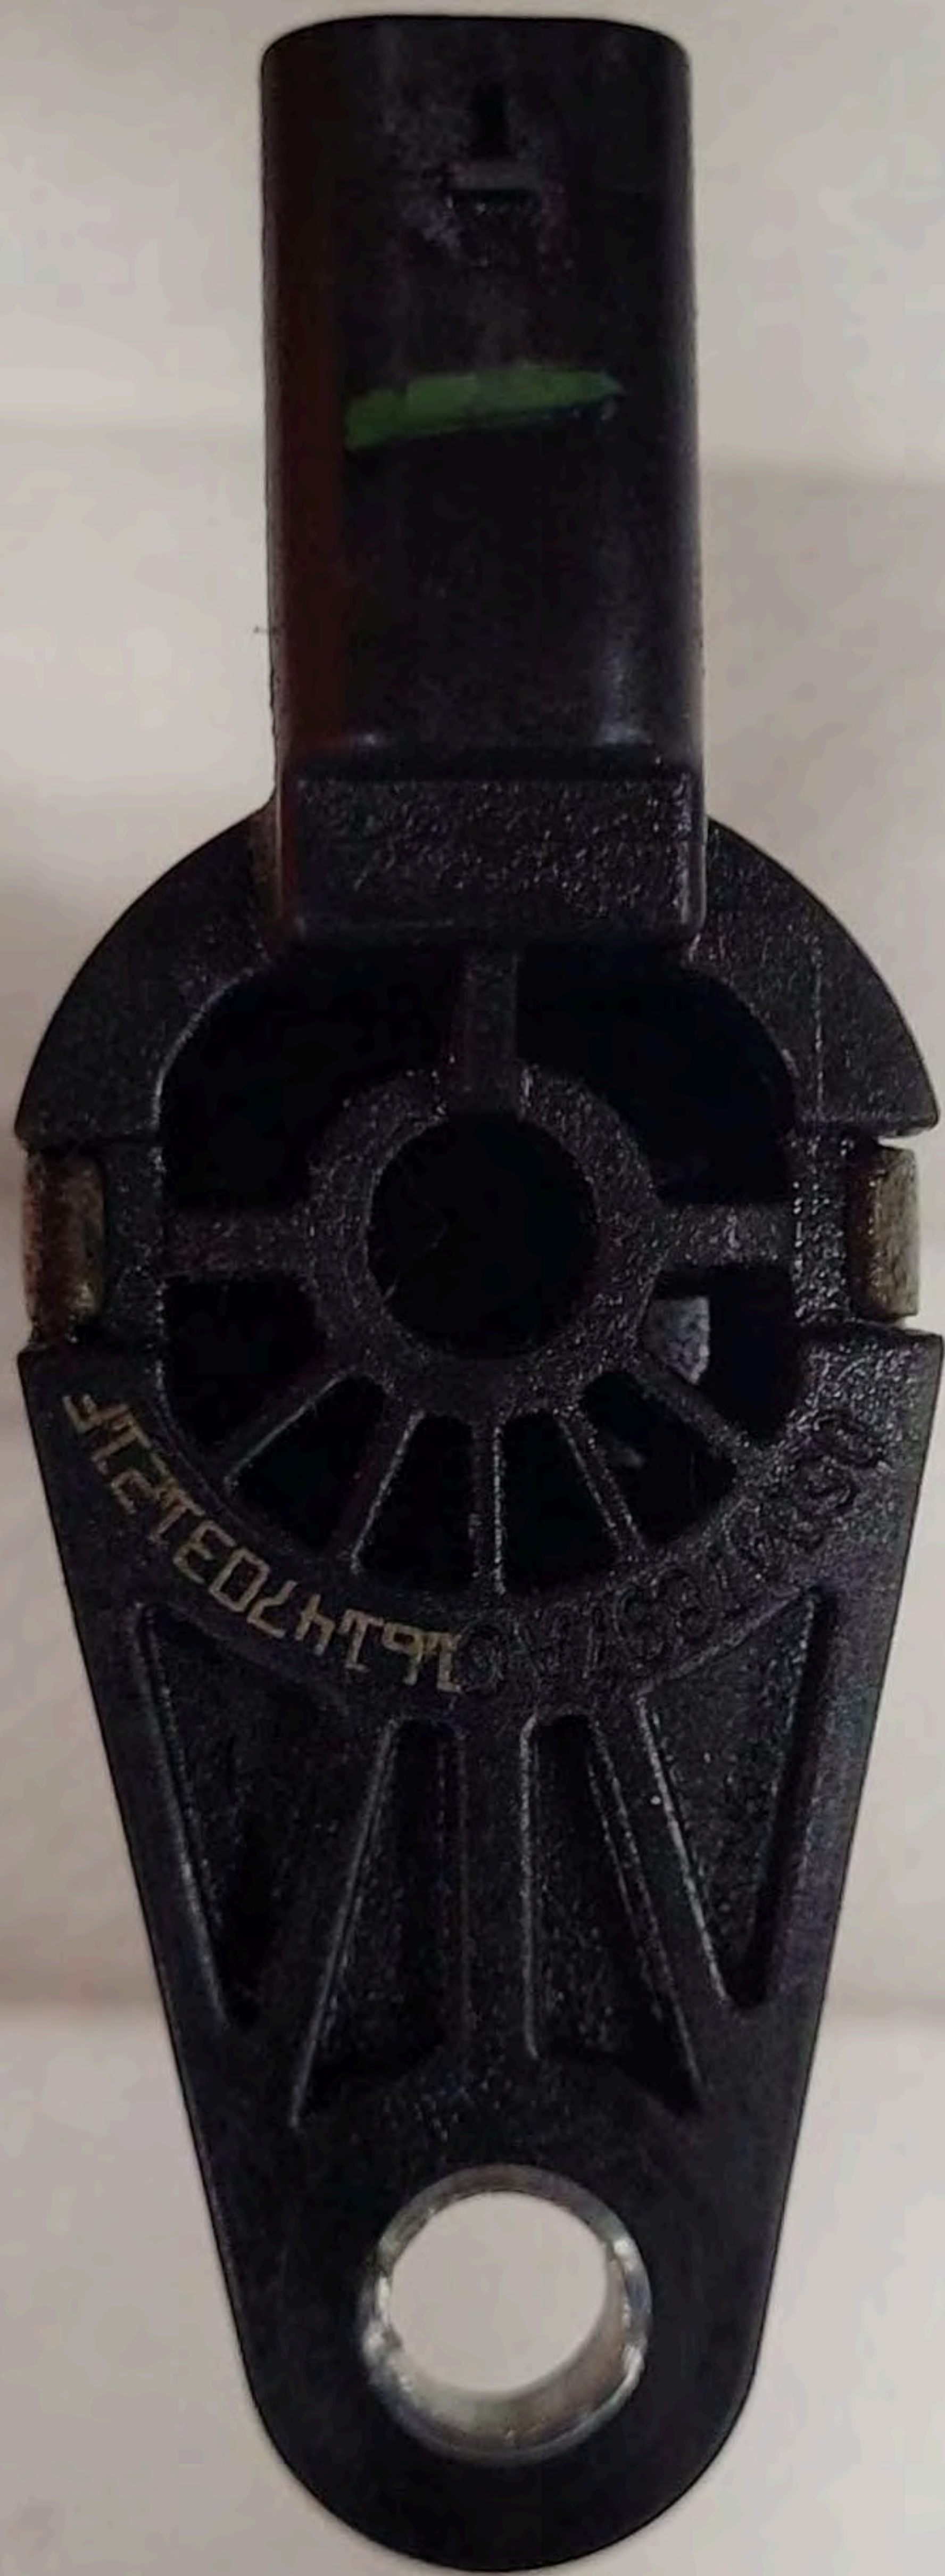
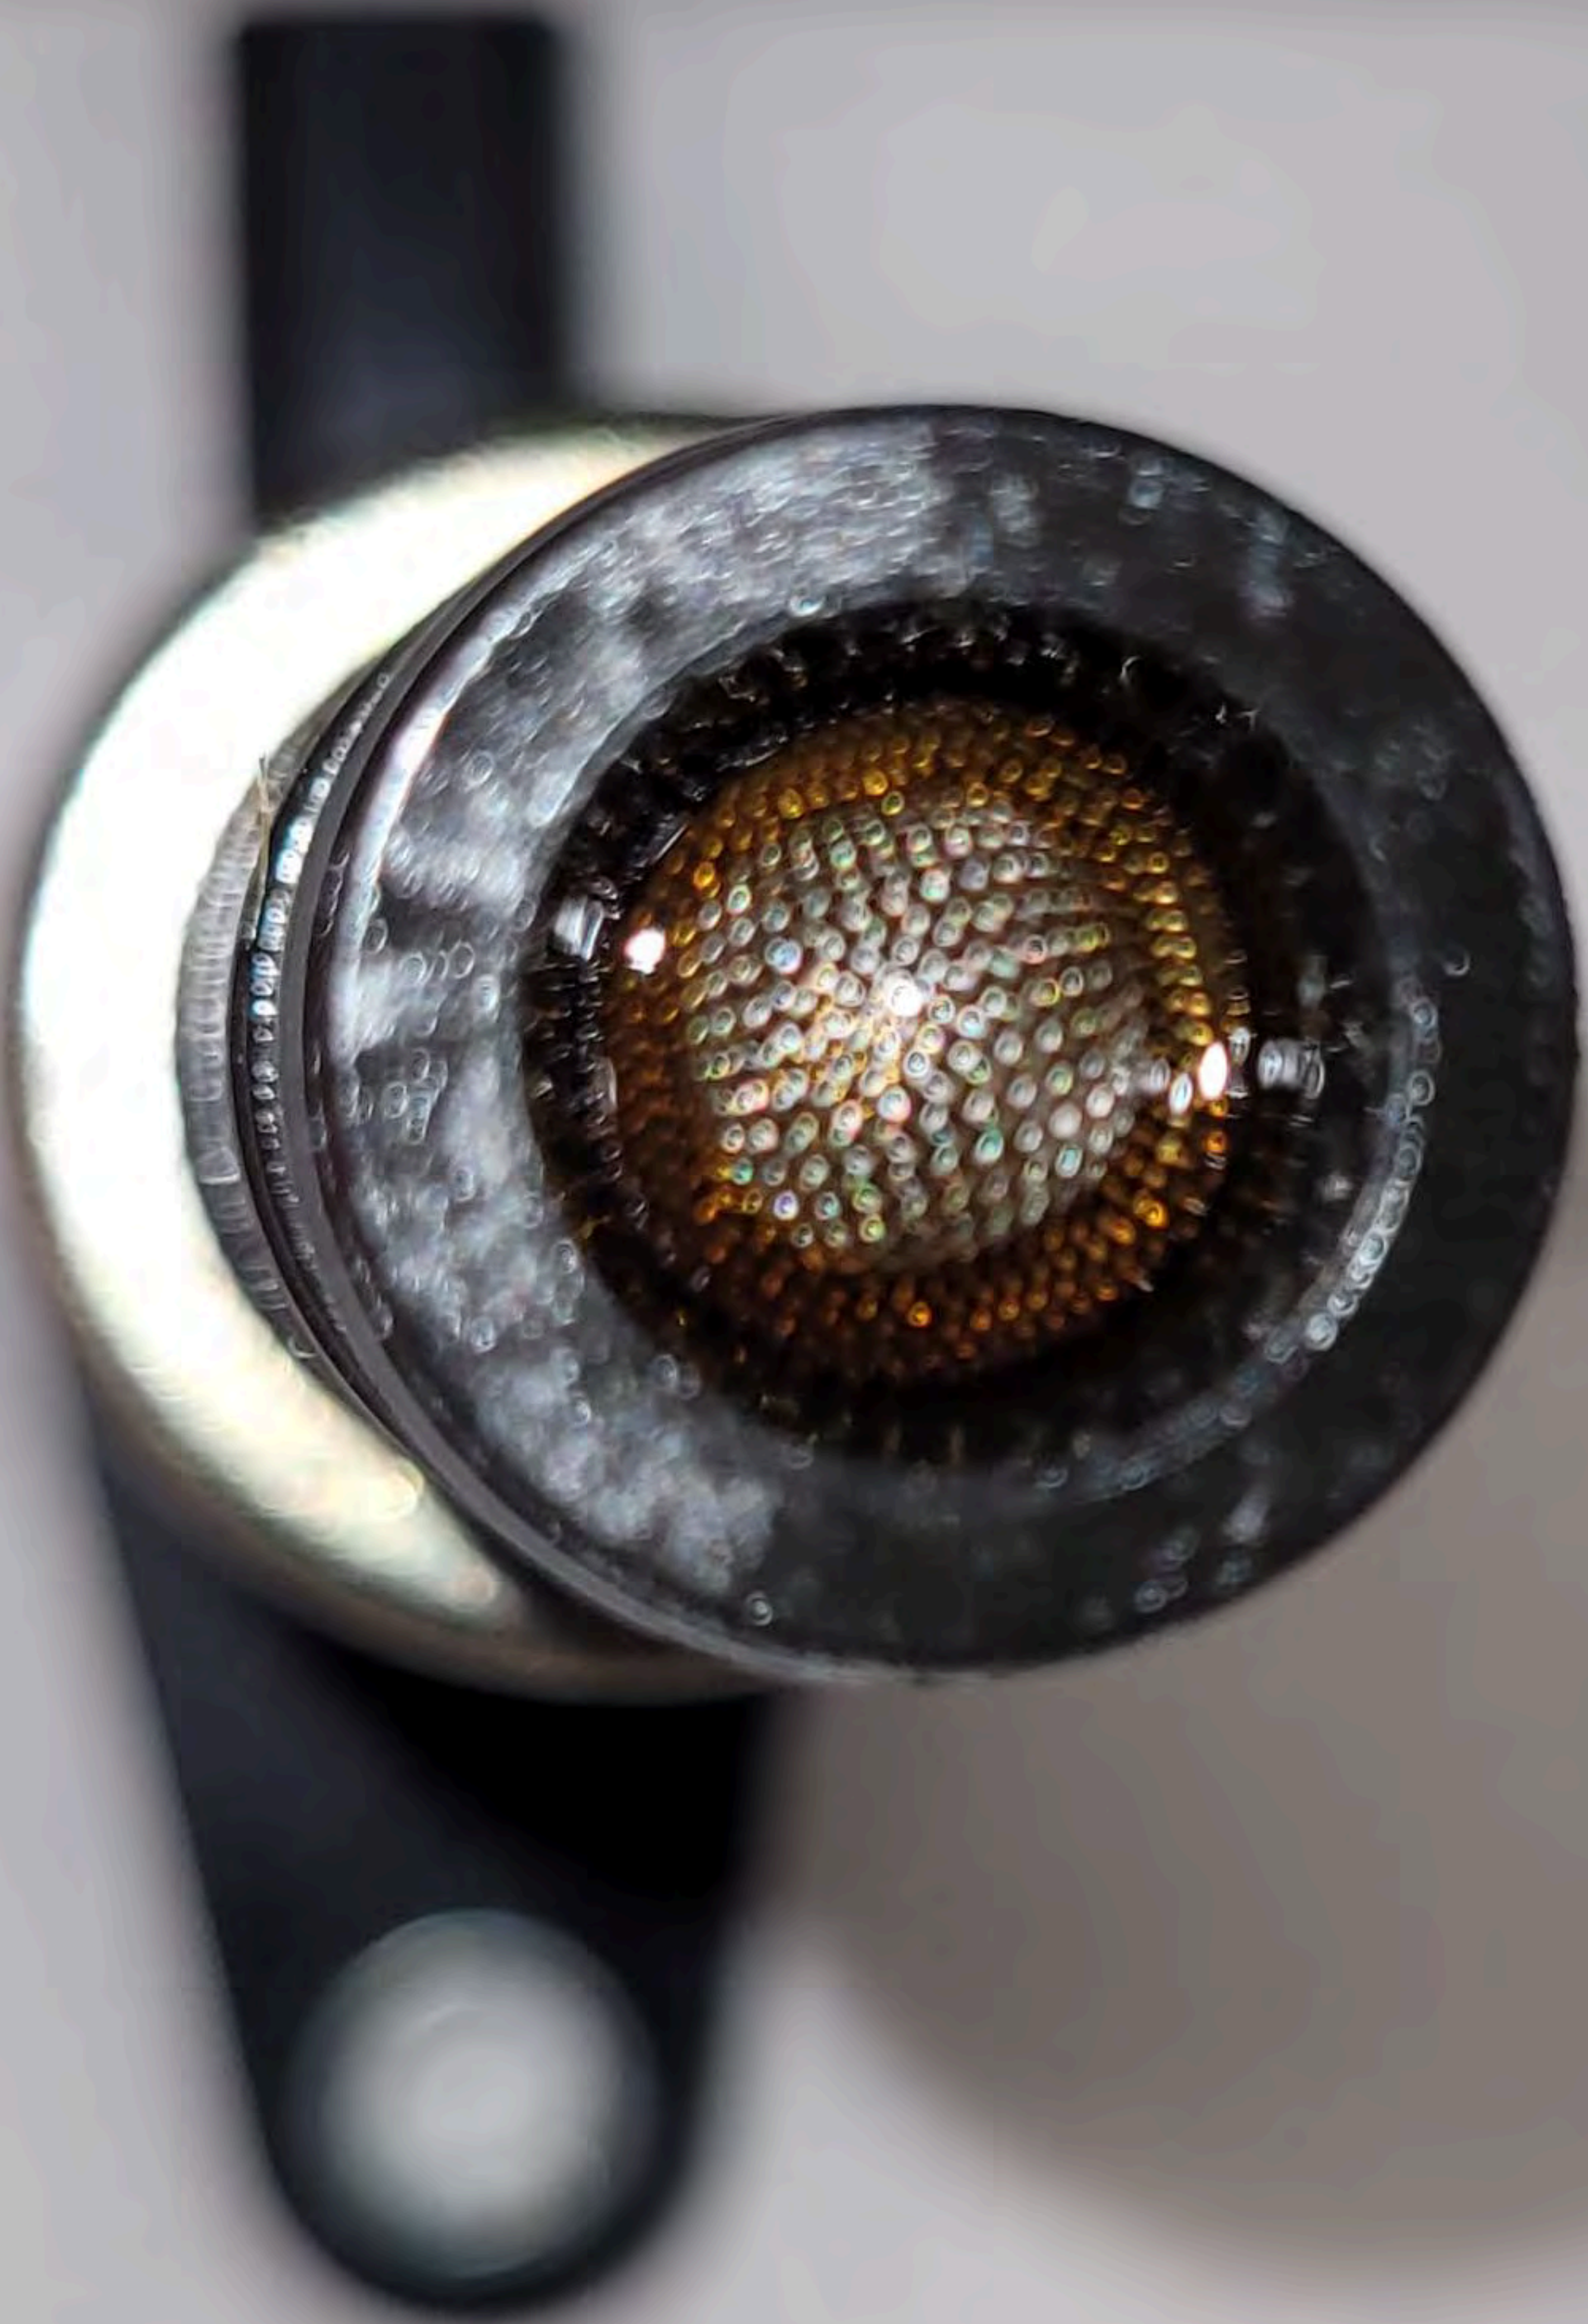
Could you please add these photos to my complaint number 11547934. I also included a link from YouTube of several Jeep owners experiencing the same issues due to defective VVT solenoid part #05047897AC. In the photos provided its clear the bonding agent used for the screen came loose and wedged the internal plunger from operating properly. The same issue found in the YouTube video. Have a great week and thanks for your help.
