Technical Service Bulletin

GROUP BODY	NUMBER 25-BD-004H
DATE MAY 2025	MODEL(S) SEE BELOW

SUBJECT: WHITE PAINT WARRANTY EXTENSION (Z05)

Description: Certain Hyundai vehicles with exterior white paint may exhibit peeling or bubbling on metal body panels: hood, fender(s), roof, door(s), quarter panel(s), and tailgate/trunk. The paint warranty coverage for affected vehicles has been extended to 10 years/unlimited miles from the date of original retail delivery or date of first use, and is valid for original and subsequent owners.

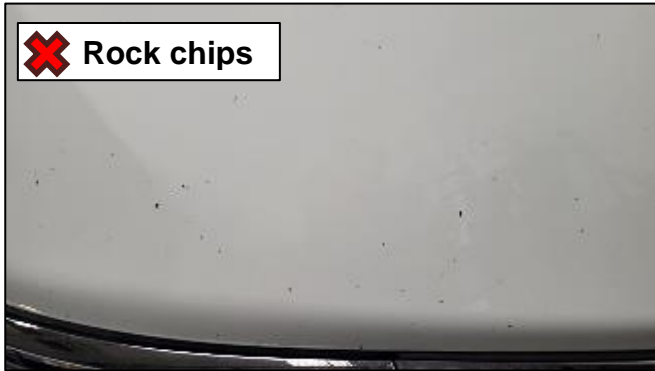
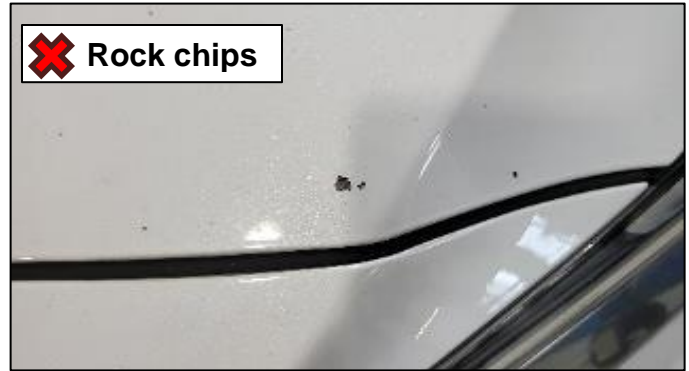
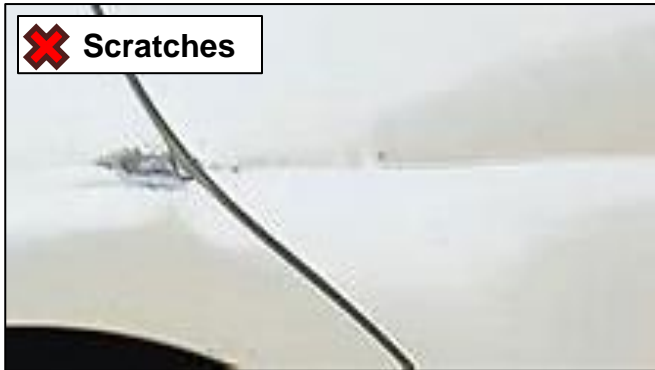
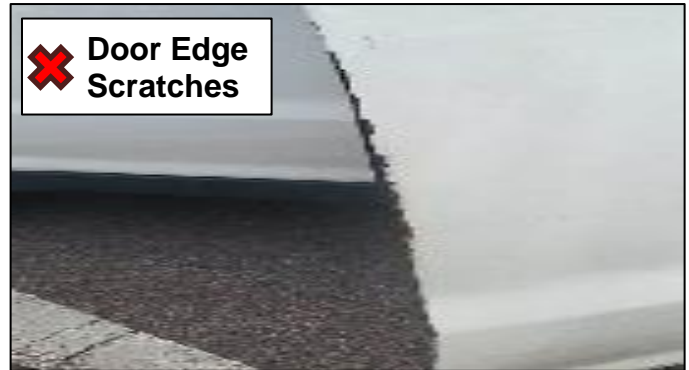
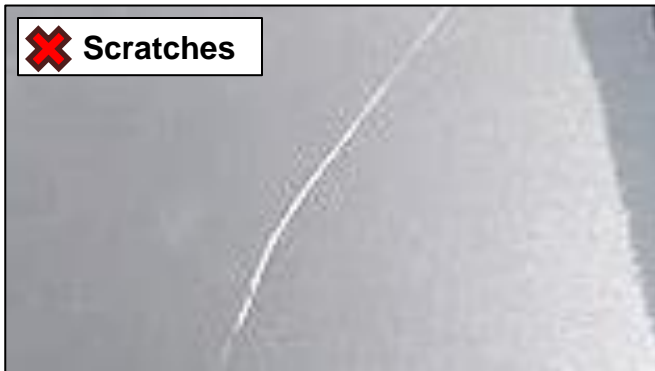
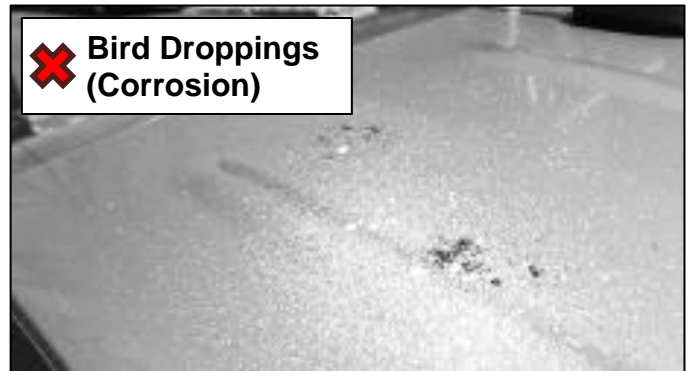
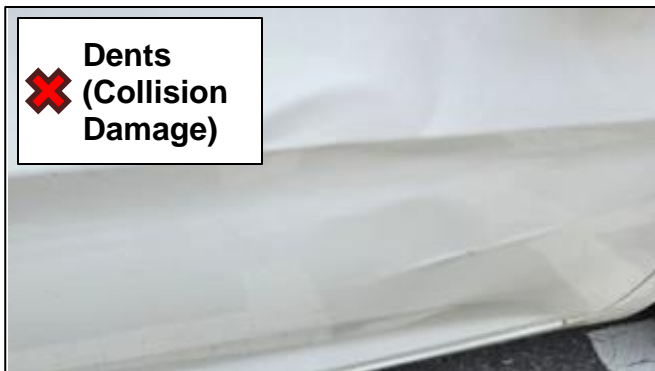
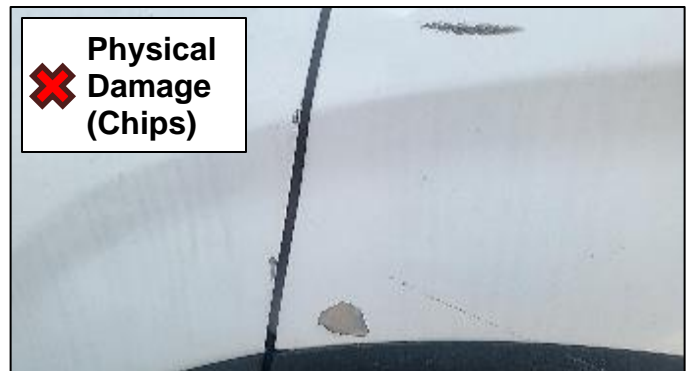
Paint issues such as rock chips, scratches, bird droppings, sap/wax, aftermarket wraps, collision damage, and/or customer-induced damage are excluded (❌ = **NOT** covered) by the warranty extension.

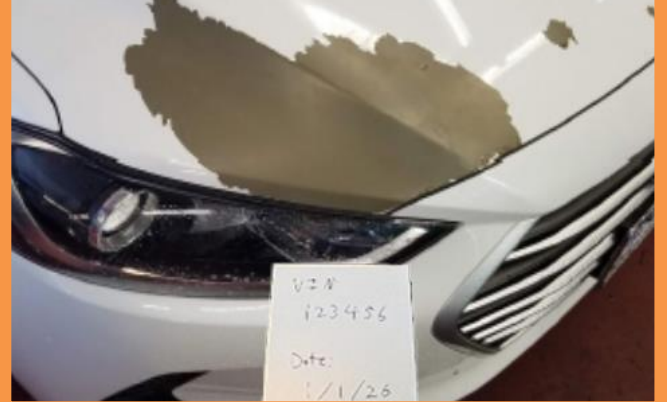
Photo(s) of Problem Area(s)

Using STUI, take photos of the affected panel(s)/area(s) exhibiting peeling and/or bubbling of the white paint with the last 6 digits of the VIN and the date of repair on a piece of paper. Also photograph the LH & RH side, hood & roof, and front & rear areas to document vehicle condition.
