## Vehicle Owner's Questionnaire (VOQ)

STATE FARM MUTUAL AUTOMOBILE INSURANCE COMPANY  
**AUTO CLAIM SERVICE RECORD - FULL**

BROOKS REPORTS, INCORPORATED

Re: Insured: [REDACTED]  
Claim #: 40 2421 304  
Loss Date: August 18, 2000  
Our File: BR00090

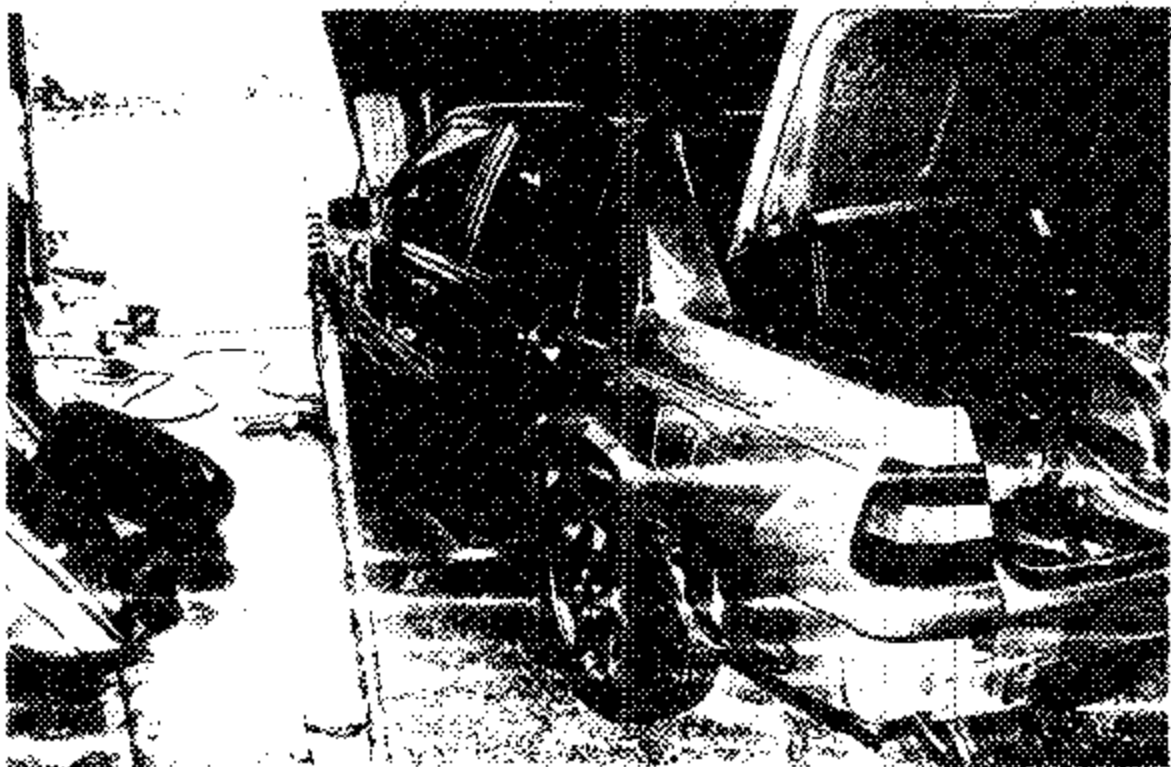
PHOTO 4 REAR - DRIVER SIDE VIEW

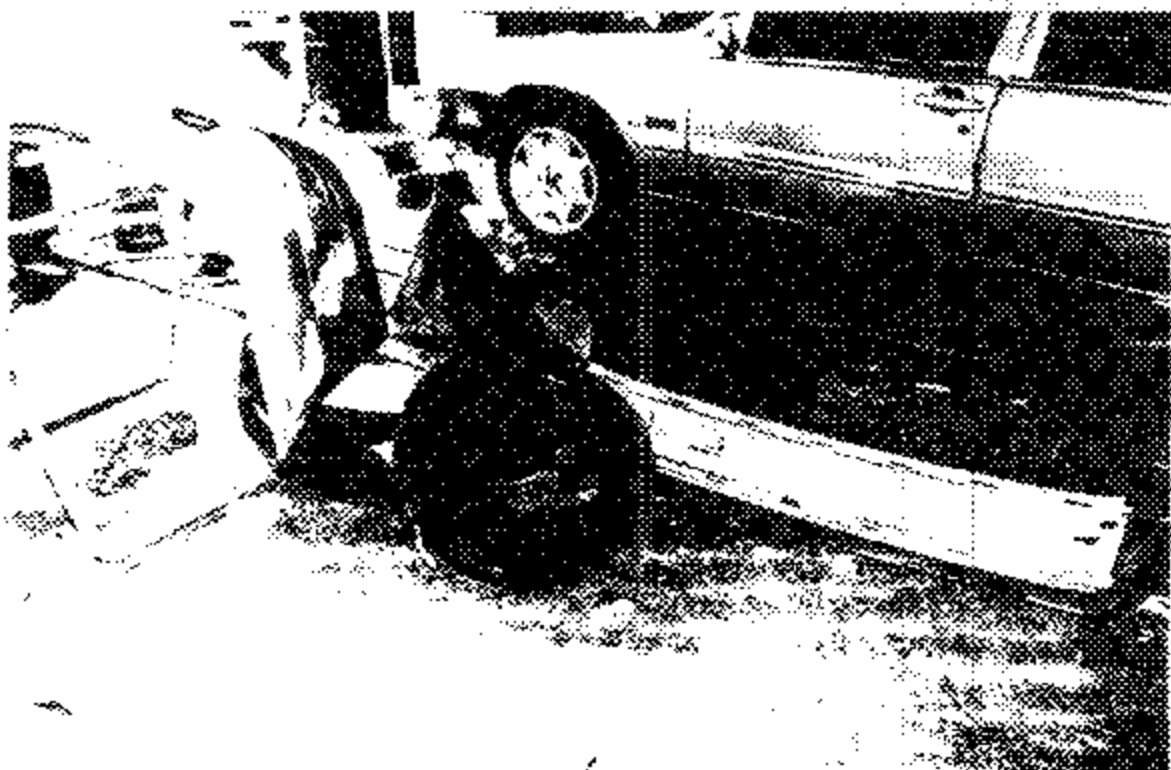
PHOTO 1 CAR WITH THE DRIVER SIDE REAR TIRE

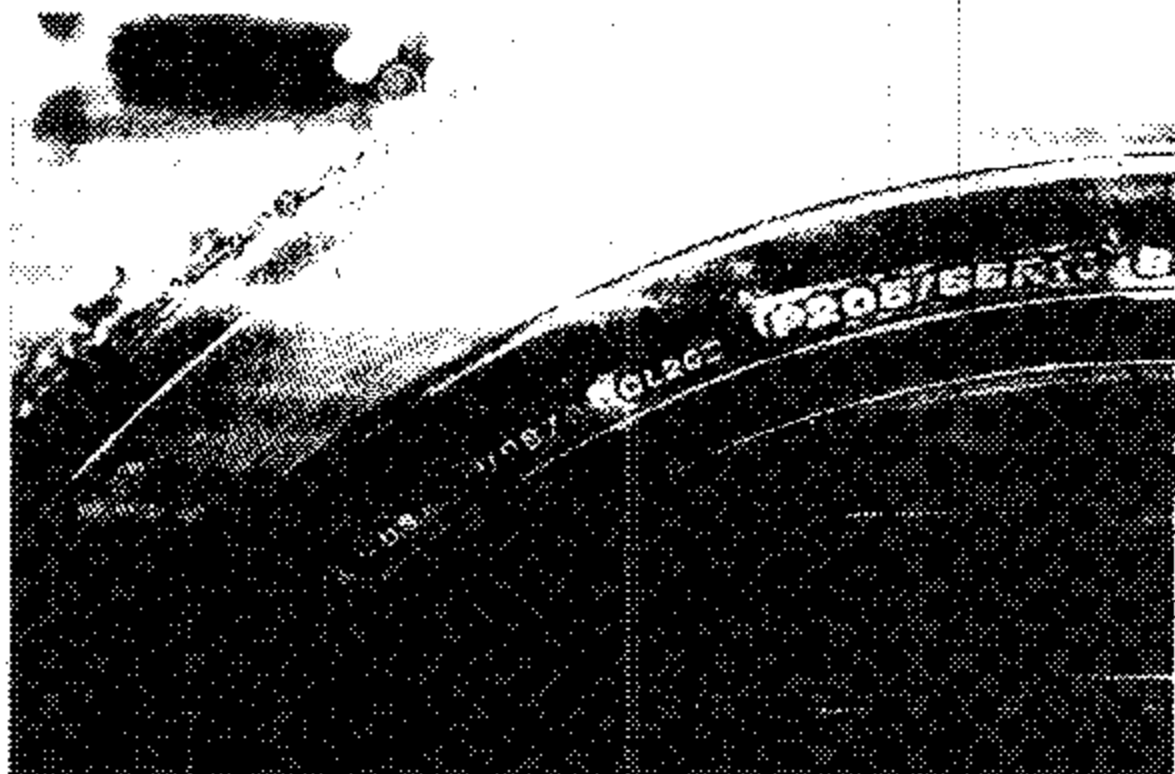
PHOTO 9 TIRE IDENTIFICATION TURANCA T P205/55R18 89T GL202 TUBELESS STEEL BELTED RADIAL MFS

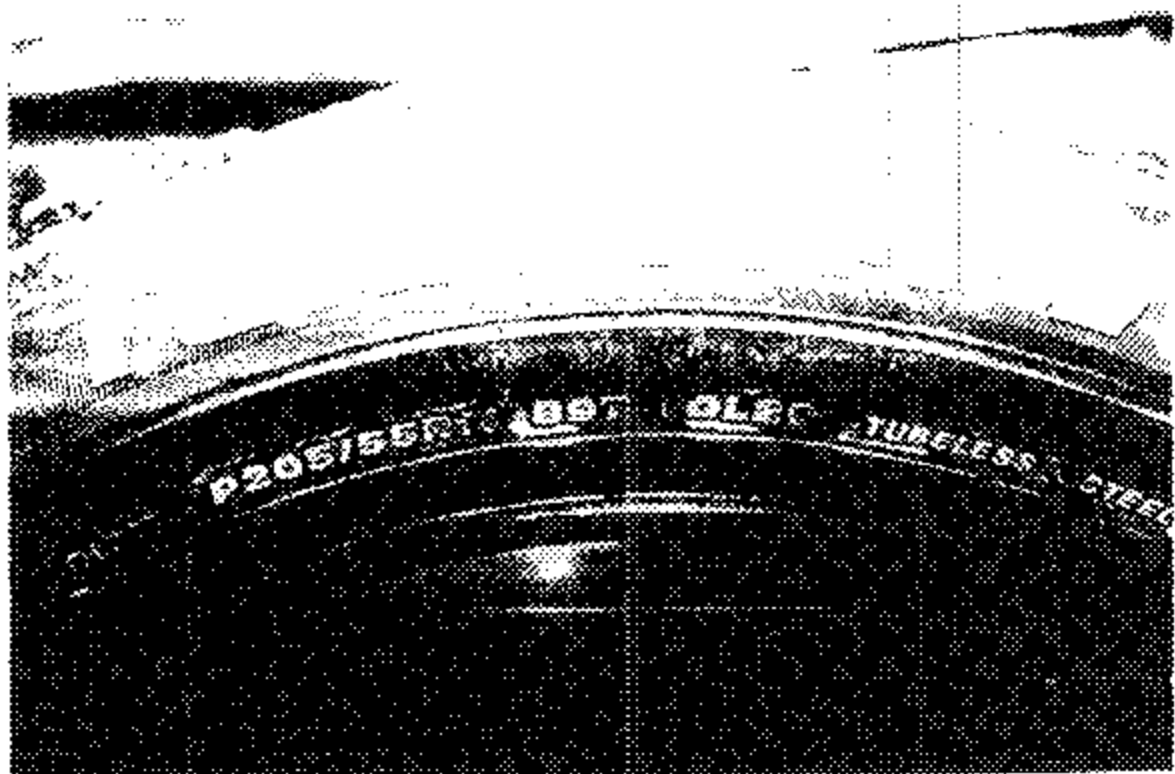
PHOTO 10 SUBJECT FIRE IDENTIFICATION MARKINGS

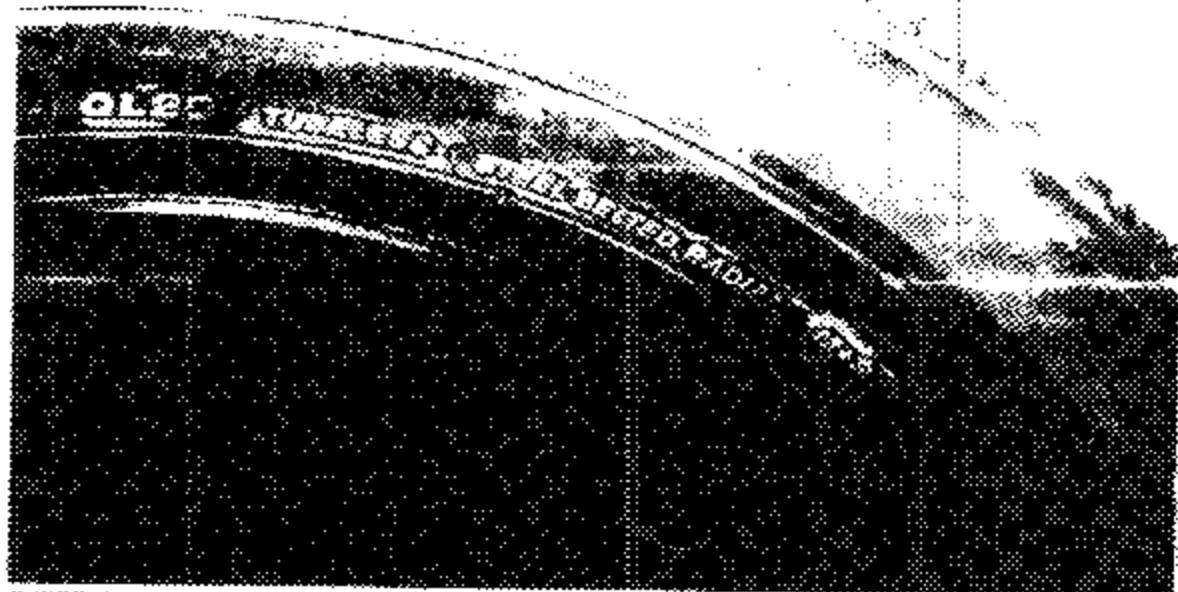
PHOTO 11 SUBJECT TIRE - IDENTIFICATION MARKINGS

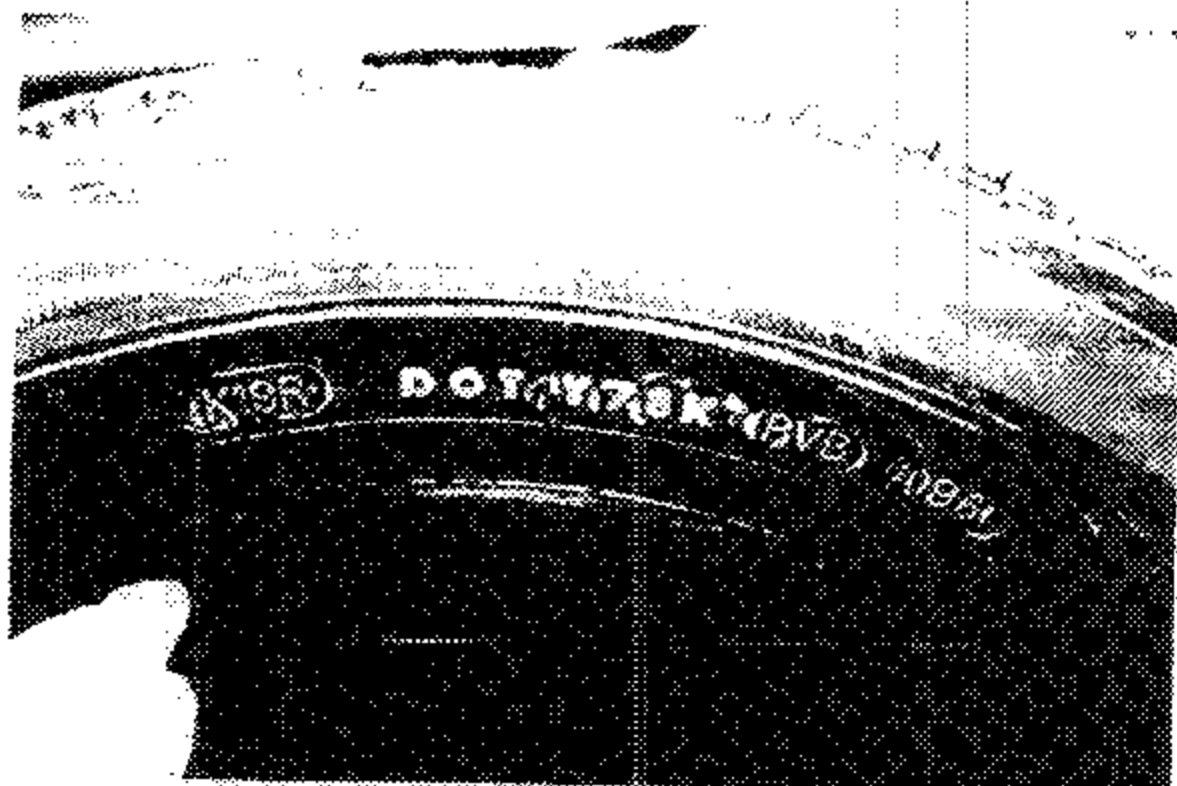
PHOTO 12 SUBJECT TIRE - IDENTIFICATION MARKINGS
