National Crash Analysis Center

2010 Toyota Venza (Baseline BL) FE Model Validation, Trend & Robustness Study

FE Model Information

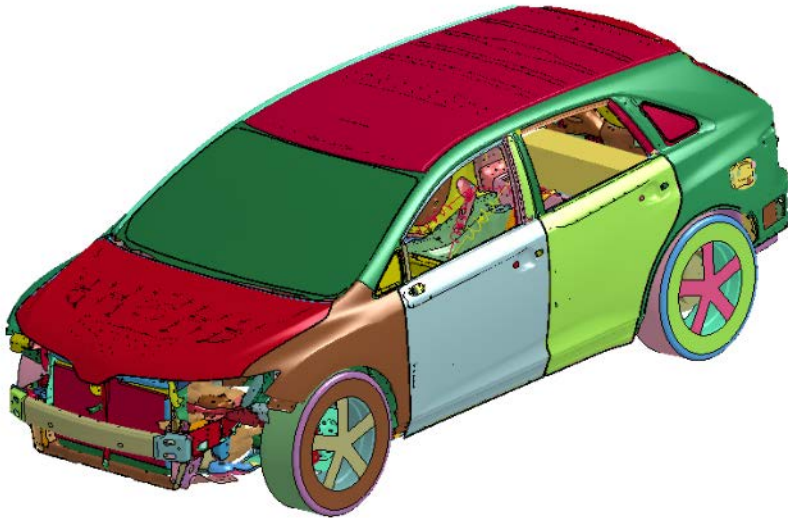
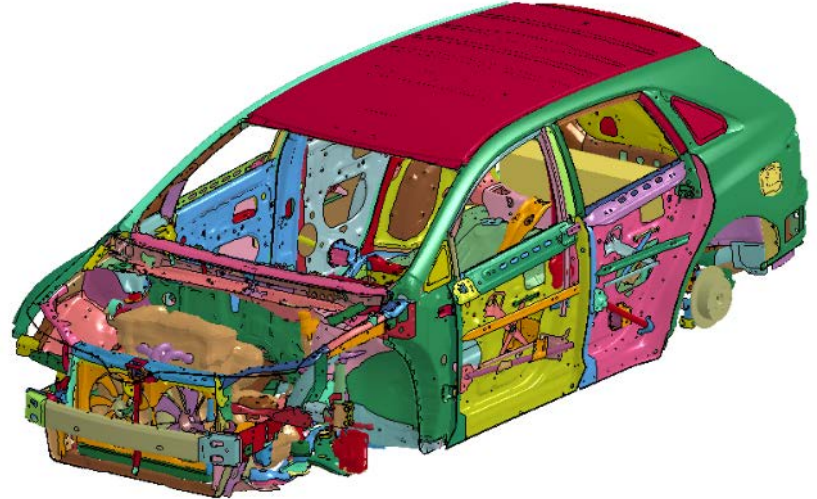
File Name: Venza_BL_V1c.key	
Total Number of Parts	1143
Total Number of Elements	1389892
Total Number of Nodes	1374798
Total Number of Shell Elements	1292715
Total Number of Solid Elements	97082
Total Number of Beam & Discrete Elements	95

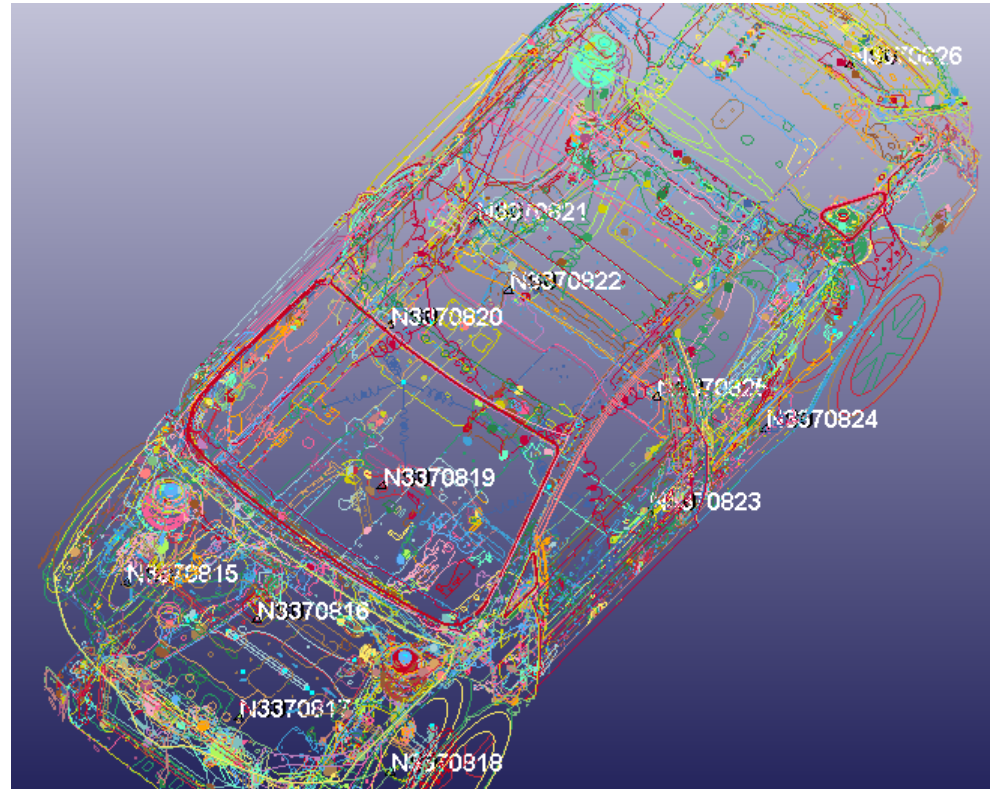
Accelerometers

3370815	BRAKE_CALIPER_RH
3370816	ENG_TOP
3370817	ENG_BOTTOM
3370818	BRAKE_CALIPER_LH
3370819	IP_CENTER
3370820	BPLR_BOTTOM_INNER_RH
3370821	SIDE ROCKER REAR RH
3370822	REAR SEAT XMBR RH
3370823	BPLR_BOTTOM_INNER_LH
3370824	SIDE_ROCKER_REAR_LH
3370825	REAR SEAT XMBR LH
3370826	REAR TRUNK CENTER

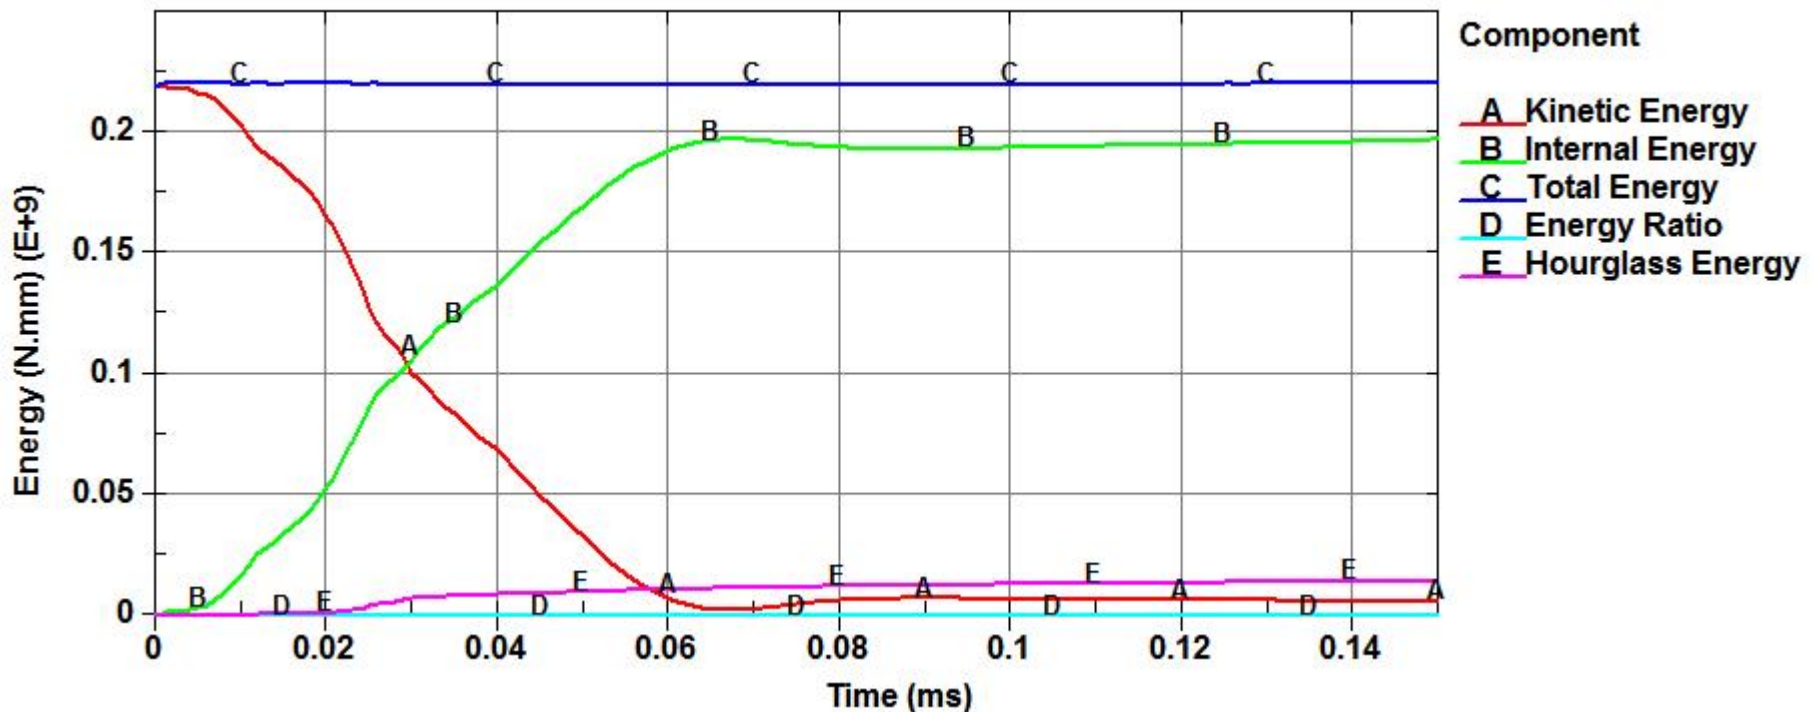
Energy Comparison

- Energy comparison looks OK
- No energy spikes & total energy remains constant
- Hourglass energy remains low

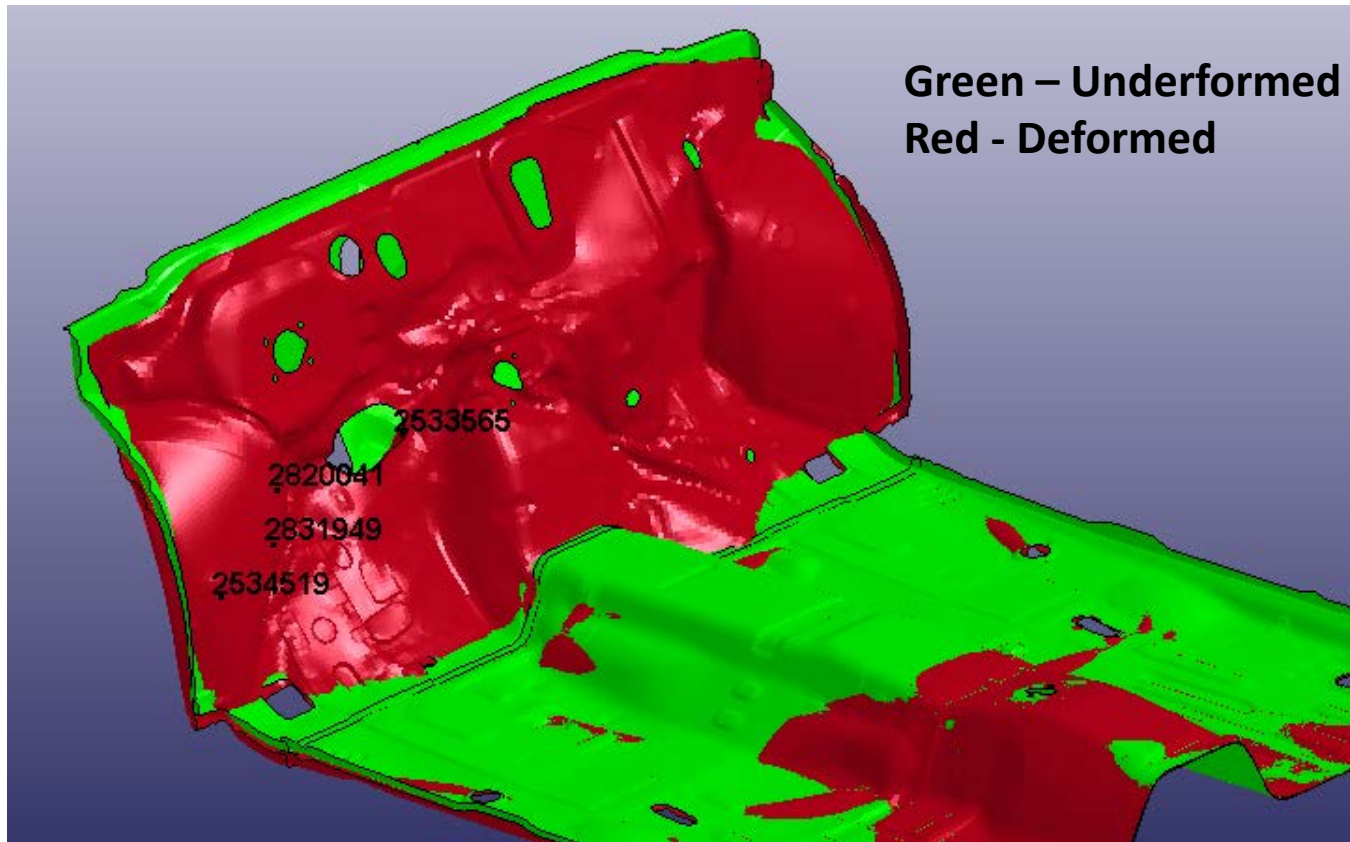
Intrusion Comparison – 35 mph

- Intrusion measurements not available in the 208 test
- Peak footwell intrusion in the simulation occurs @ 65 ms
- Hence the slightly stiffer pulse after 65 ms may not majorly influence the occupant injury risks

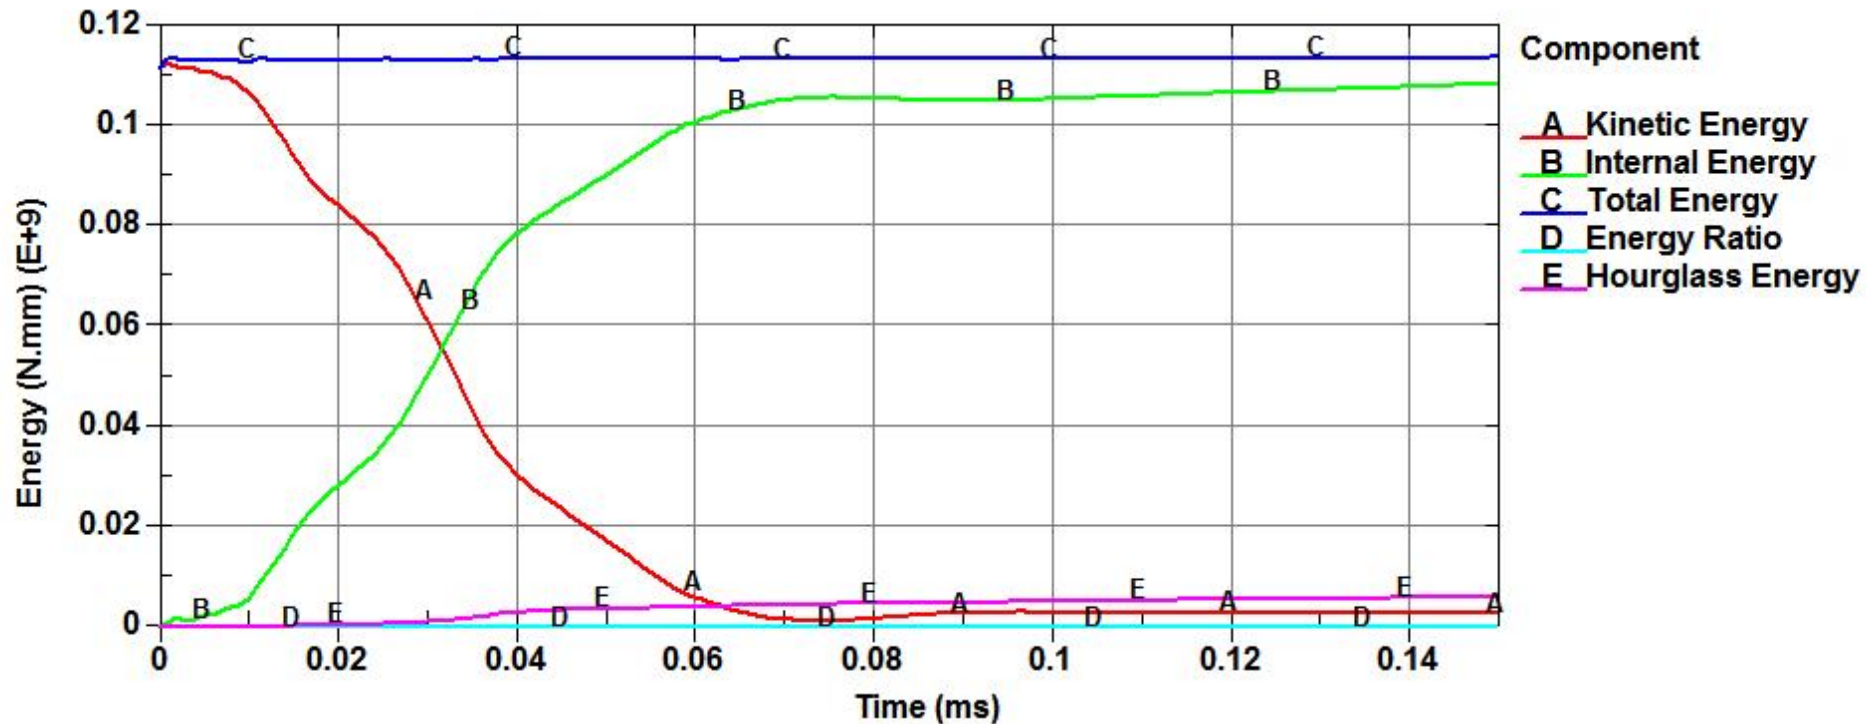
Energy Comparison

- Energy comparison looks OK
- No energy spikes & total energy remains constant
- Hourglass energy remains low

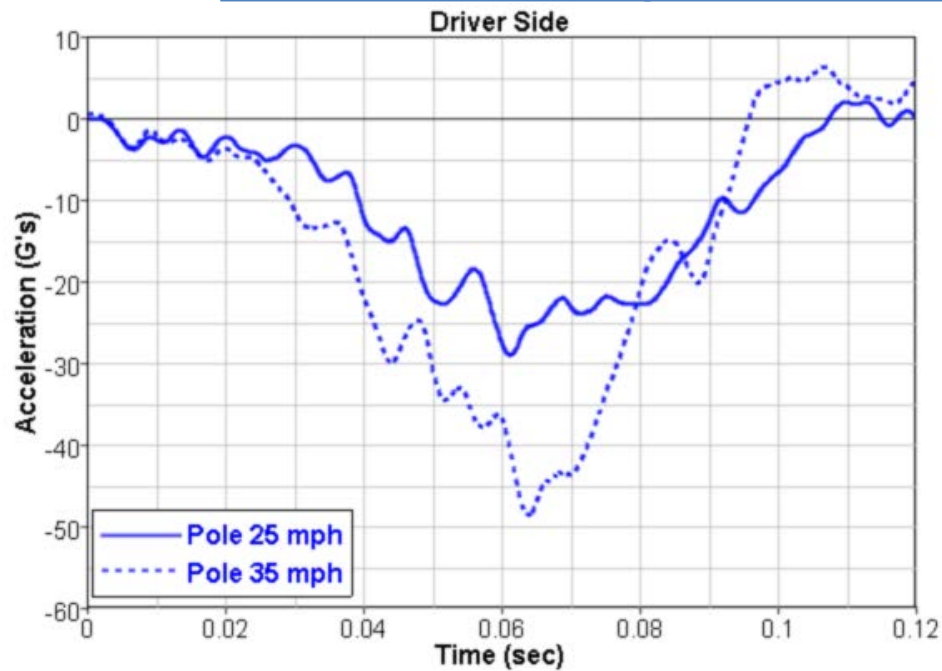
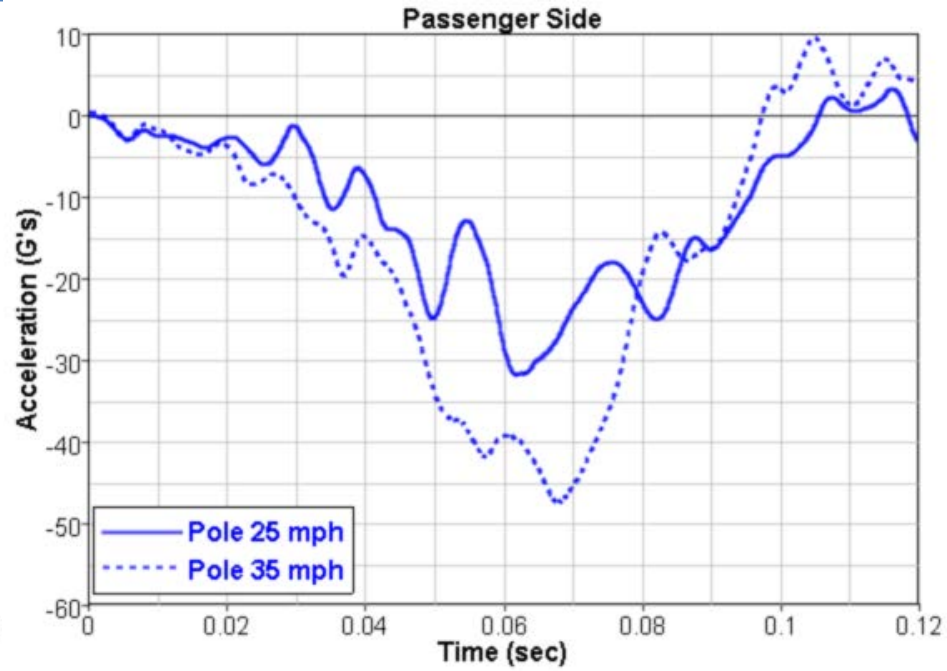
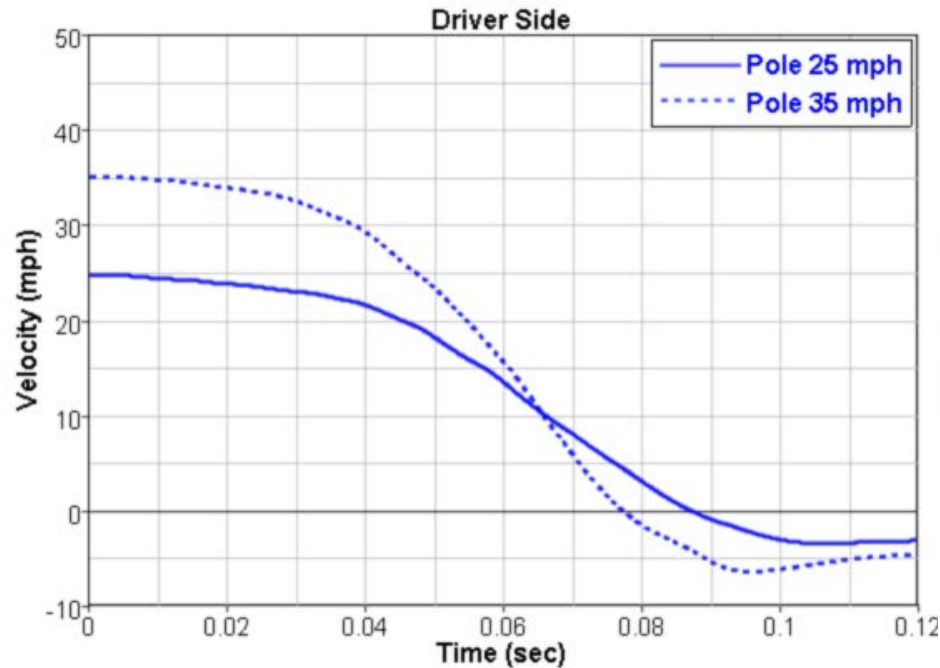
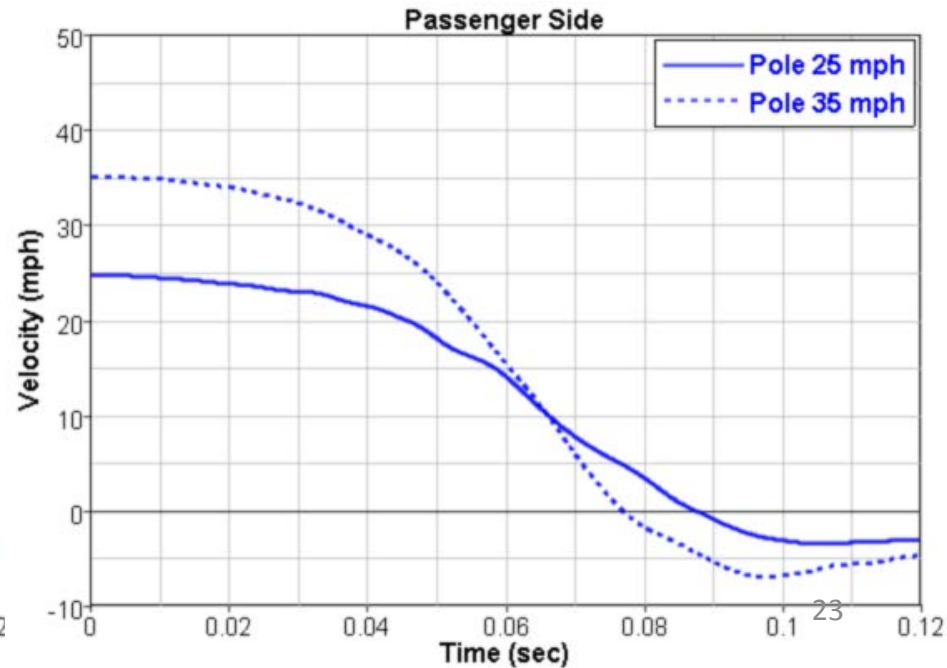
Centerline Impact into 10" pole @ 25 & 35 mph

- Centerline impact into fixed 10" diameter pole & 35 mph
- 40% and Full overlap v-t-v impact into Silverado @ 35 mph

- Full frontal impact into fixed barrier: 35 mph & 25 mph
- 40% overlap impact into deformable barrier: 40 mph & 25 mph
- Centerline impact into fixed 10" diameter pole: 35 mph & 25 mph
