**National Highway
Traffic Safety
Administration**

PEDESTRIAN CASE SUMMARY

PSU 90 CASE NO. 629P TYPE OF ACCIDENT CAR/PEDESTRIAN MOVING IN ROAD WITH TRAFFIC

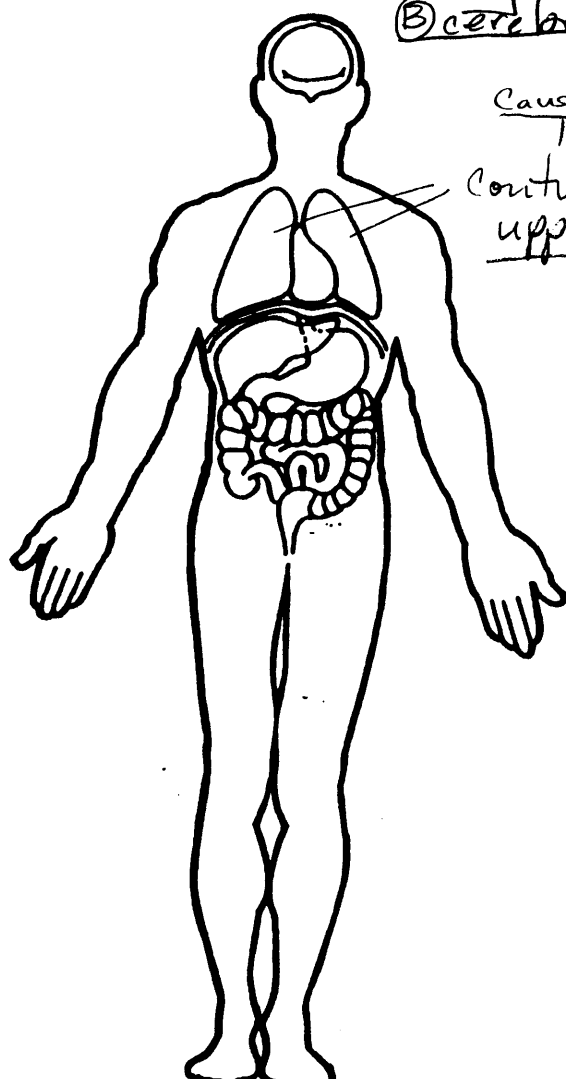
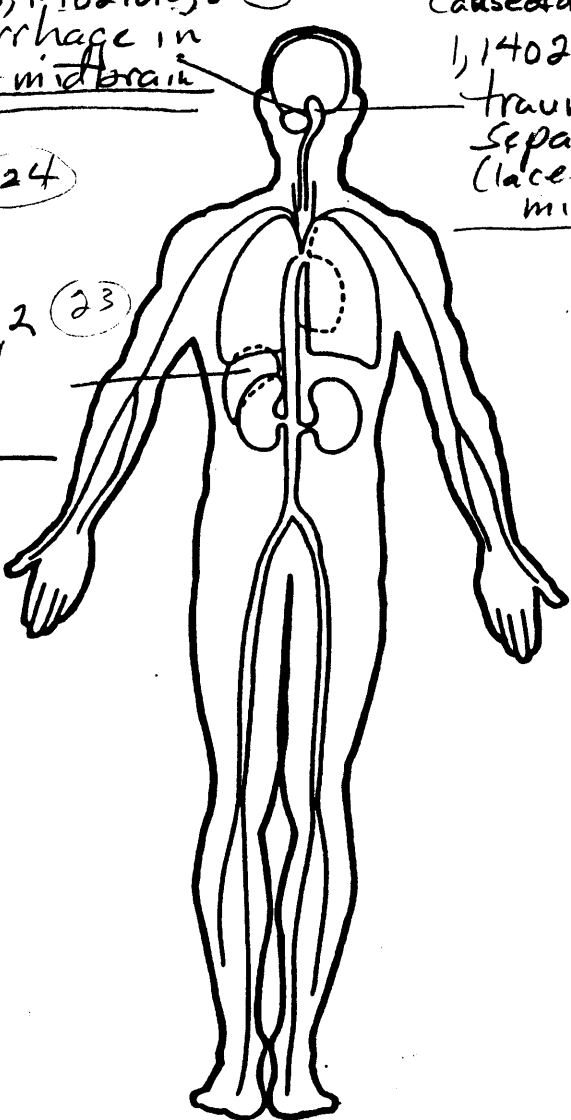
OFFICIAL INJURY DATA – INTERNAL INJURIES

diffuse subarachnoid hemorrhage
③ cerebellum
 Cause of death #3
 1,441410.4,3
contusions ③ lungs (24)
upper lobes

1,140684.3,1,34
 1,140684.3,2,35
 Cause of death #2
 1,140210.5,8 (36)
hemorrhage in pons + mid brain
 Cause of death #1
 1,140212.6,8 (37)
traumatic separation (laceration) mid brain
 1,544222.2,2 (23)
superficial lacerations spleen

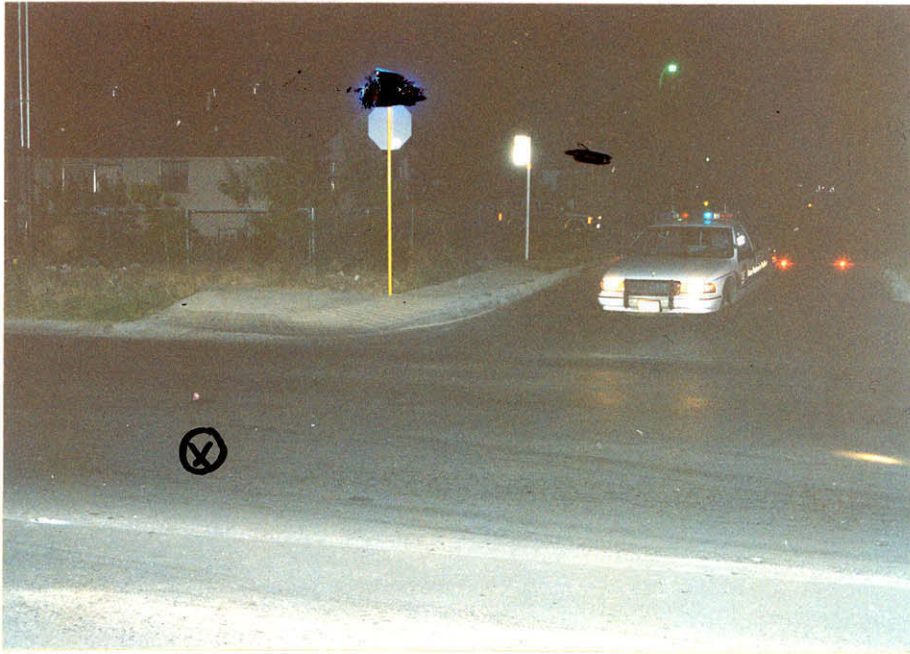
PSU 90-629p (1996) #1

Slide No.	Vehicle No.	Direction of Picture	Description of Slide Subject Matter
1	/	East	Back along path of Ped. (X) = POI
2			Ped walking North in direction of V'
2		North	looking from POI area toward FRP
3		North	POI to FRP. (Hat)
4		North	Ped's hat
5		North	ped's glasses
6		North	FRP of Ped + Point where Driver moved vehicle after Final Rest
			North of Ped in lane #2
7		East	" " " "
8	South	" " " "	
9	South	" " " "	
10	1	—	Frontal view (on scene)
11	1	—	side view of Hood and w/s damage
12	1	—	cowl and w/s damage
13	1	—	Roof damage to vehicle as Ped flipped
—	—	—	completely over vehicle #1
14	1	—	" " " "
15/16	1	—	vehicle interior
17-20	—		views of Ped at FRP
