TECHNICAL INSTRUCTIONS
FOR
SAFETY RECALL 90L
DENSO ACCELERATOR PEDAL MODIFICATION
2007 – 2010 MODEL YEAR CAMRY

In early October, Toyota announced it will initiate a Safety Recall Campaign (Special Service Campaign) for potential floor mat interference with the accelerator pedal. The condition involves the potential for an unsecured or incompatible driver's floor mat to interfere with the accelerator pedal and cause it to get stuck in the wide open position.

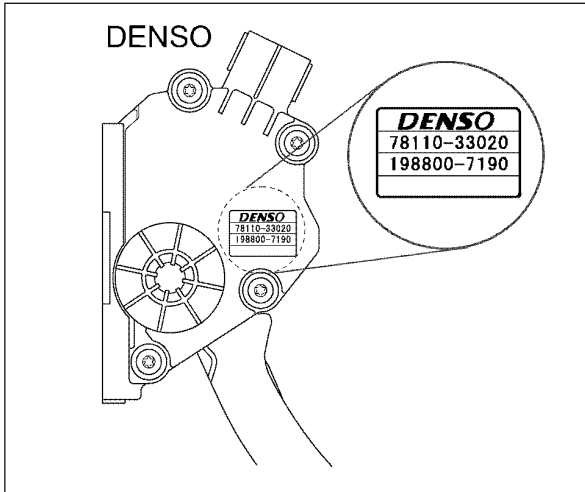
1. IDENTIFY AND REMOVE THE DENSO ACCELERATOR PEDAL ASSEMBLY

- Verify the vehicle has a Denso accelerator pedal assembly by identifying the manufacturing imprint as illustrated here.
- If the pedal is manufactured by Denso continue following the instructions.
- If the pedal is manufactured by CTS, DO NOT CONTINUE WITH THESE INSTRUCTIONS.

Modifications should only be performed on Denso pedals.

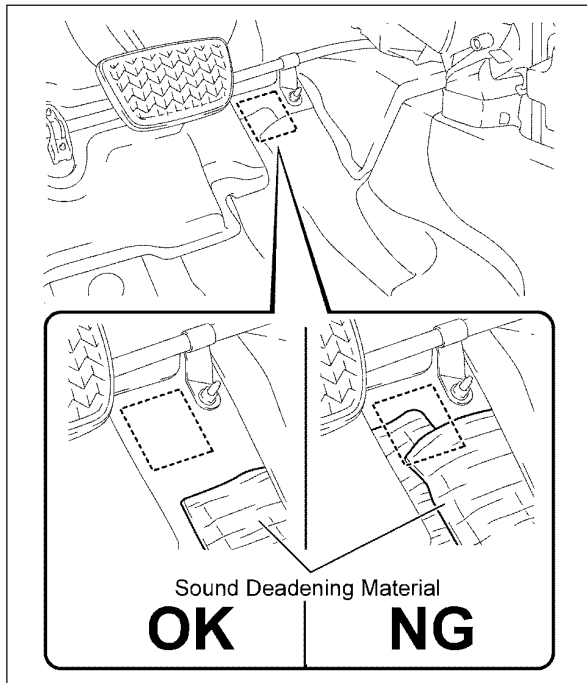
4. RUBBER PAD APPLICATION

- a) Inspect the rubber pad application area for sound deadening material.
 - If OK (no sound deadening material in pad application area), proceed to step “b” below.
 - If NG (sound deadening material found in application area), please refer to APPENDIX “C” for “REMOVE THE SOUND DEADENING MATERIAL”.

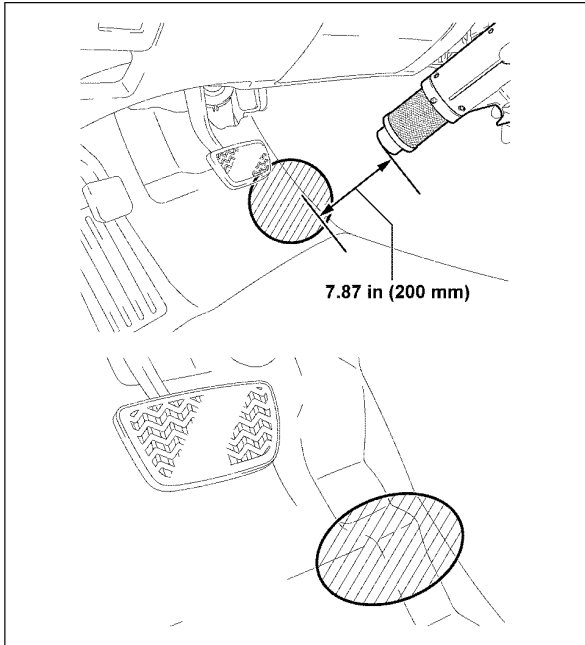
- g) Heat the floor carpet area for 2 minutes as shown and smooth it out by pushing it with your hand. Heat the same area again for another minute, and smooth the carpet firmly.

- Always wear protective gloves when heating the floor carpet.
- Keep the hair dryer/ low temperature heat gun more than 8 inches (20 cm) away from the floor carpet, and stop after 1 or 2 minute intervals. Continuous heating of the floor carpet may cause damage.
- DO NOT leave hair drier or low temperature heat gun inside the vehicle when it is hot, to prevent unintended heat damage to interior parts.
