REPORT NUMBER 124-GTL-10-005

SAFETY COMPLIANCE TESTING FOR FMVSS 124 ACCELERATOR CONTROL SYSTEMS

MAZDA MOTOR CORPORATION
2010 MAZDA 6, PASSENGER CAR
NHTSA NO. CA5403

GENERAL TESTING LABORATORIES, INC.
1623 LEEDSTOWN ROAD
COLONIAL BEACH, VIRGINIA 22443

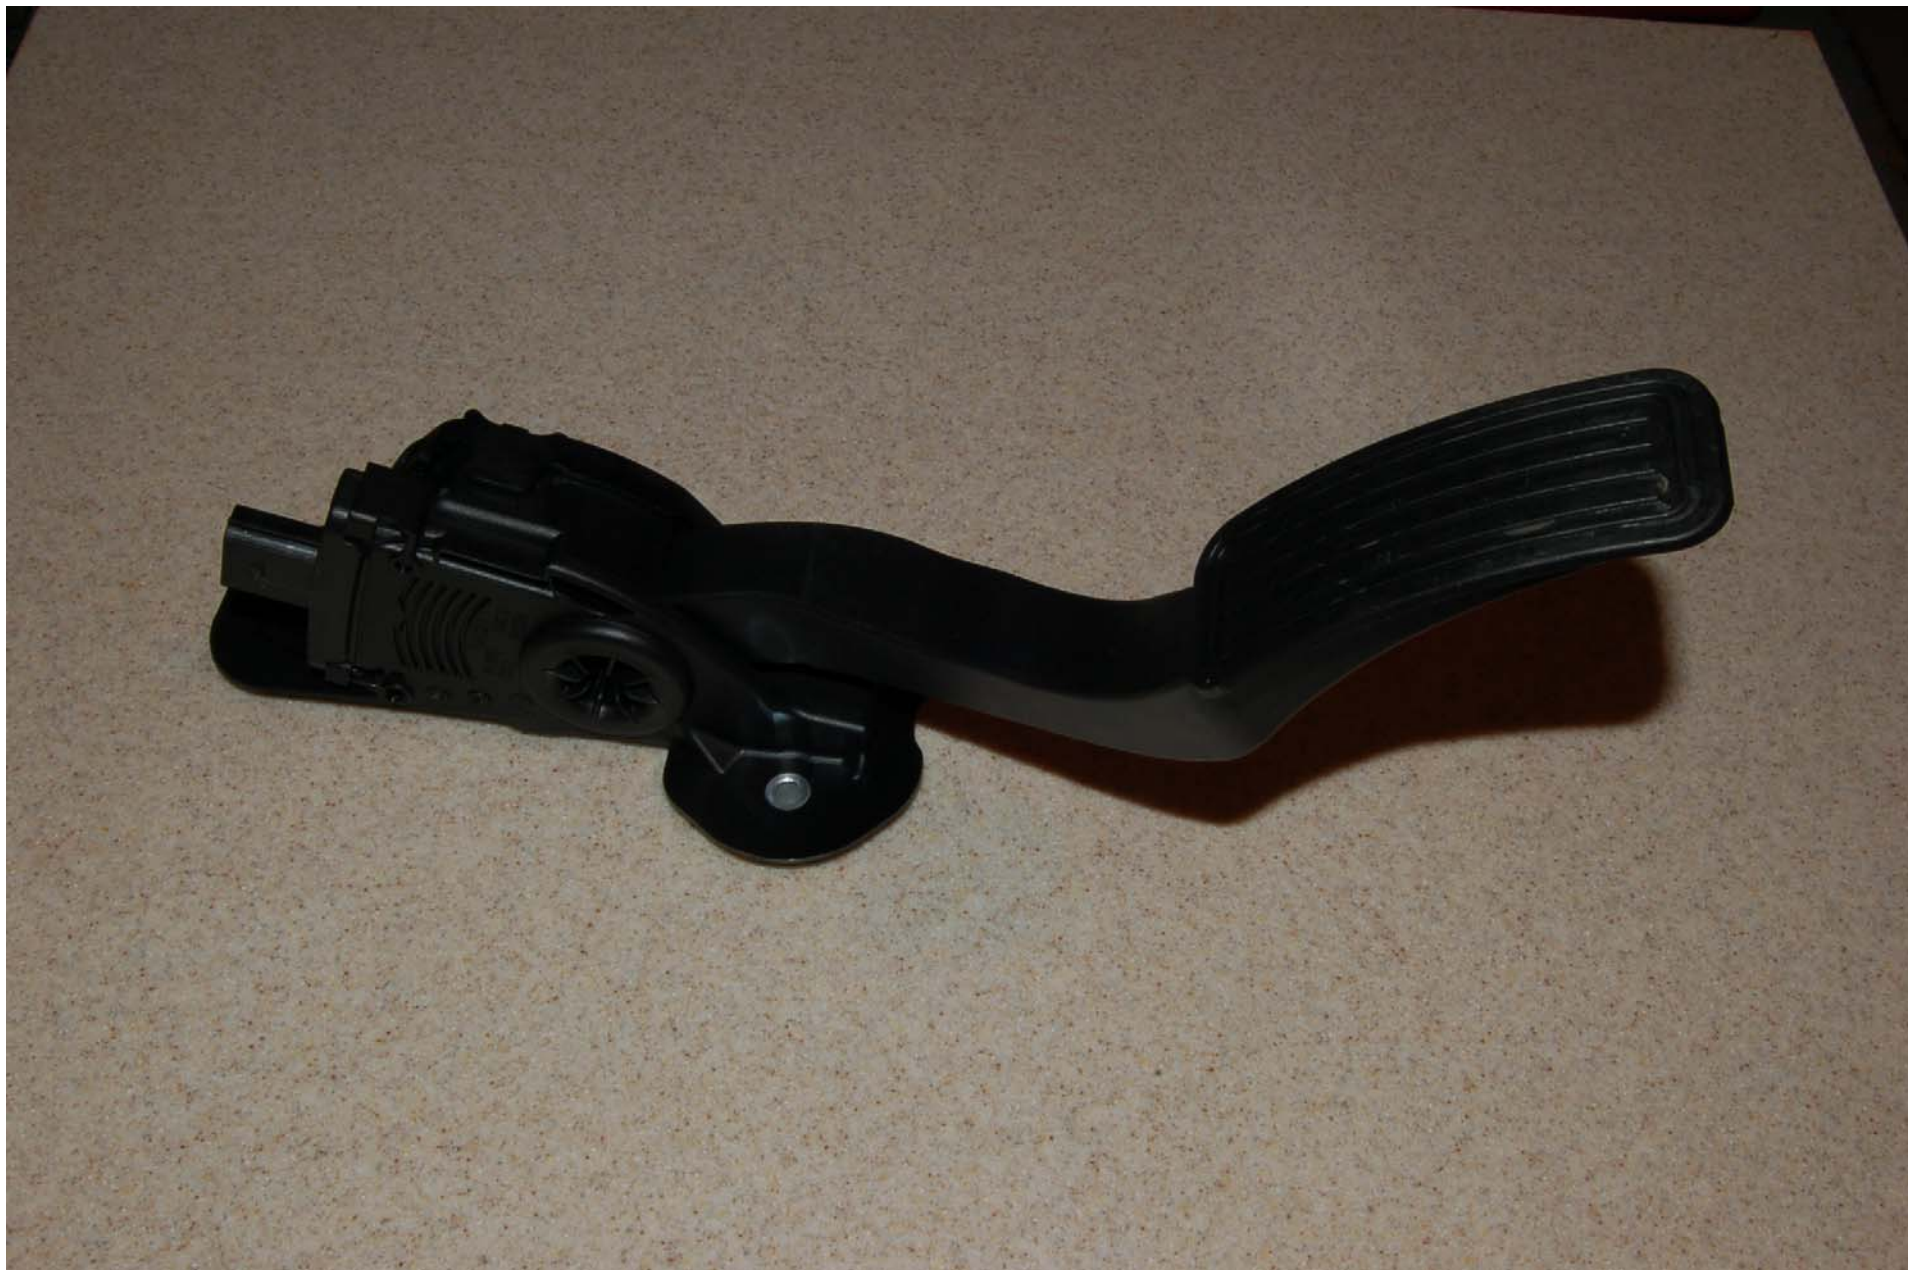
FIGURE 5.6
ACCELERATOR PEDAL ASSEMBLY

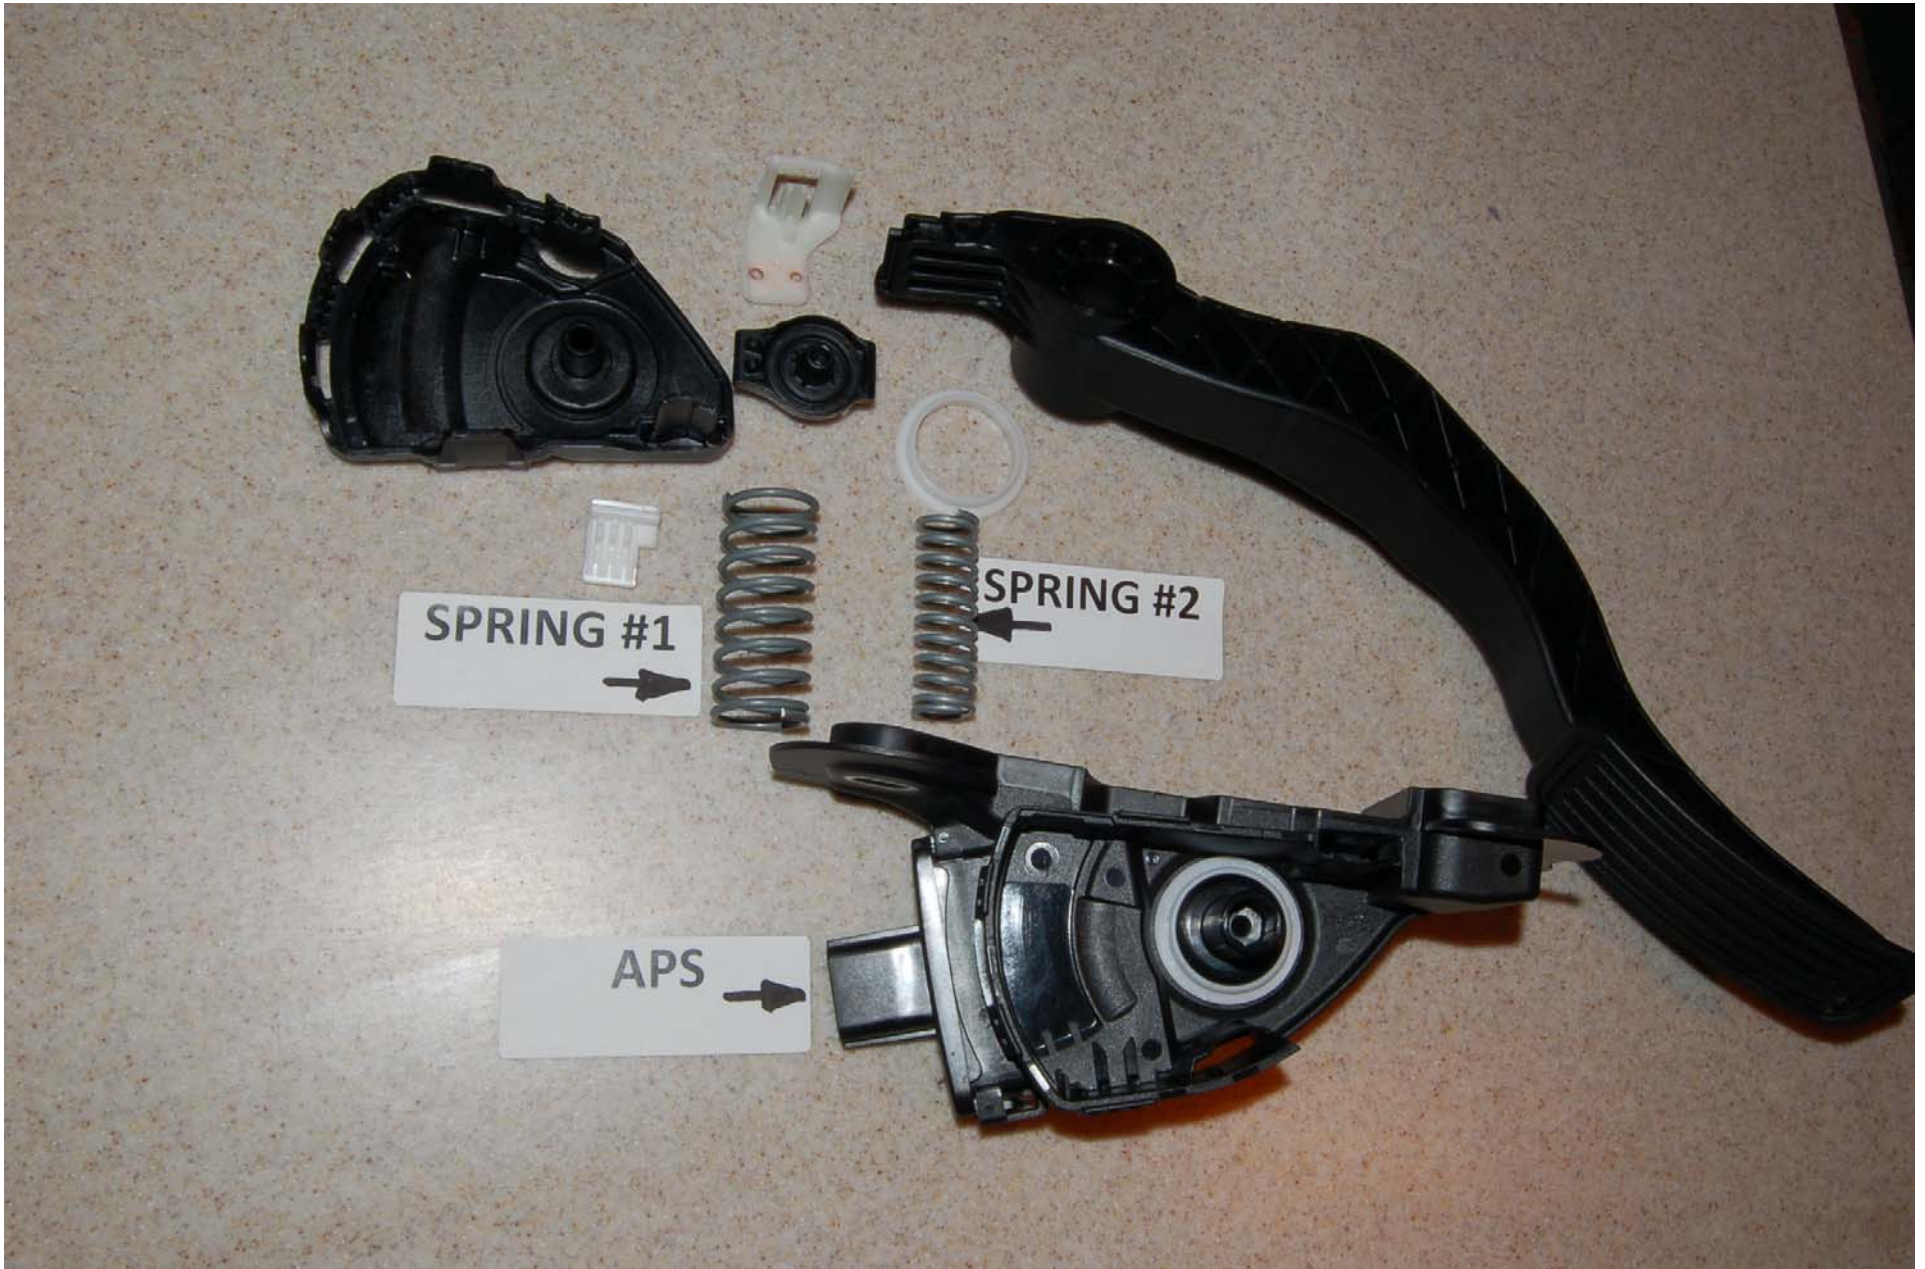
FIGURE 5.7
CLOSE-UP OF SPRINGS 1 & 2

SYSTEM CONDITION: #1 SPRING DISCONNECTED (OUTER SPRING) ON ACCELERATOR PEDAL ASSEMBLY

SYSTEM CONDITION: #2 SPRING DISCONNECTED (INNER SPRING) ON ACCELERATOR PEDAL ASSEMBLY

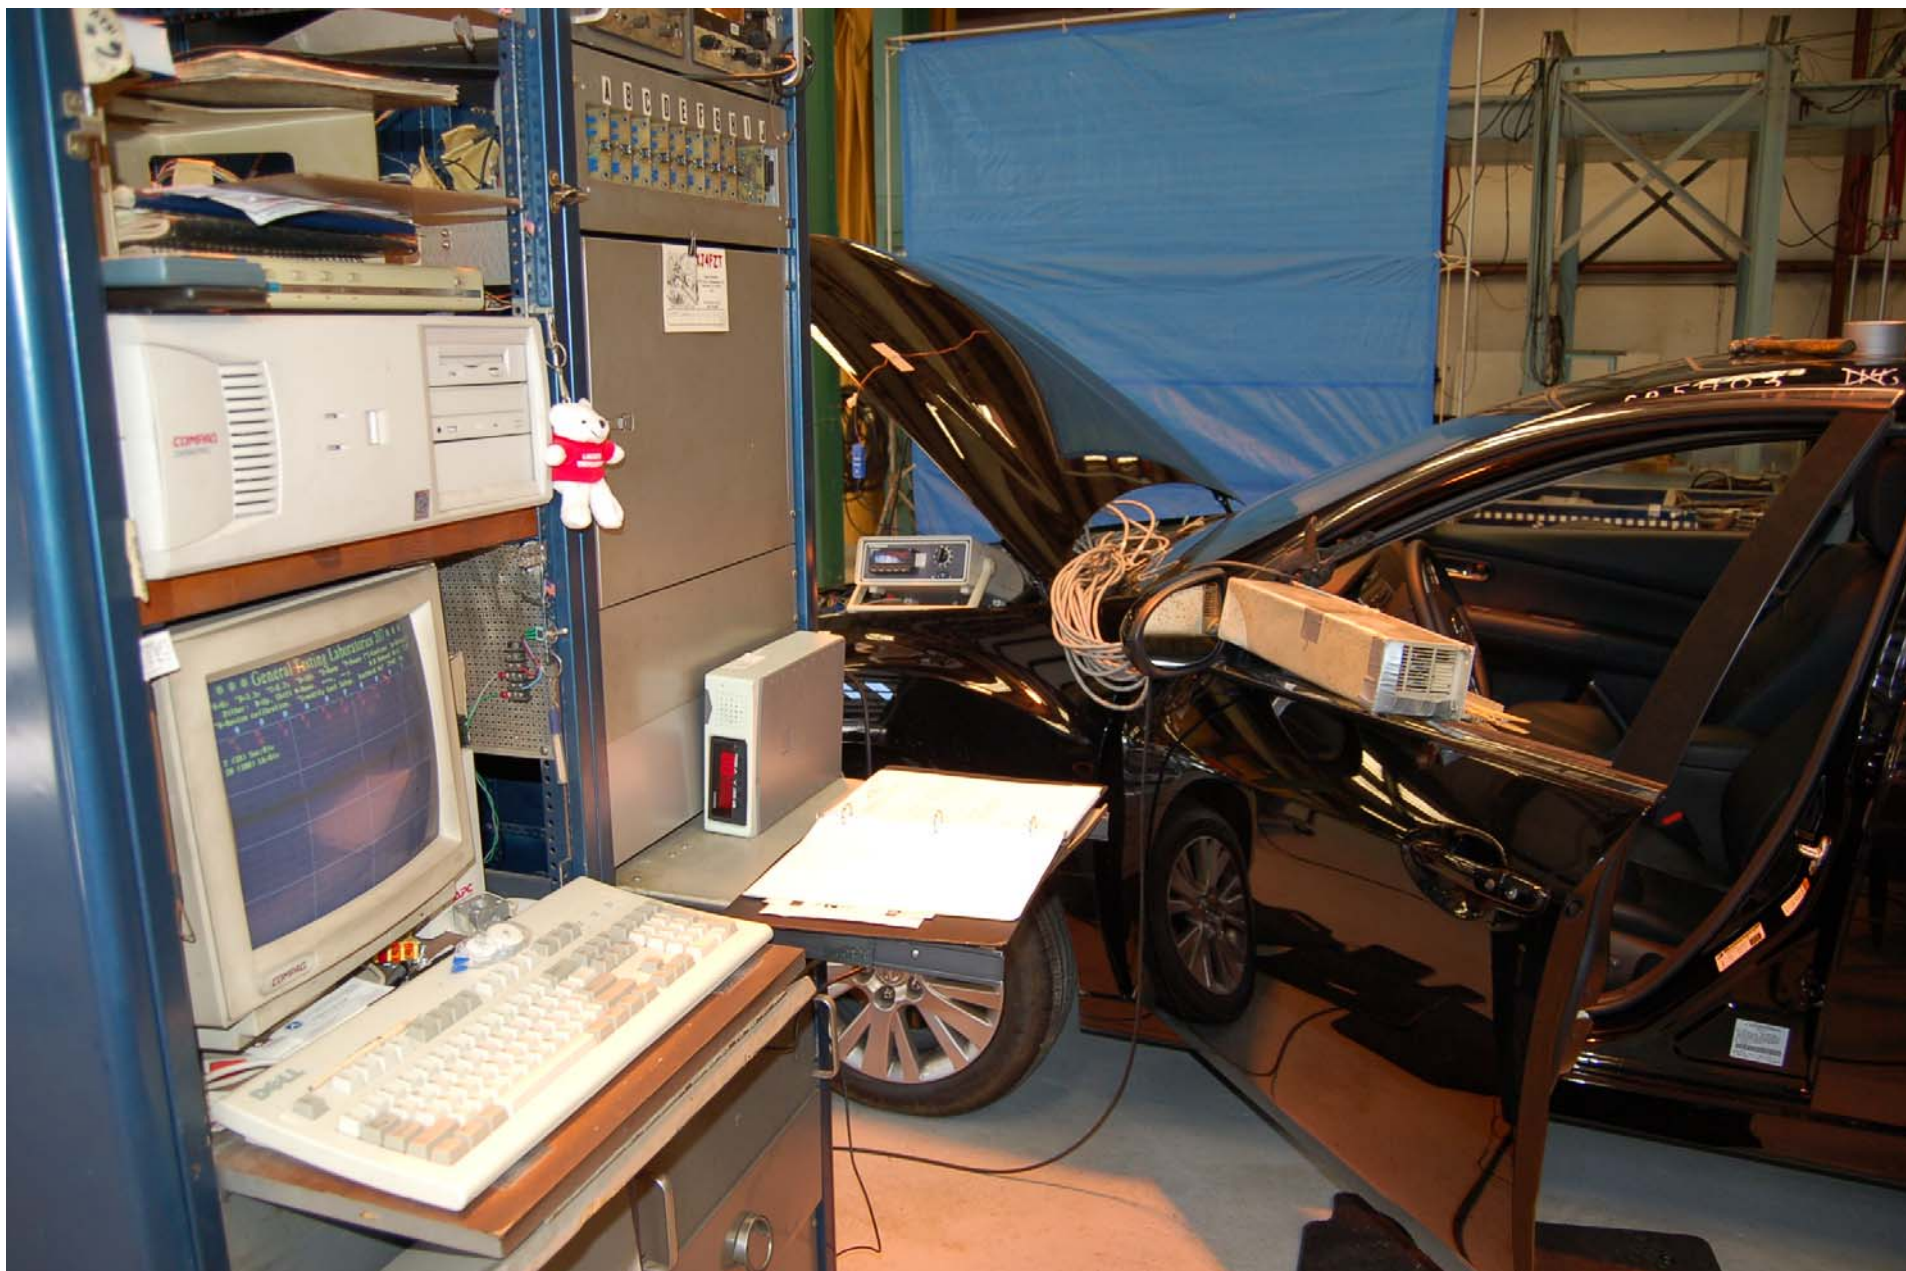
FIGURE 5.9
TEST SET-UP

The vehicle is equipped with two throttle position sensors (TPS) on the air throttle plate shaft. Output from one of the two sensors was used to measure throttle position and data was recorded at 100 HZ with GTL' s data acquisition system. Testing was conducted to simulate the normal removal of the driver's foot from the accelerator pedal. This was performed by depressing the accelerator with a control rod which incorporated an electrical contact strip in the depressing end. The accelerator was depressed to the required amount and then the control rod was quickly removed from the pedal, releasing the accelerator and activating the contact strip for time zero. Failures (excluding spring disconnect) were induced simultaneously with release of the accelerator pedal. Testing was performed with the vehicle in drive and the engine running. Testing could not be conducted in neutral as throttle plate movement in this condition was limited upon accelerator pedal application.
