REPORT NUMBER: 201U-CAL-10-10

**SAFETY COMPLIANCE TESTING FOR FMVSS 201
OCCUPANT PROTECTION IN INTERIOR IMPACT
UPPER INTERIOR HEAD IMPACT PROTECTION**

**HONDA OF AMERICA MANUFACTURING COMPANY, INC.
2010 Honda Insight**

FINAL REPORT

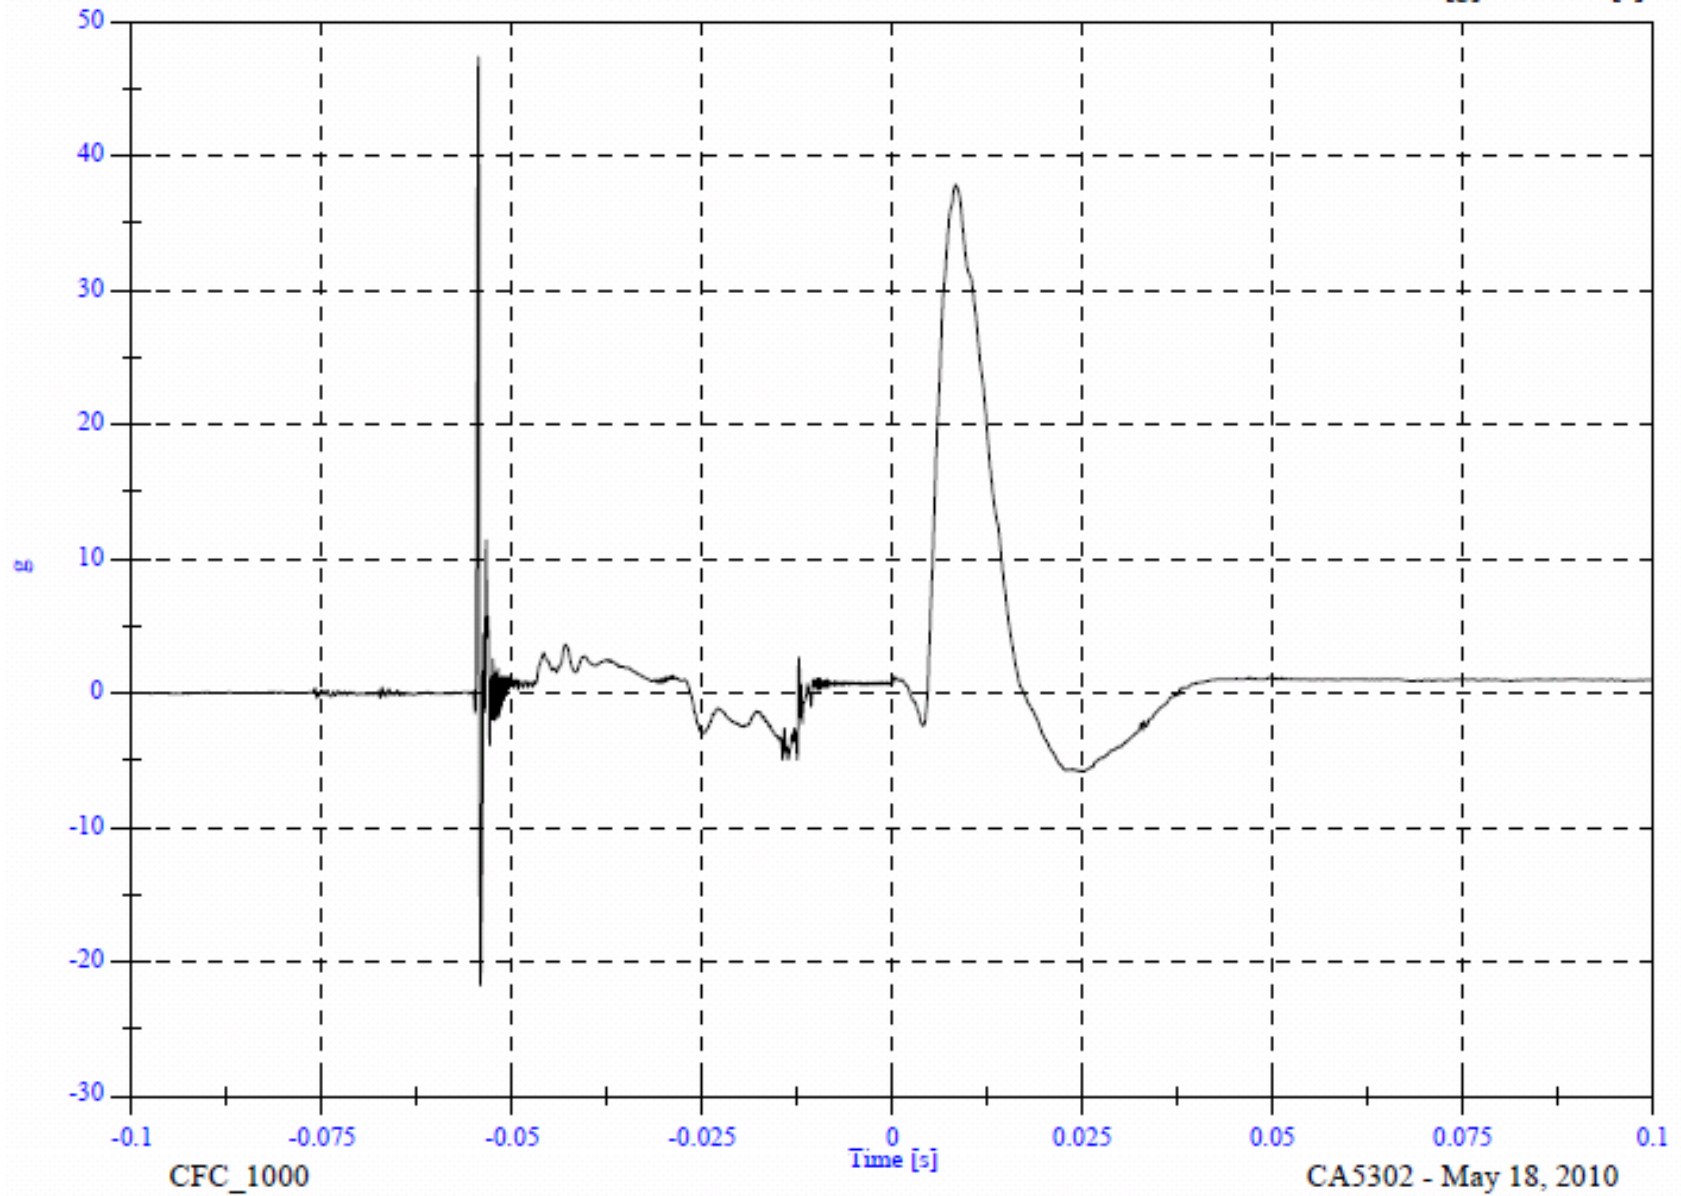
URCG RH Side

Headform Z Acceleration

Max: 47.4 [g] at -0.054 [s]
Min: -21.7 [g] at -0.054 [s]

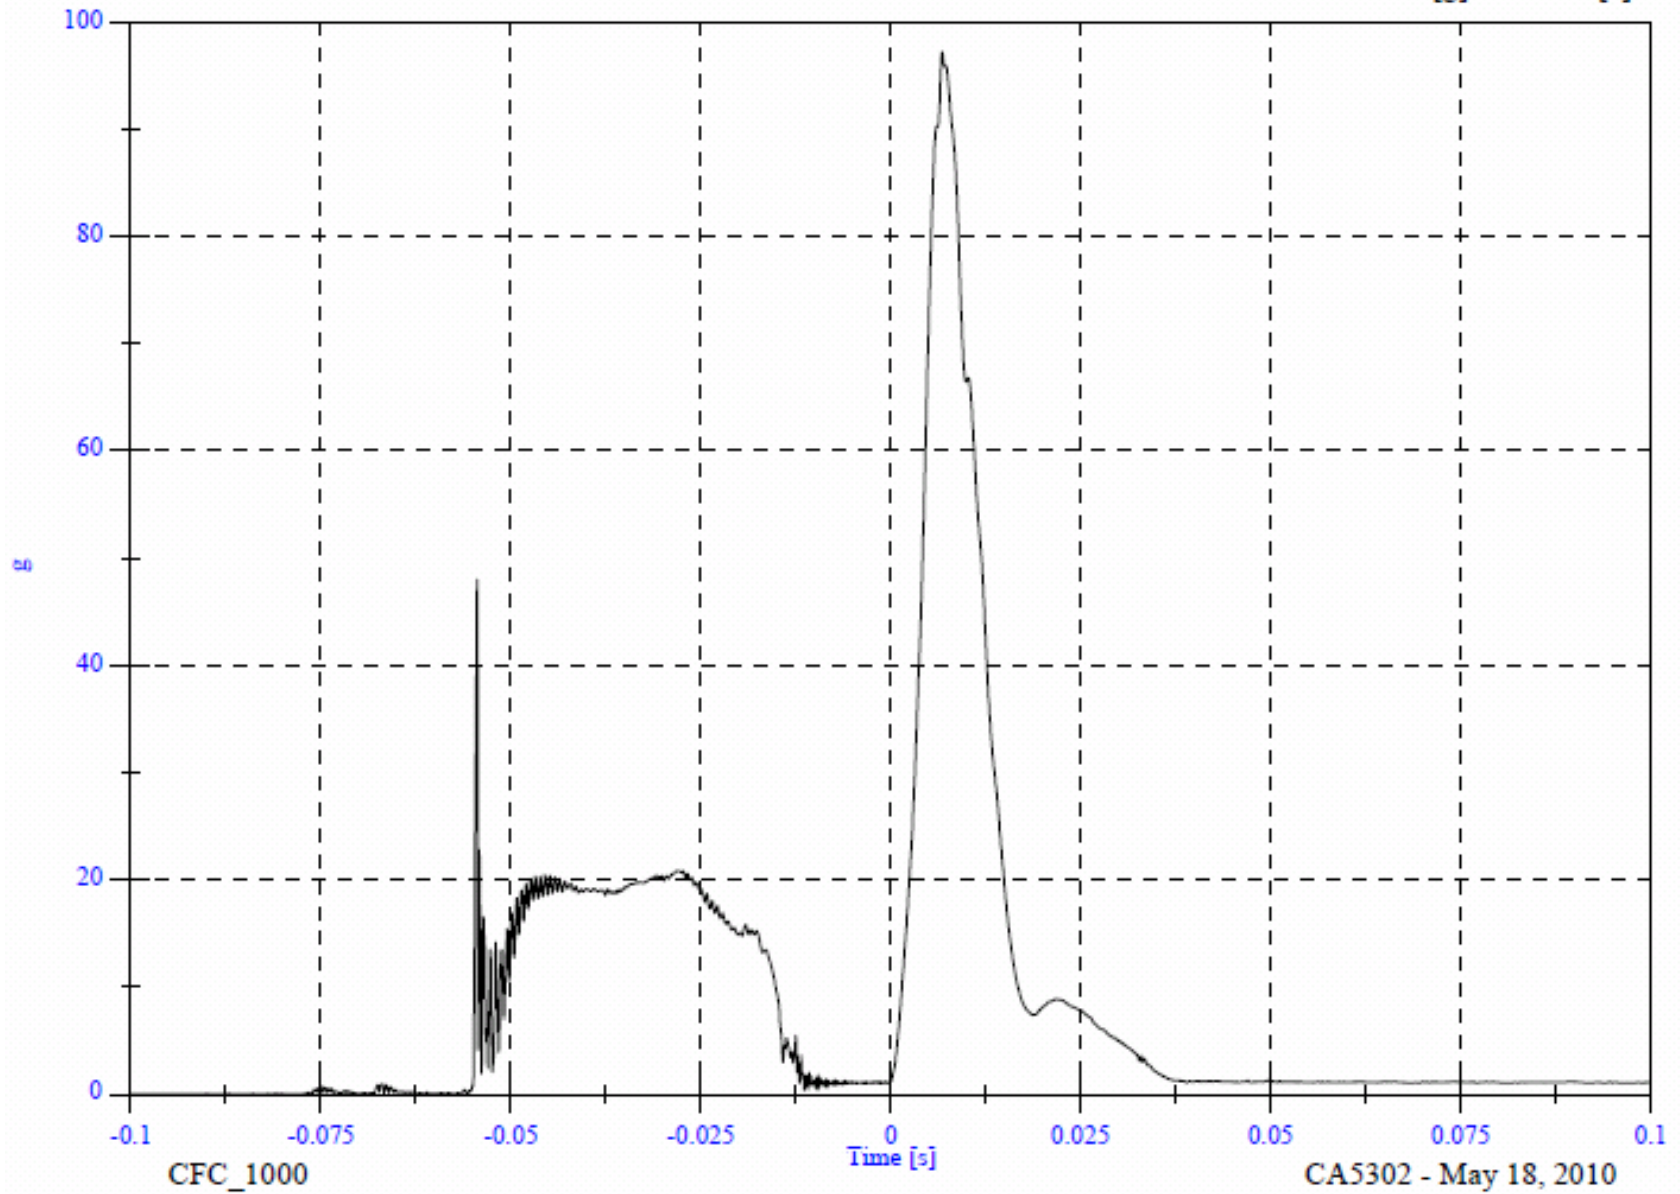
URCG RH Side

Headform Resultant

Max: 97.2 [g] at 0.007 [s]

Min: 0.0 [g] at -0.098 [s]

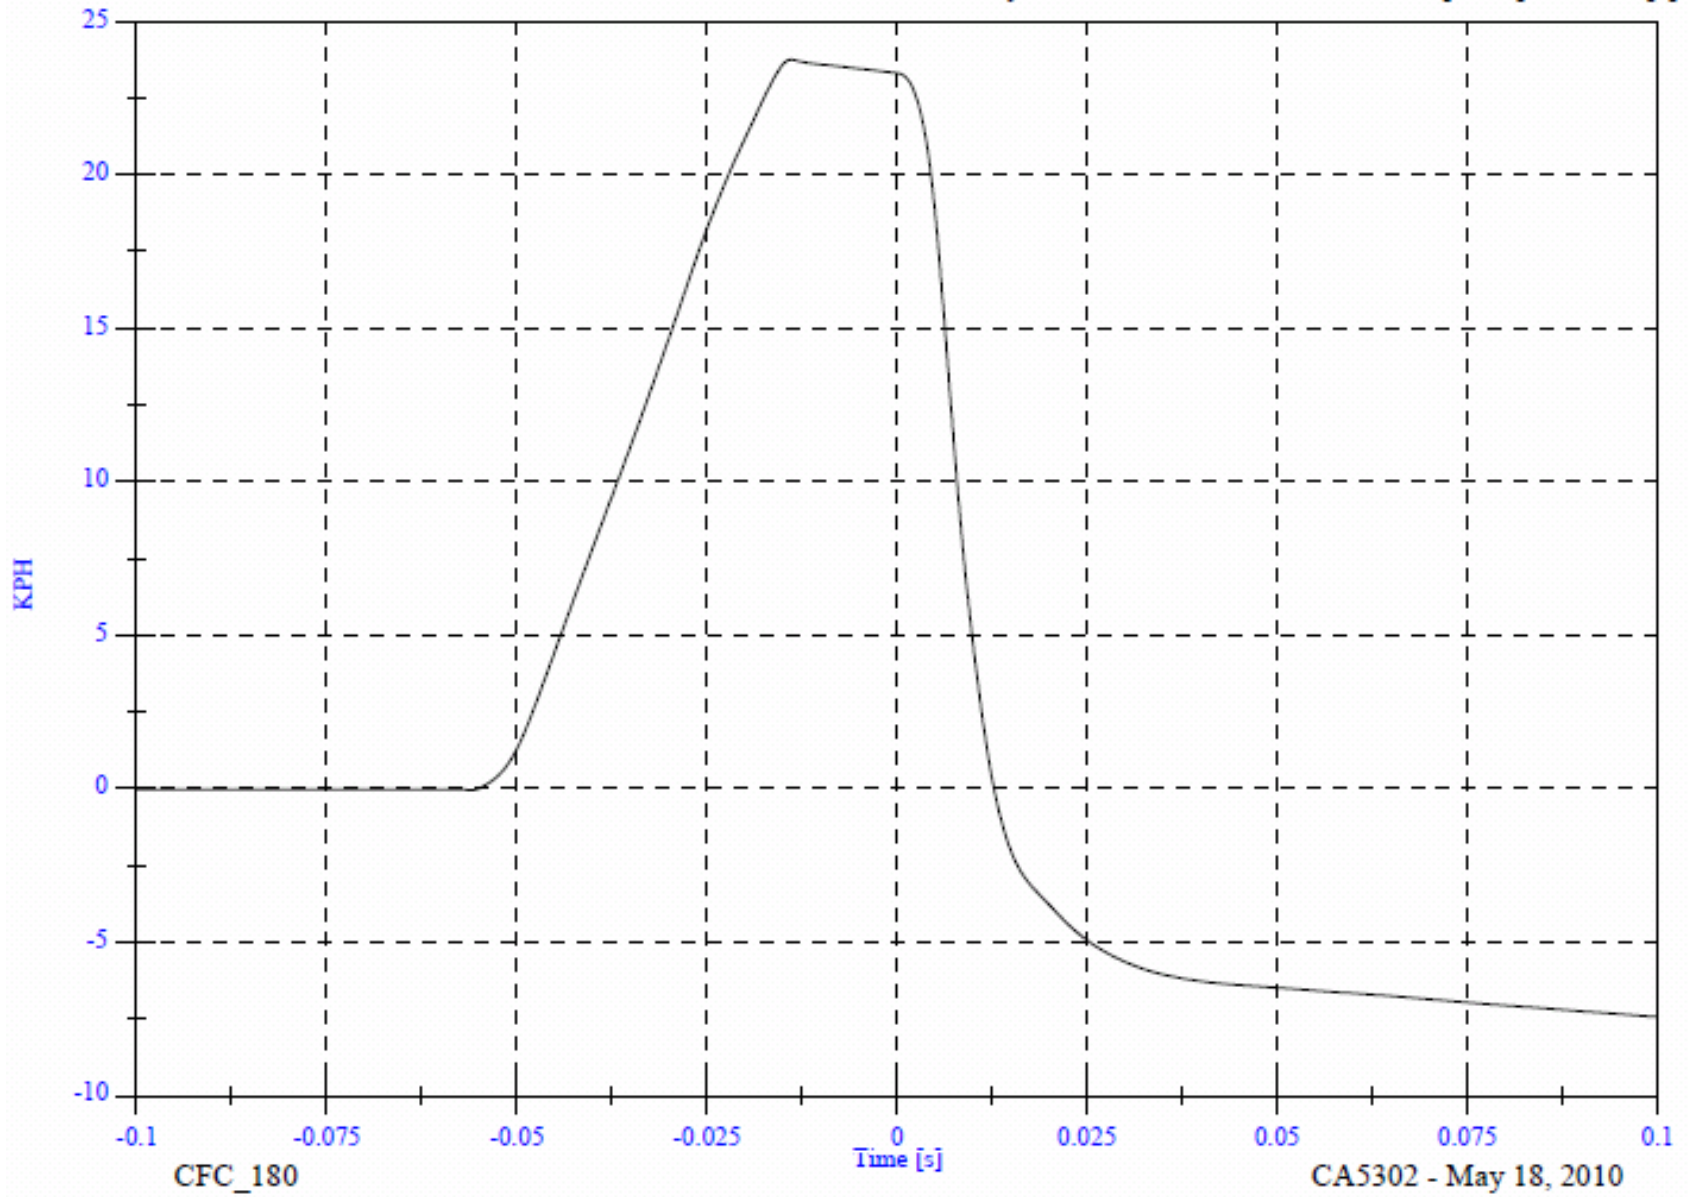
URCG RH Side

Max: 23.7 [KPH] at -0.014 [s]

Min: -7.4 [KPH] at 0.100 [s]

Headform Velocity

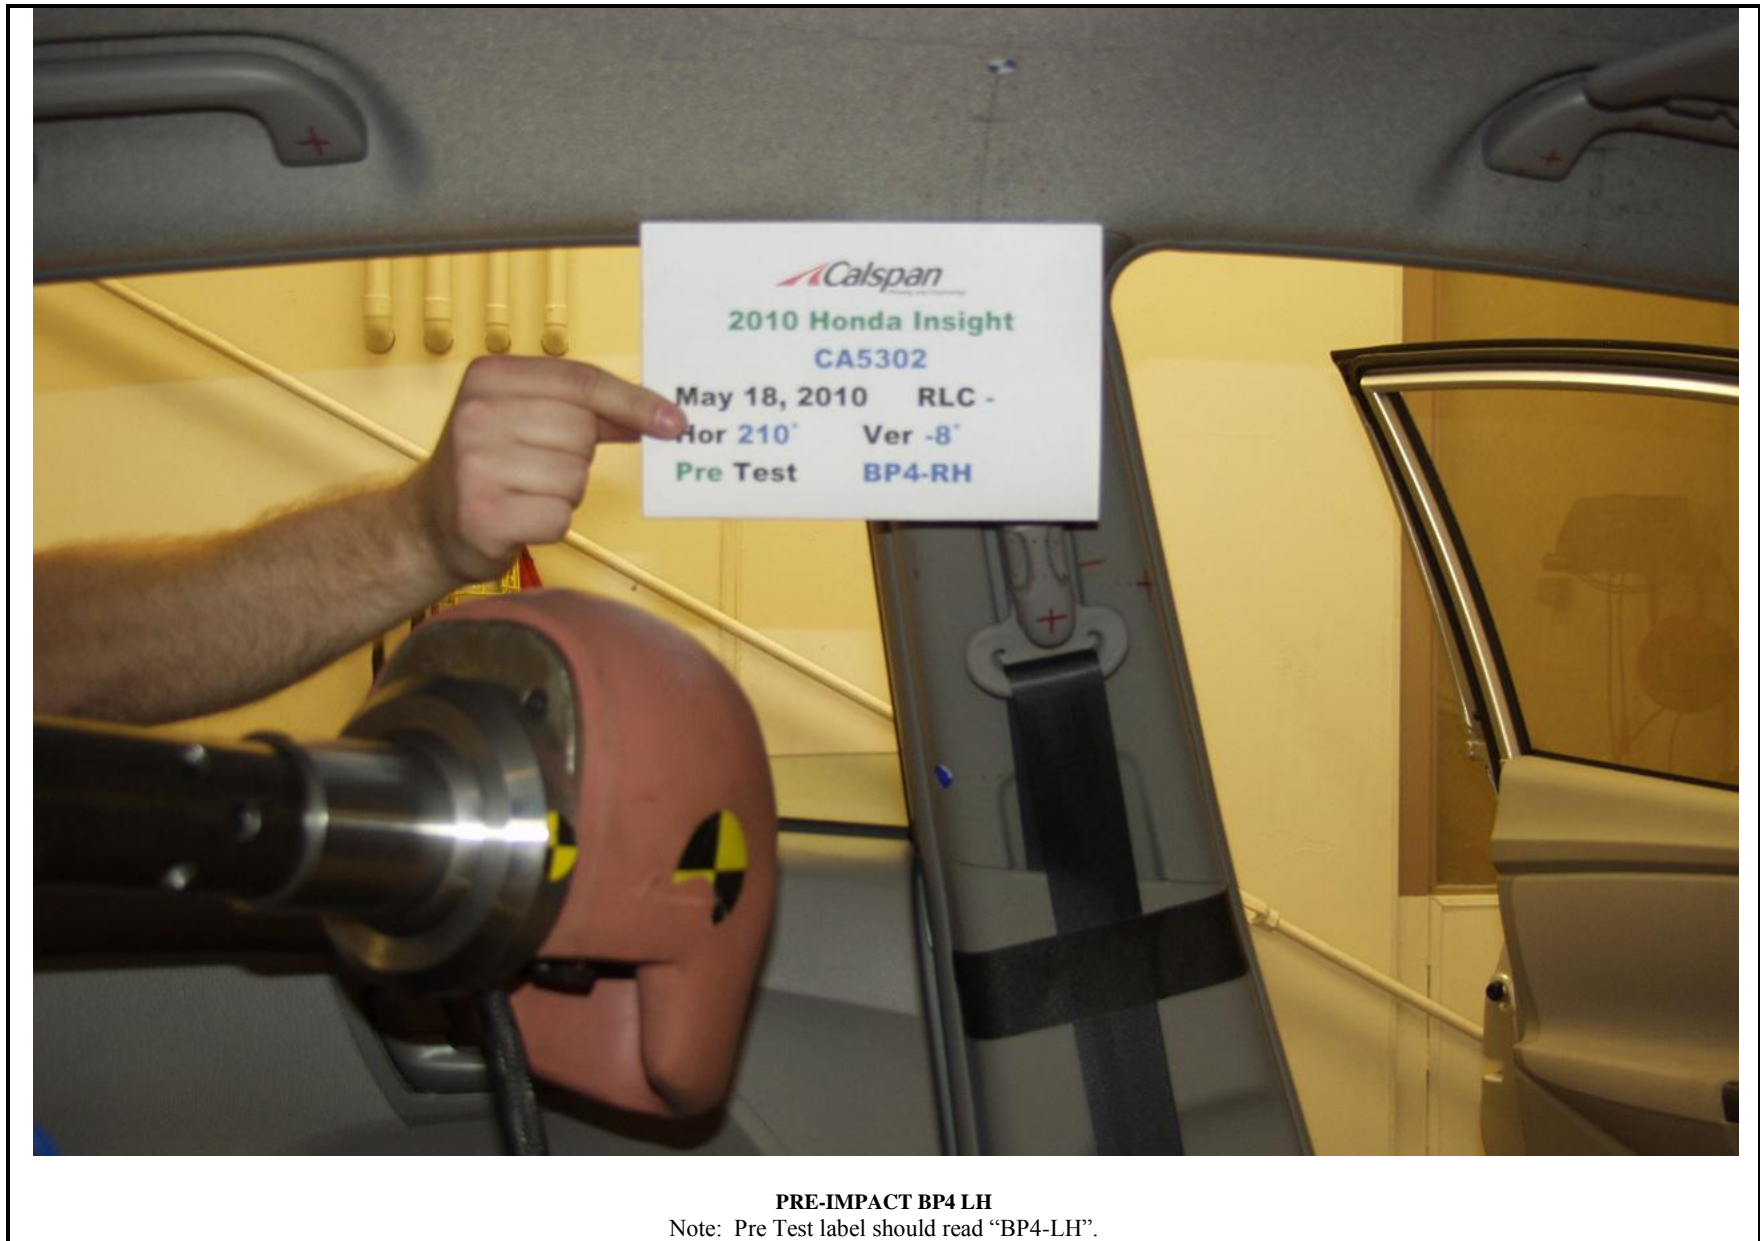
PRE-IMPACT BP4 LH

Note: Pre Test label should read "BP4-LH".

| TARGET CODE | Target Coordinates | | | | | | Approach Angles (degrees) | | Velocity (kph) | FMH HIC | HIC(d) |
|---|---|---|---|---|---|---|---|---|---|---|---|
| BP4 | 1643.19 | -637.82 | 755.40 | 1642.38 | 632.21 | 758.60 | 210 | -8 | 23.93 | 521.4 | 559.8 |

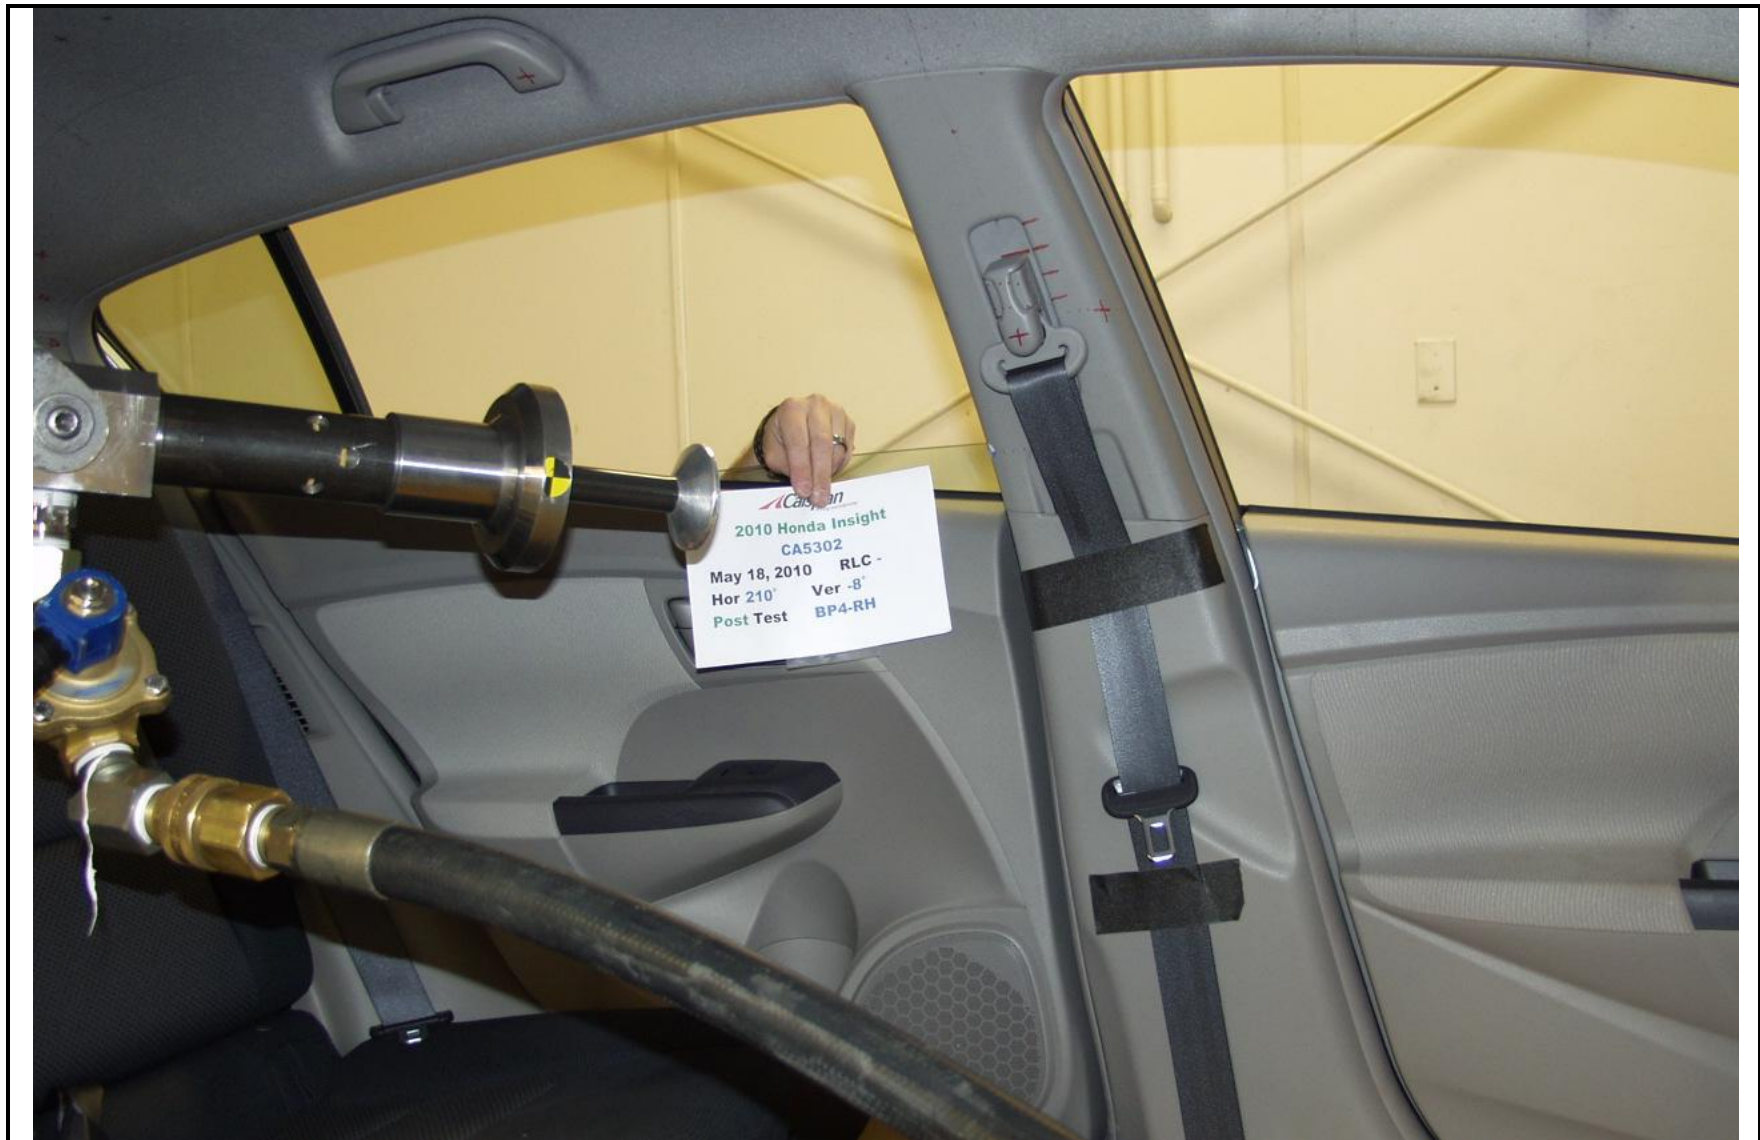
POST-IMPACT BP4 LH

Note: Post Test label should read "BP4-LH".
