# SAFETY COMPLIANCE TESTING FOR FMVSS NO. 138 TIRE PRESSURE MONITORING SYSTEMS

KIA MOTORS CORPORATION  
2019 KIA SEDONA L  
MPV  
NHTSA NO. C20194200

U.S. DOT SAN ANGELO TEST FACILITY  
131 COMANCHE TRAIL, BUILDING 3527  
GOODFELLOW AFB, TEXAS 76908

| 4. Title and Subtitle<br><br>Final Report of FMVSS No. 138 Compliance Testing of 2019 Kia Sedona L MPV, NHTSA No.C20194200 | | 5. Report Date<br>March 27, 2019 |

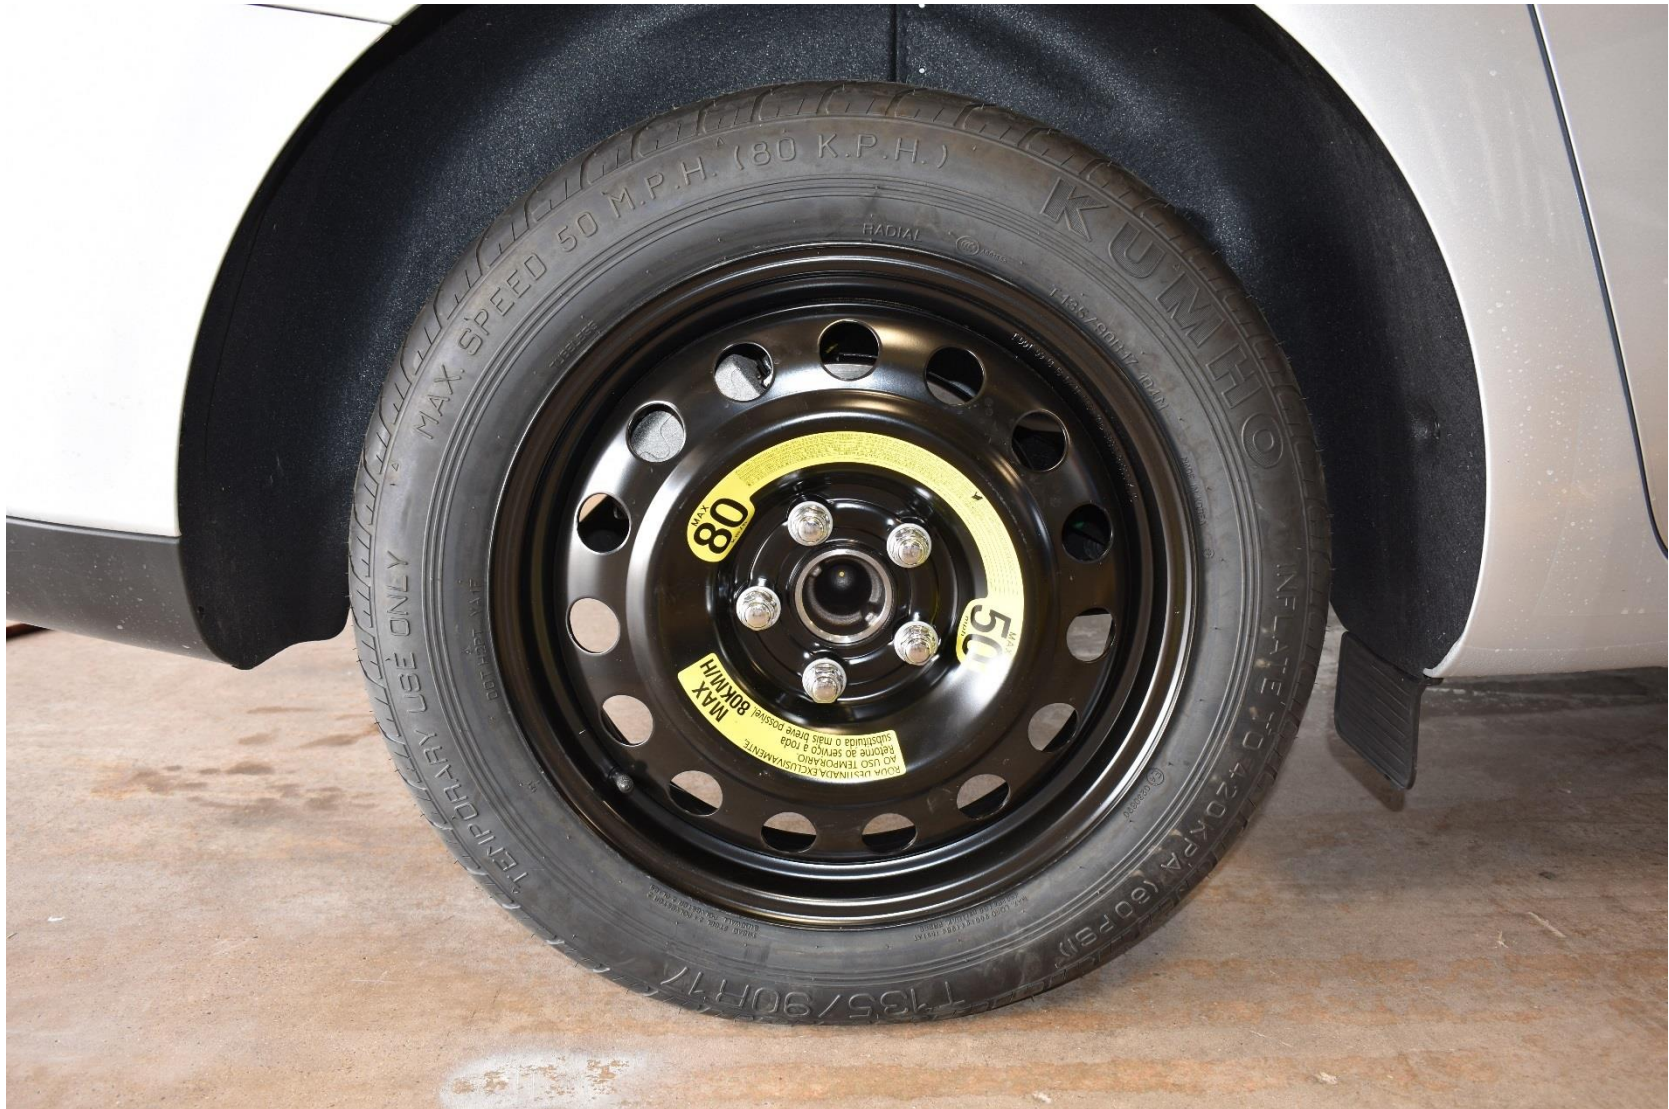
FIGURE 5.15  
MALFUNCTION 1 - SPARE TIRE WITHOUT TPMS  
SENSOR MOUNTED ON RIGHT REAR AT LLW

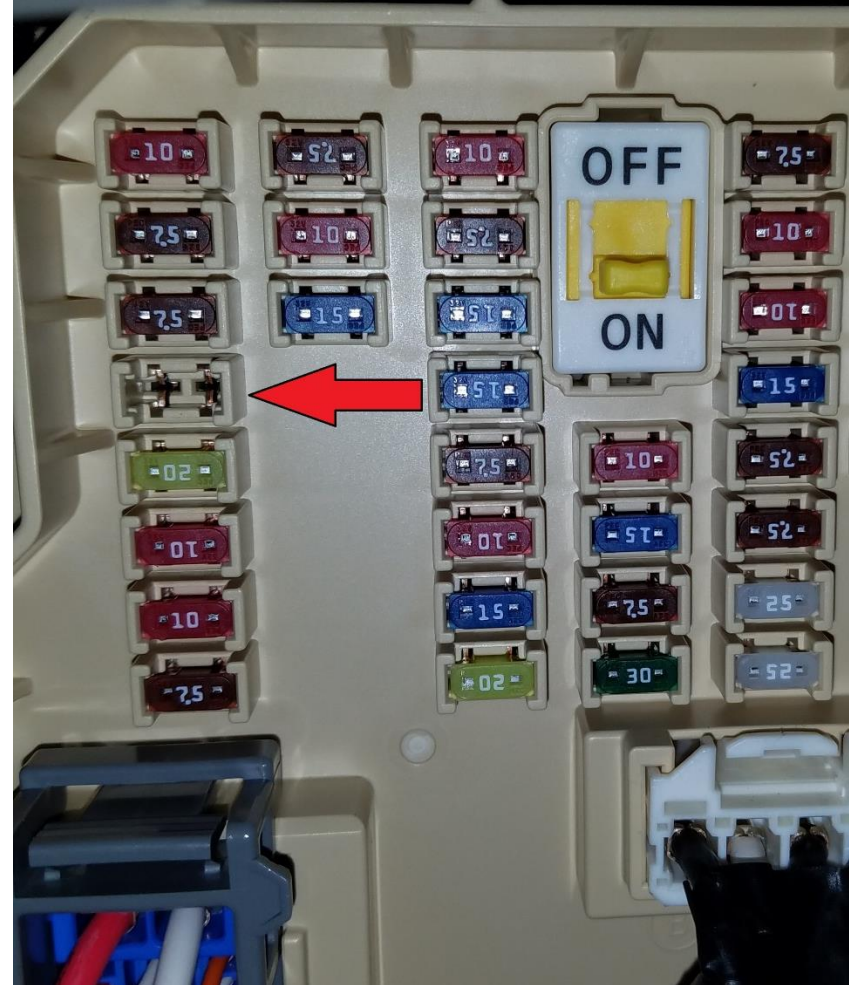
FIGURE 5.16  
MALFUNCTION 2 – TPMS FUSE REMOVAL

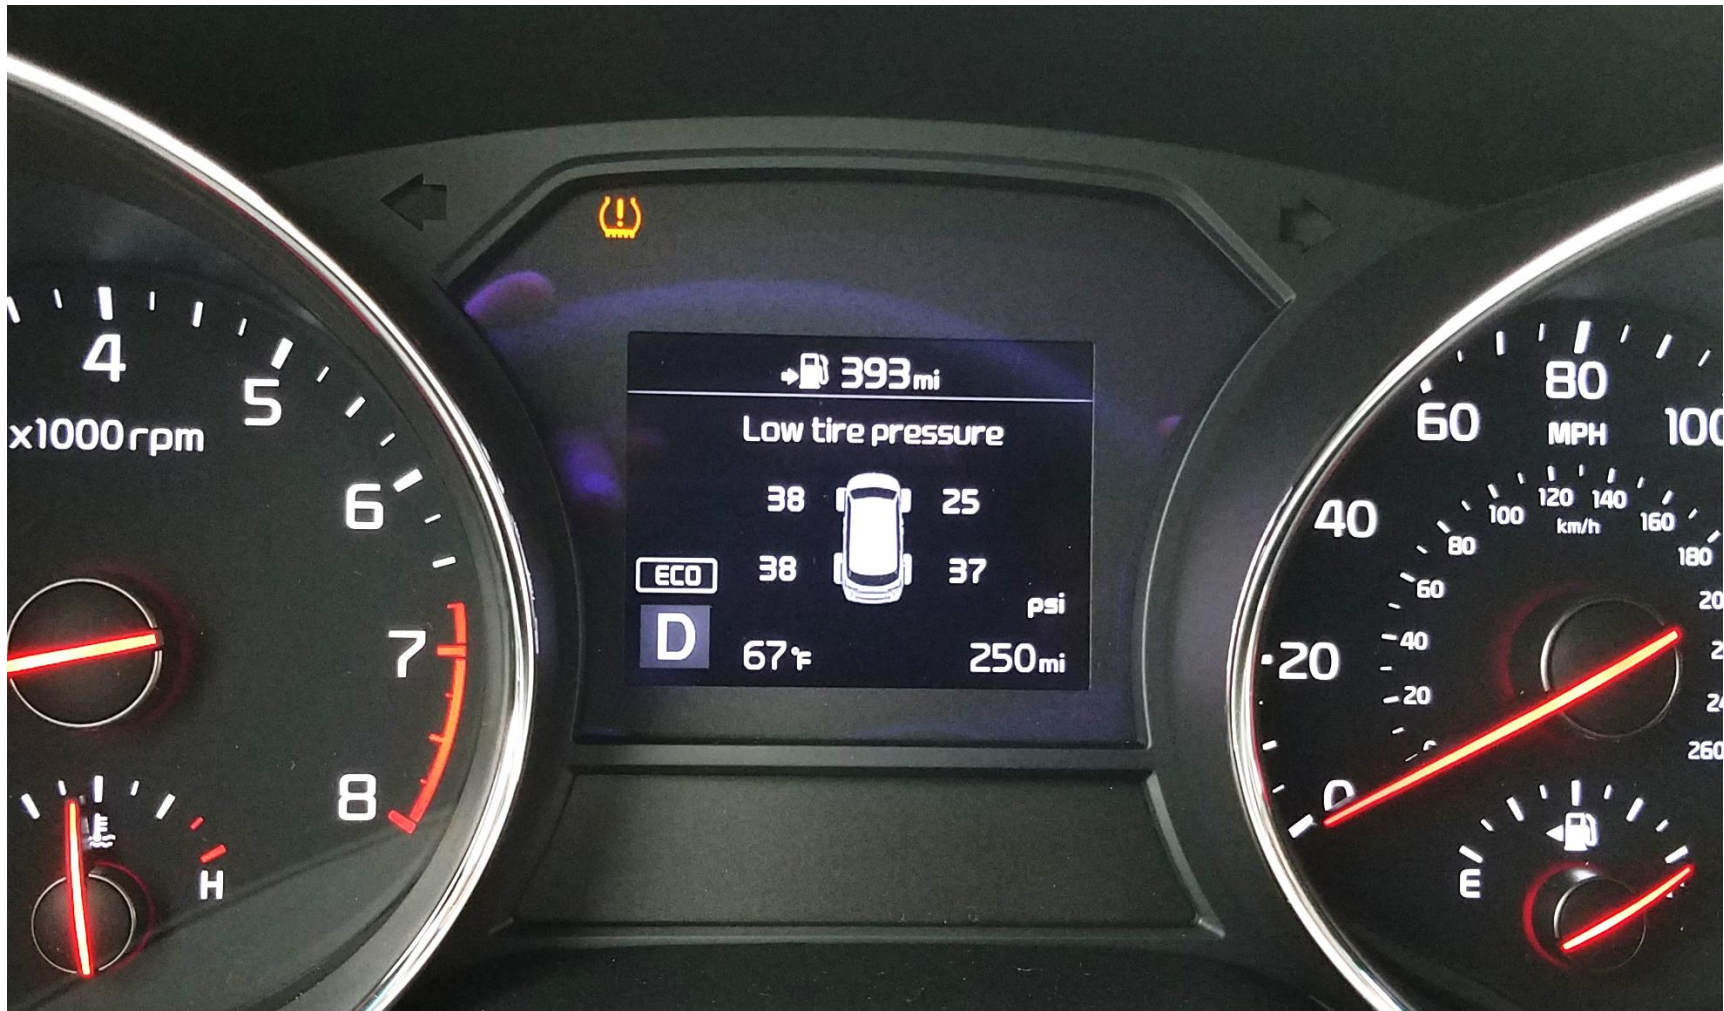
FIGURE 5.17  
 TPMS LOW TIRE PRESSURE/MALFUNCTION TELLTALE  
 WITH DISPLAY SHOWING LOW TIRE LOCATION

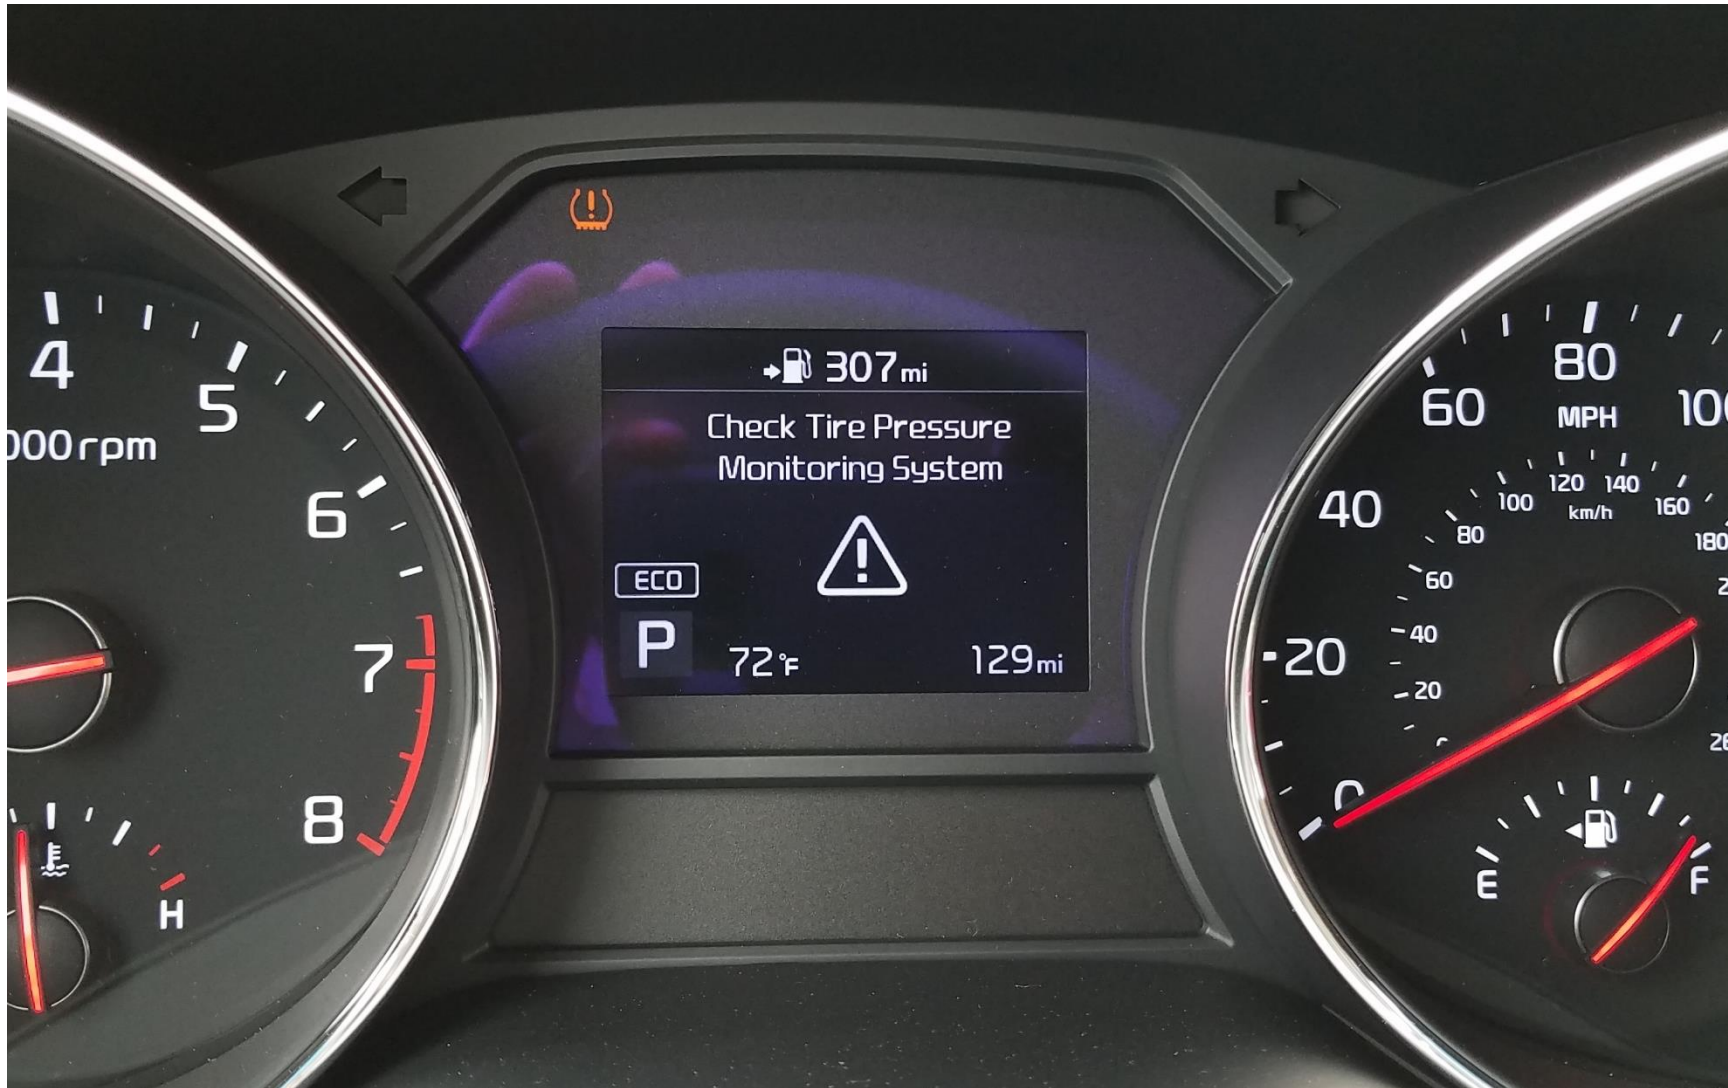
FIGURE 5.18  
TPMS LOW TIRE PRESSURE/MALFUNCTION TELLTALE  
WITH DISPLAY SHOWING MALFUNCTION WARNING

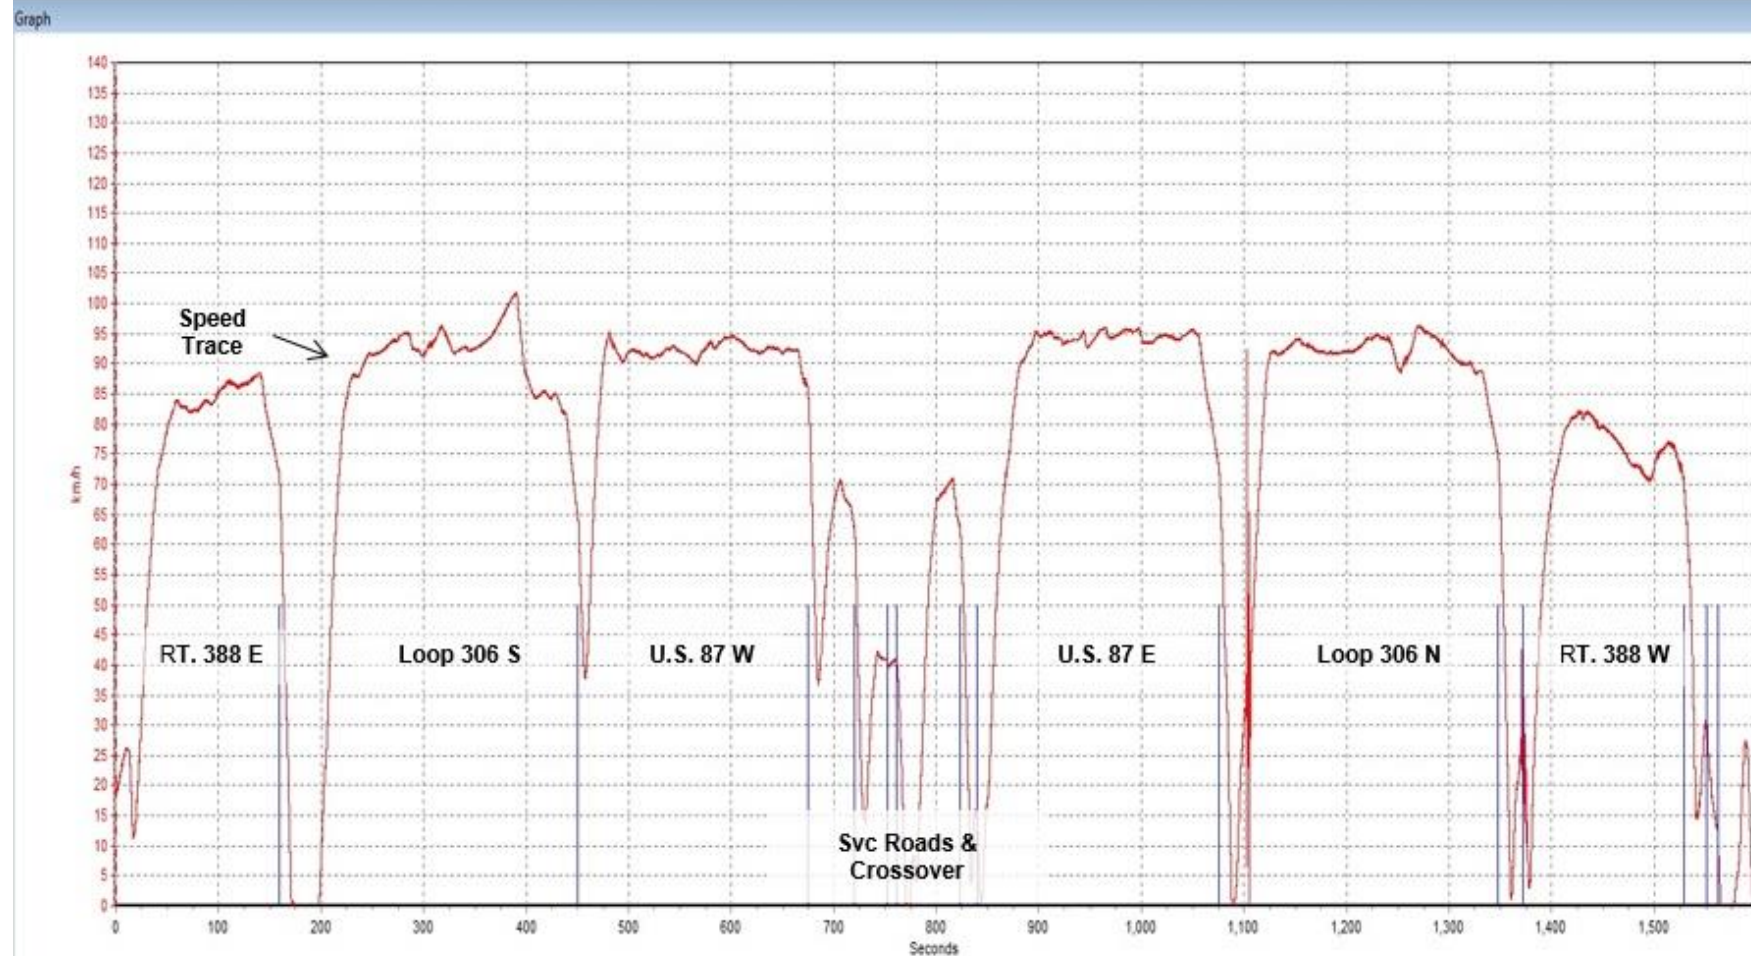
Scenario B: Left Front, Left Rear, Right Rear, Right Front Tires at LLVW  
Test Date: 3/7/19  
Data File Time: 26:38 minutes  
Cumulative Driving Time: 20:28 minutes  
Start Point: GAFB North Gate

2019 Kia Sedona LF, LR, RR, RF Calibration Run LLVW (Scenario B)
