**Sealight LED H11  
Replaceable Headlamp Light Source**

FINAL REPORT 108-CAN-20-001

**TEST REPORT**

Specification: FMVSS 108 / Part 564

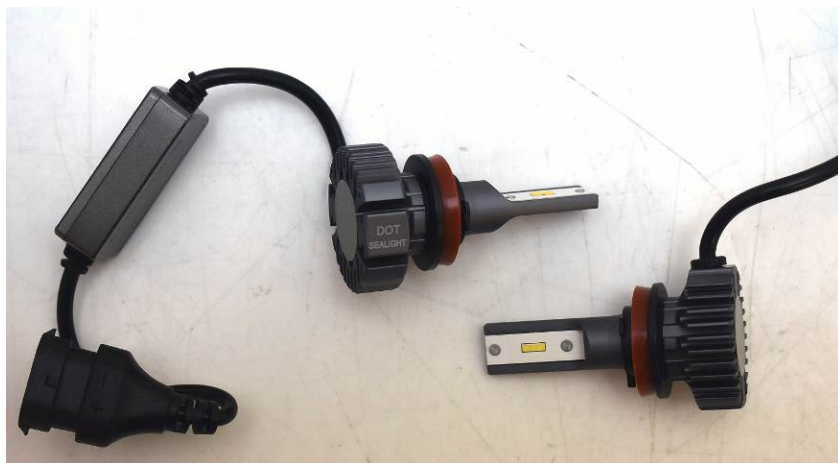
Photo of samples

Samples have a significantly different base from what is specified in NHTSA-1998-3397-34. Base is separated into multiple parts and use LEDs as light source which is neither a resistive filament source nor a discharge source as described in FMVSS 108 S14.7.3.

Sample can be mounted into a typical H11 holder. A typical H11 plug can connect and provide power to sample if connector polarity is observed. Sample base is not indexed as specified on Sheet H11-3 (Dimension XA), so plug can be rotated 180° and reinserted if sample does not energize when voltage is applied.

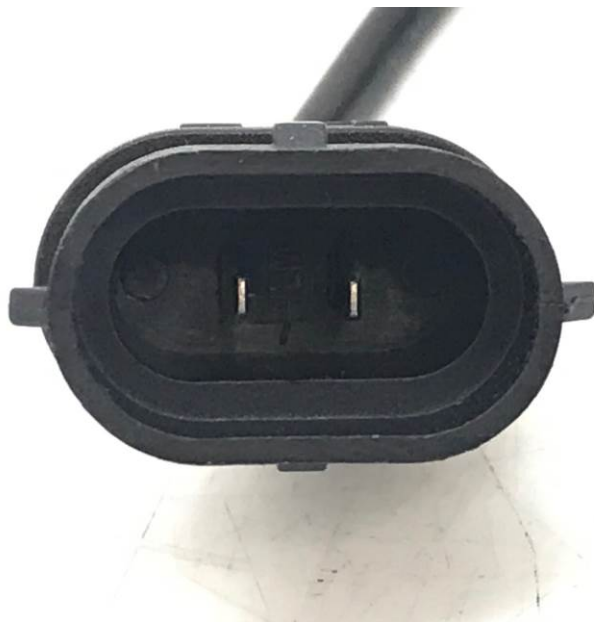
Photo of sample

Samples do **NOT** meet the dimension requirements of the PGJ19-2 base.

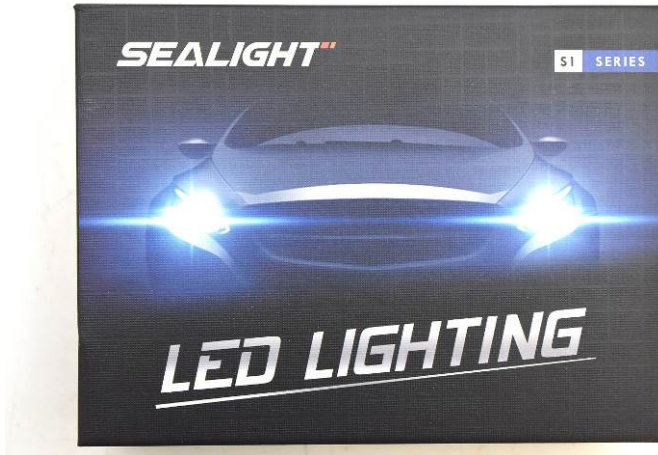
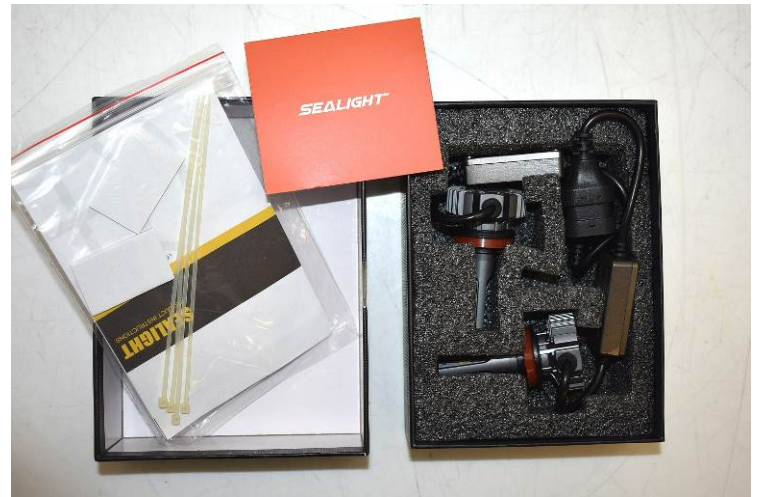
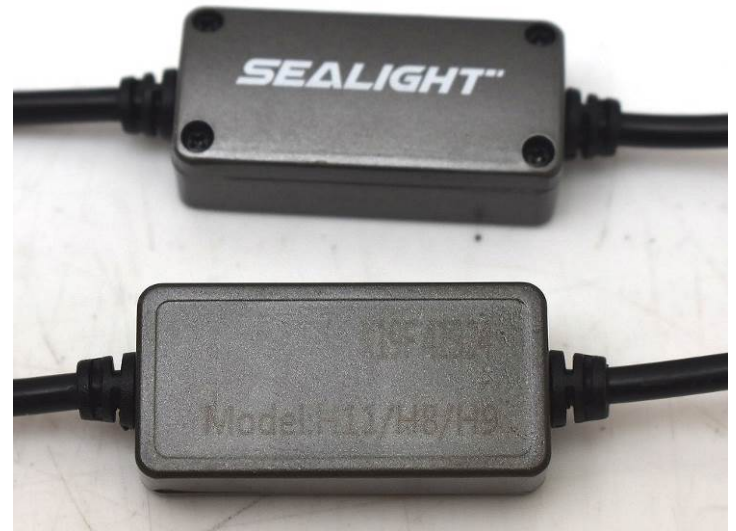
**PHOTOGRAPH SHEET**

Samples are LED sources that can be installed in lamps designed for standard halogen H11 replaceable light sources. Each sample has an array of LEDs, instead of a filament, mounted vertically about the RLS' reference axis.

However, the markings of multiple H type models ("Model:H11/H8/H9") are of replaceable light sources with different requirements.
