ODI Action Number: **PE99-040**

Subject: **VOLVO CARS OF NORTH AMERICA, INC.  
1995 - 1998 VOLVO 850/900/70/90 SERIES**

## **ALLEGED INADVERTENT SIDE AIR BAG DEPLOYMENT FAILURES**

**CALSPAN REMOTE INADVERTENT SIDE AIR BAG DEPLOYMENT  
INVESTIGATION**

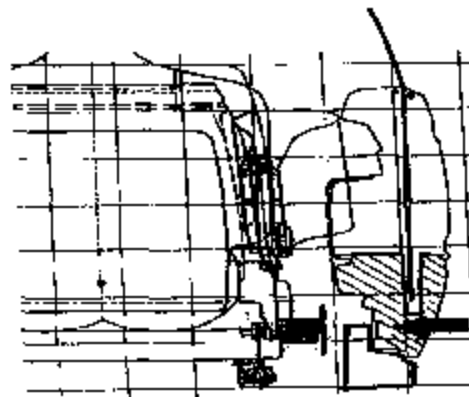
### **Volvo's Sipsbag Seat Installation**

The Sipsbag's sensor was located on the outboard aspect of the lower seat frame and the module was contained in the outboard seat back. The ventilated Sipsbag was made of polyamide with an internal coating of silicone rubber. It was designed to deploy when an impact triggers a mechanical sensor and drives a firing pin into a percussion cap. Speed, force, and deformation equivalent to a side impact at a minimum of approximately 18 km/h (11 mph) is required to initiate the deployment of the side air bag system. The conditions required to trigger the Sipsbag are:

- Speed > 2 m/s
- Force > 500 N
- Stroke > 2 mm

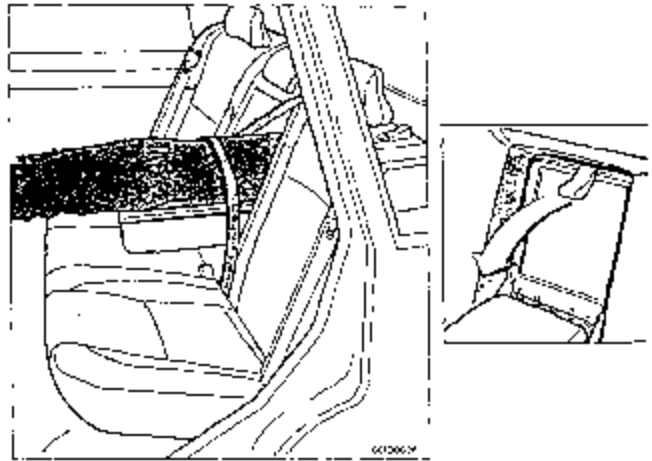
## Long load storage (sedans)

There is a flap located in the panel behind the rear seat which makes it possible to carry long loads such as skis, etc. To open, pull the strap forward.

The owner did not follow the Volvo SIPS bag warnings. Additionally, Volvo's "long load" opening for items like hockey sticks and skis, that passes between the center back seat and the trunk, was not utilized. This is clearly stated in the Volvo owner's manual.

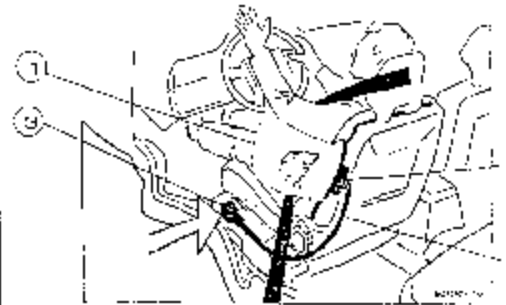
1 - Airbag, 2 - cable, 3 - sensor unit, 4 - gas generator

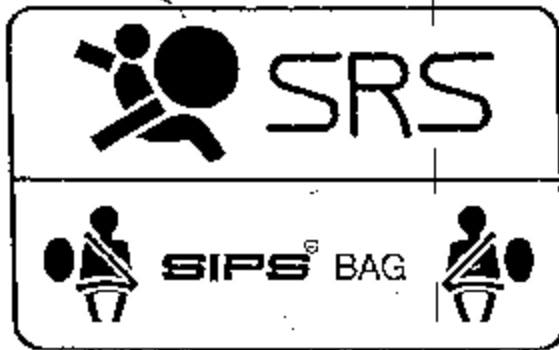
8600533A

Decal on front windshield combined with SRS decal.  
Decal indicates whether car is equipped with SIPS bag.
