HOLIDAY RAMBLER®  
ALUMA-LITE®  
TRAVEL TRAILERS

**PARTIES INVOLVED:** [REDACTED]  
**COURT CAPTION:** [REDACTED] v. Holiday Rambler and Rangitsch RV  
**COURT NAME:** U.S. District Court, Missoula Division, Montana  
**CAUSE NO.:** CV 97 140 M LBE  
**FILING DATE:** 9/95  
**DEFECT CLAIMED:** Stability Involving a 1996 Aluma-Lite 31CFS travel trailer. See attached letter from local counsel.

# OVERVIEW OF COMPLETE 1995 31CFS

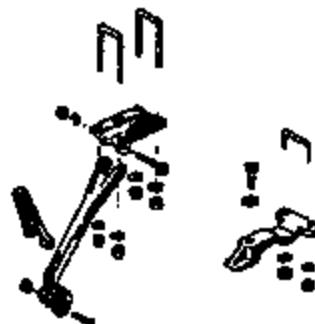
Dual Cam Sway Control Components

Dual Cam Sway Control properly installed

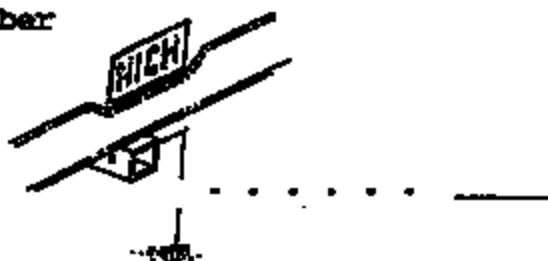
1. With the vehicle running, measure the number of inches from parking surface to the inside-top of the 2" square receiver box
